# How to Replace the Audio Jack

Quick and simple trouble shooting to determine the cause of a lack of sound coming from Skullcandy Lowrider OE (Over-the-Ear) headphones.

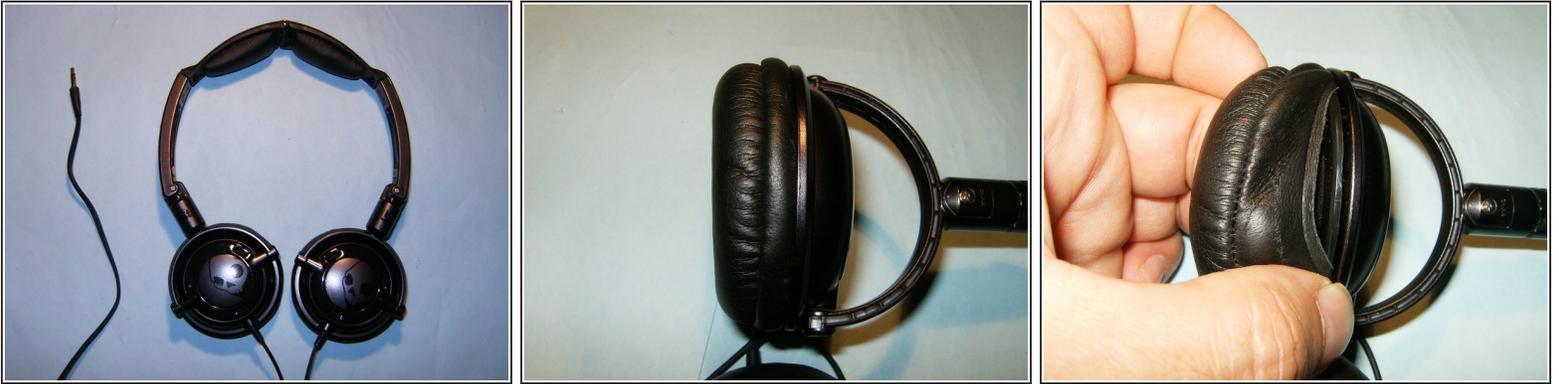
## Step 1 — How to Replace the Audio Jack

- Here is the complete headphone. I got no sound from either side when I plugged it in to my old iPod.
- The cushion is simply stuck into a space between the speaker (driver) and the case.
- Remove the cushion by gently tugging it out of that groove.

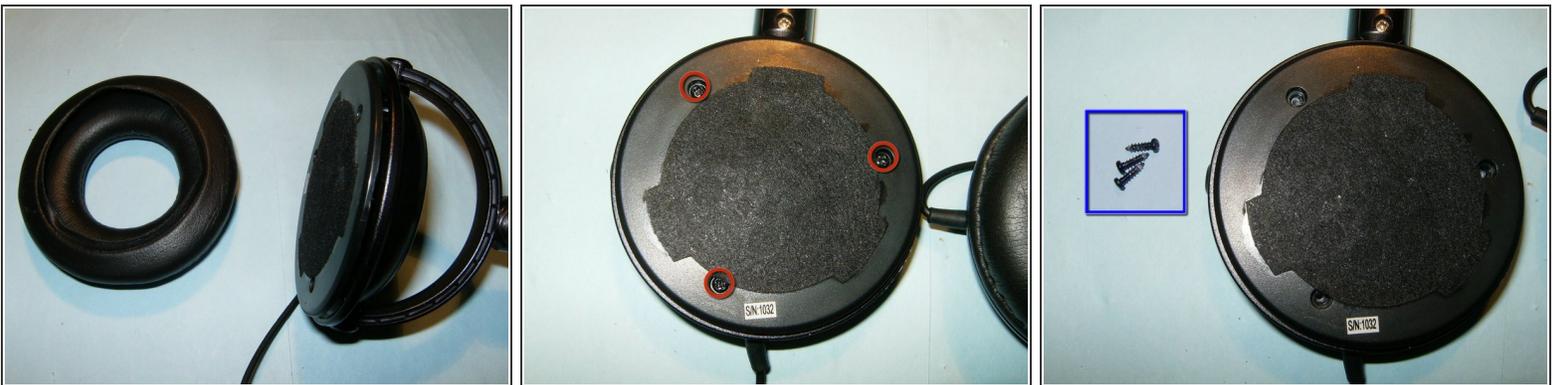
## Step 2

- Here is a shot of the device with the ear cushion removed and intact (replacements are available online).
- Here are the three Phillips screws that need to be removed.
- The screws are all of the same size, so do not worry about separating them.

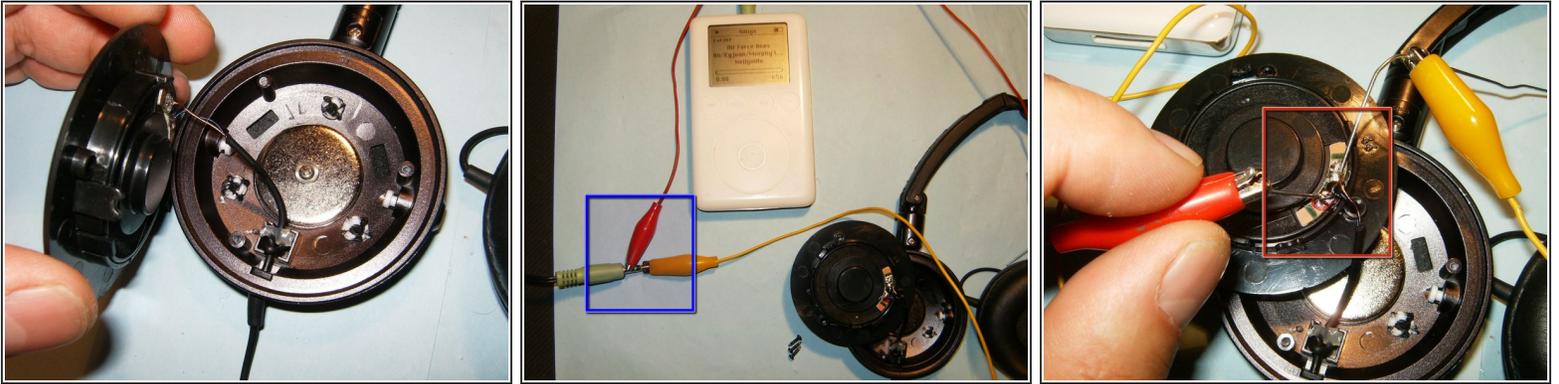
### Step 3

- With the three screws removed, the driver will simply fold up to reveal the wiring. In this case, the color code for the wires is Blue for left and Gold for ground.
- Here is the way I connected some alligator test leads. Use a male-male 3.5 mm stereo cable. Attach one lead to the sleeve, the upper part of the connector, and one lead to either tip (front) or Ring (middle) of the connector.
- Attach some test points to the end of the alligator cables and touch the solder connections of the speaker (driver). In this case, there was clear sound. This determined that there was no signal going from the connector to the drivers.

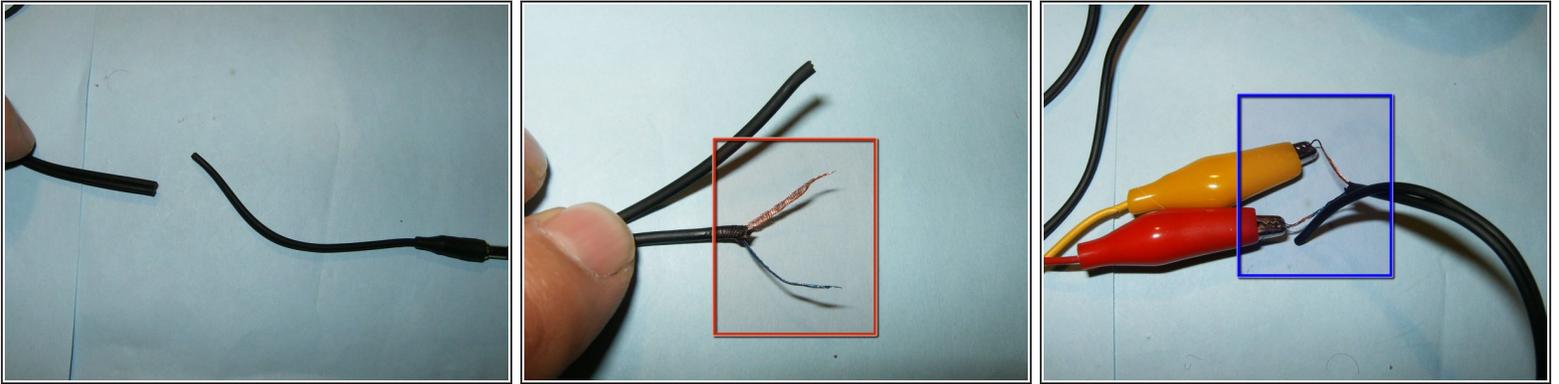
## Step 4

- Cut about 3 inches off the end of the cable.
- To make sure that it was indeed the connector, and not a cracked wire further up, remove the insulation of one set of wires. The device uses one set for each side. To remove the insulation, you can use a boxcutter, a sharp knife, a lighter, etc.
- Attach the test lead from any MP3 player, as previously shown. If the reason for the non-functioning headphones was the connector, there should now be sound coming from the headphone speaker (driver). In this case, there was. Therefore, it was indeed the audio connector that was broken.
