Siemens Surpresso brewing unit maintenance

The gaskets of the brewing unit are heavily...

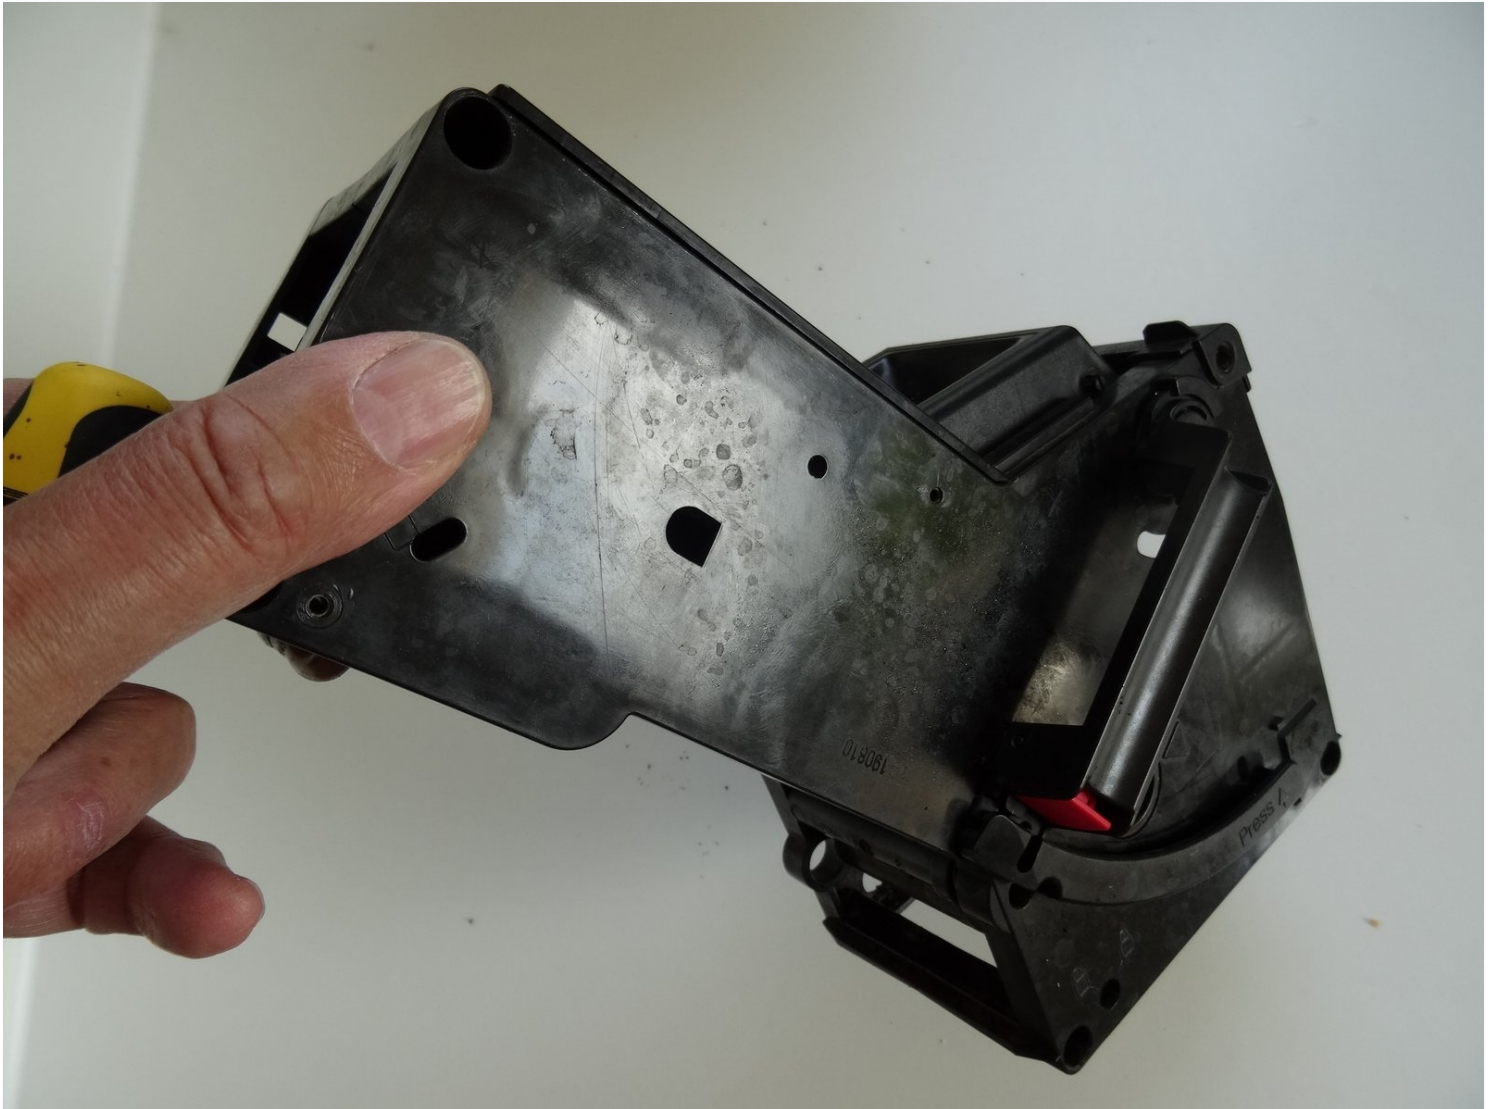
The gaskets of the brewing unit are heavily used and should be replaced from time to time. The Siemens brewing unit is identical to units of other brands, e.g. Nivona, Bosch, Melitta.

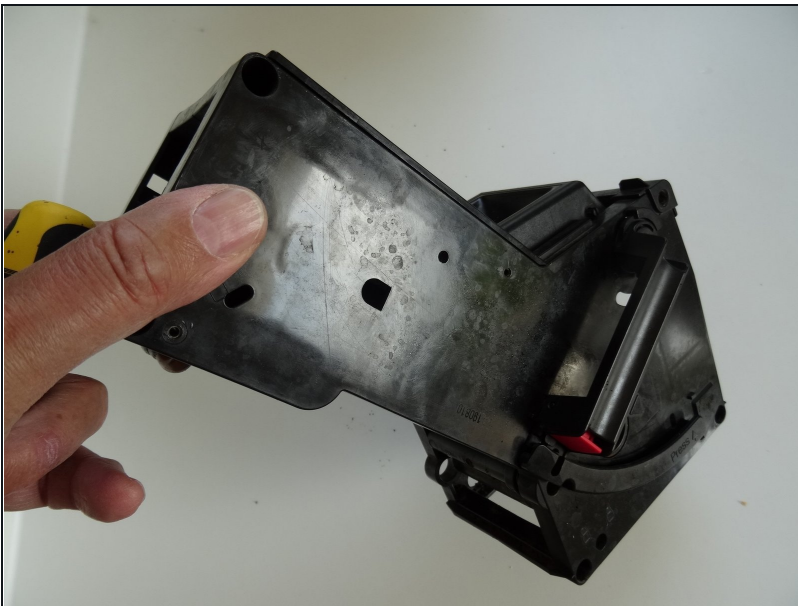
Step 1 — Brewing Unit maintenance

- Remove the brewing unit from the device.

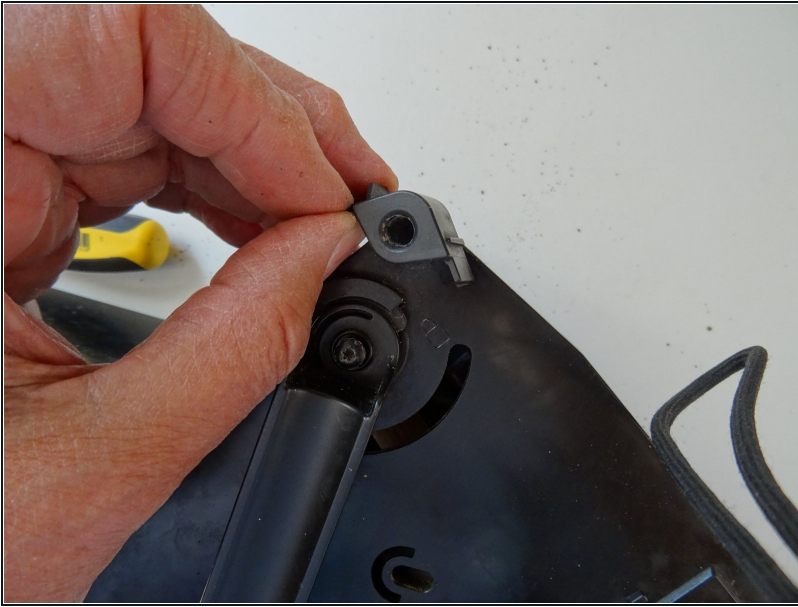
Step 2

- Take off the cap covering the screwhole in one corner. The cap ensures a better fit of the brewing unit.
- Note: some versions of the brewing unit do not have this cap.

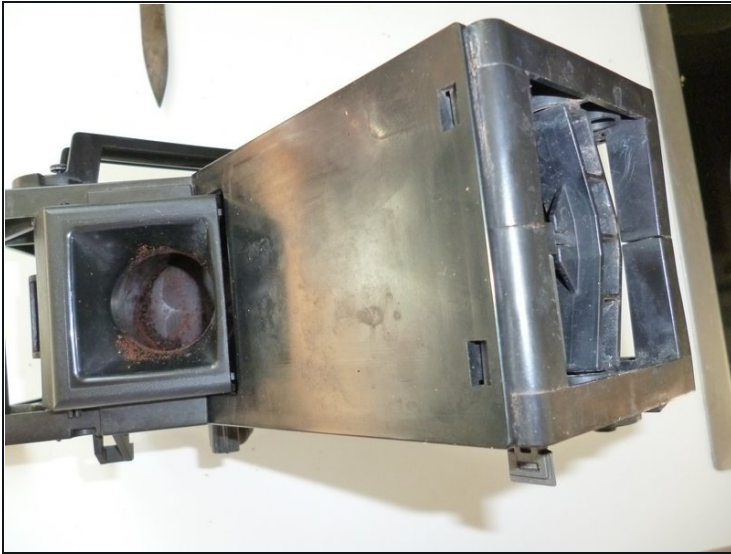
Step 4

- Unclip the upper protection panel, then remove it by lifting it up.

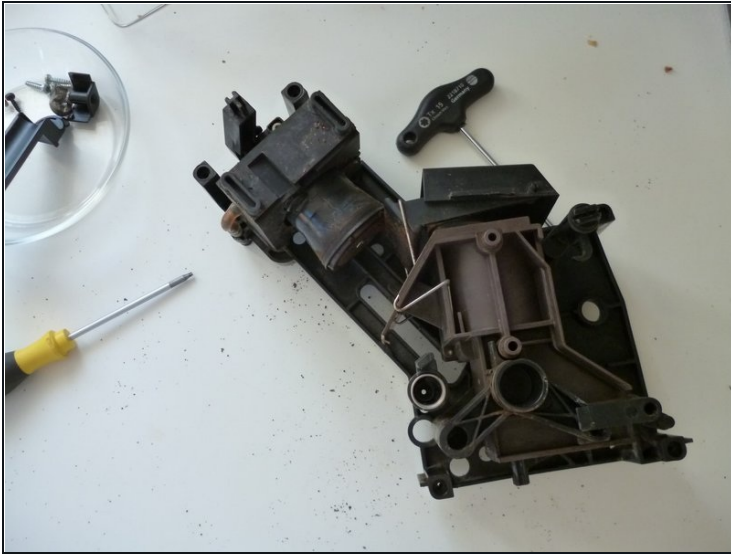
Step 6

- The inside of the brewing unit is exposed. You can see:
- The upper piston and its gasket.
- The funnel for the coffee grounds
- The lower piston.
- The hold-down clamp

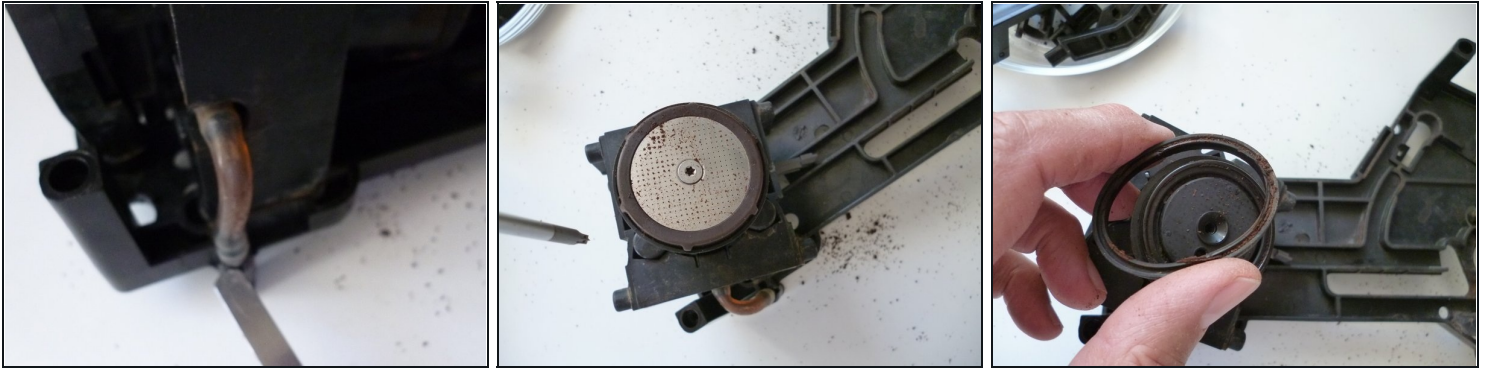
Step 8

- Remove the hose connecting the upper piston and the coffee outlet.
- Remove the upper piston.
- Remove the Torx T20 screw from the screen of the upper piston.
- Take off the cover of the gasket and the gasket.
- Replace the gaskets of the upper piston, the coffee outlet and water connector.
 - ① The lip of the piston gasket must point towards the pressure, i.e. downwards.
- Clean thoroughly all parts. Use food-proof silicone grease to lubricate the gaskets.
