Sony Vaio PCG-41216L Disk Drive Replacement

How to replace the disk drive in a Sony Vaio PCG-41216L.

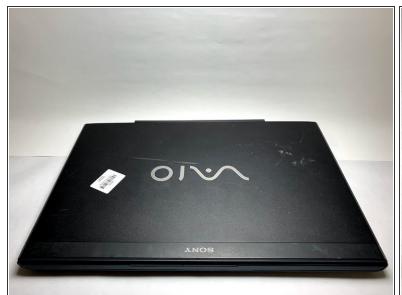
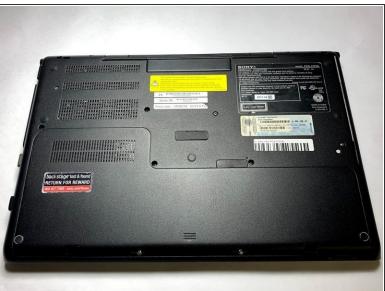
Step 1 — Disk Drive

Flip the laptop over to begin the process.

Make sure the laptop is turned off and unplugged from the power cable.

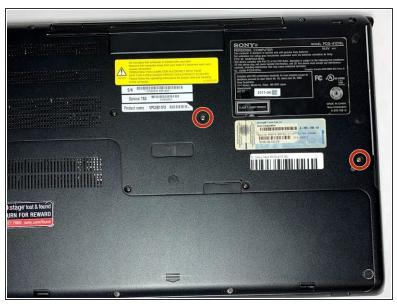
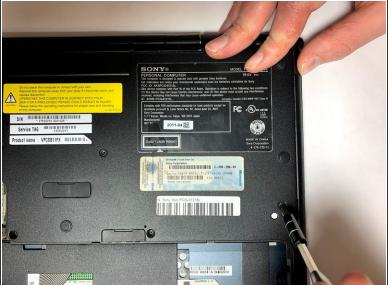
Step 2

• Remove the two 7mm Phillips #1 screws which hold the disk drive in place.

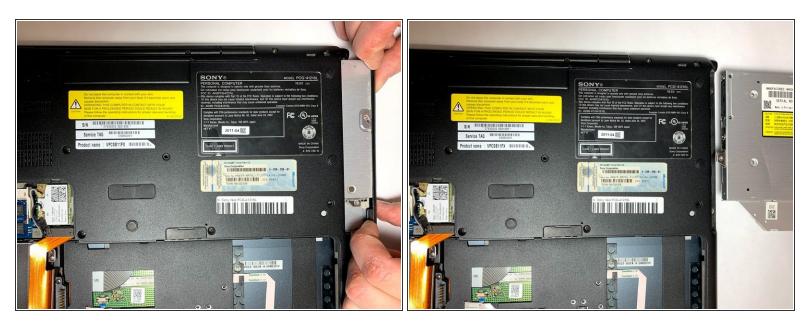
Step 3

Carefully remove the disk drive by gripping the disk drive by the edges and pulling it out of the computer. Insert the replacement unit in the same orientation and reassemble the unit.

To reassemble your device, follow these instructions in reverse order.
