Melitta Caffeo Solo outlet valve maintenance

Due to heavy usage the outlet valve needs maintenance from time to time.

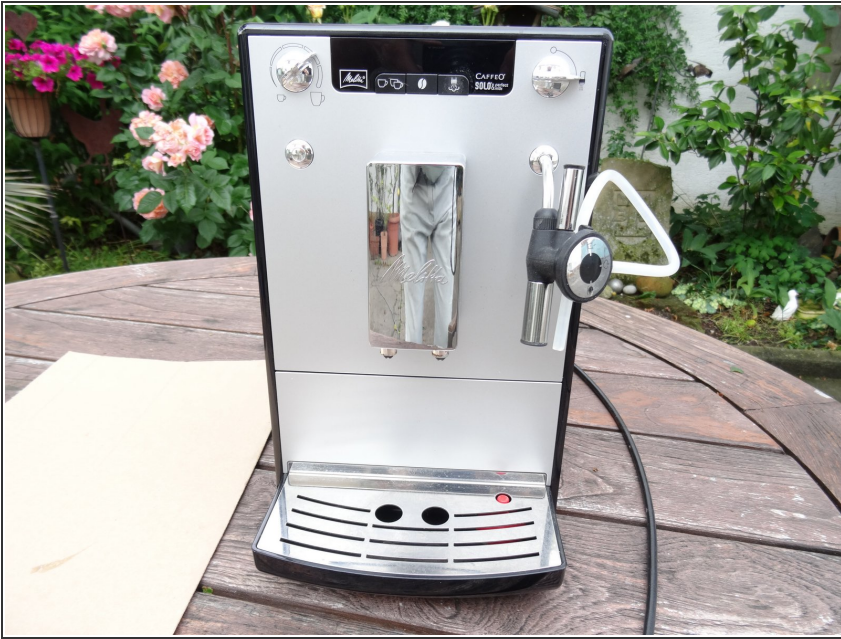
Step 1 — Open the Melitta Caffeo Solo

- Remove the water tank and drainage tray.
- Remove the side cover and remove the brewing unit.
- Remove all coffee beans.

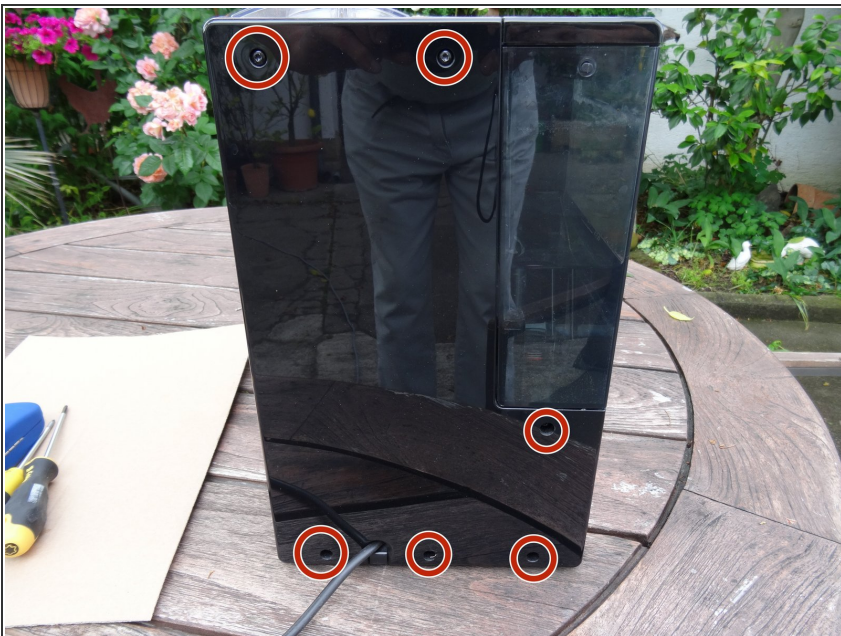
Step 2

- Unscrew and remove six Torx T10 on the rear.
- Lever the rear cover off. It will most likely be quite stuck and you will need to apply some force. You must use plastic lever tools to prevent damaging the cover.

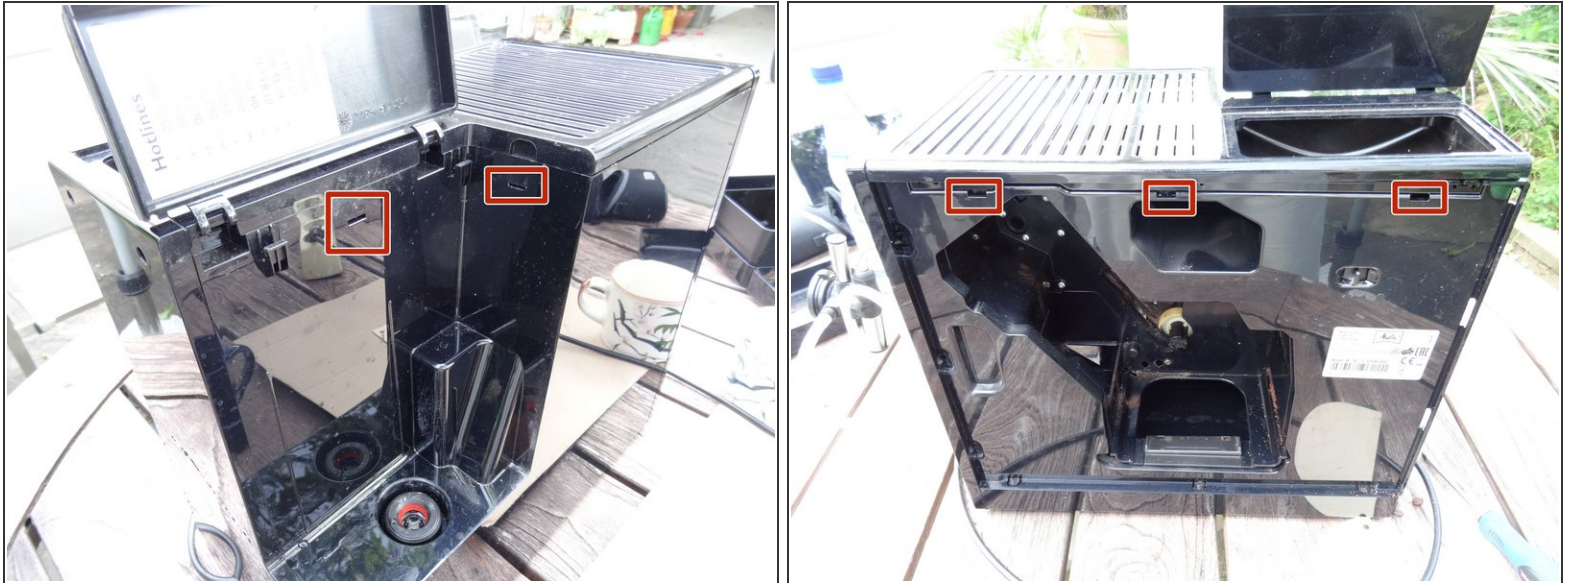
Step 3

- Press carefully into the slits on the sides using a minus screwdriver or a flat metal spatula, to release the clasps on the upper surface. These may be well tight and you have to use some force.
- You should have created a separation between the upper surface and side panels. Now lever the upper covering away using a plastic tool. This may be quite stuck and you may apply some force.

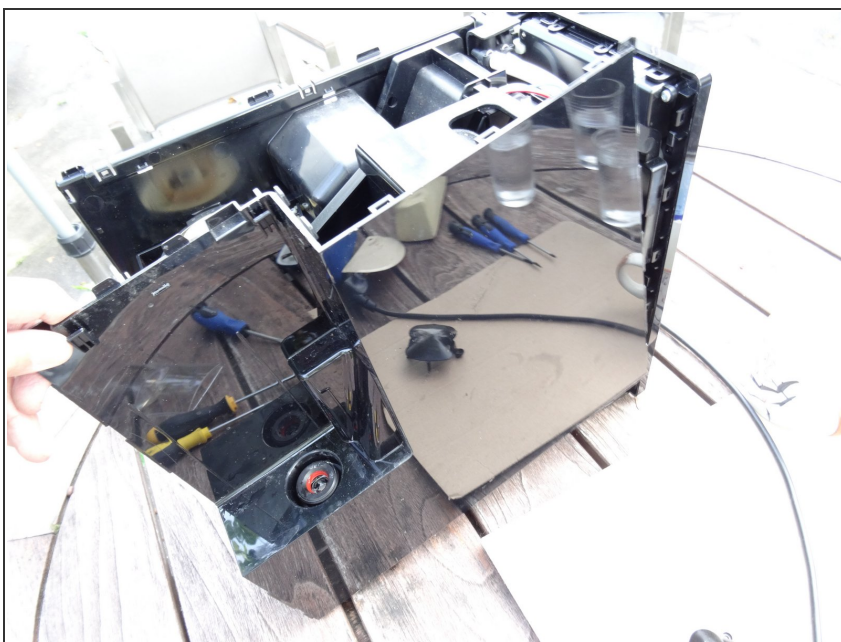
Step 4

- Place a plastic tool in the crack between front panel and left side panel and widen it. Then push the side panel to the back. The side panel will be quite stuck and you may apply some force to do this.
- Remove the hose from the water tank to the pump.
- Remove the side panel.

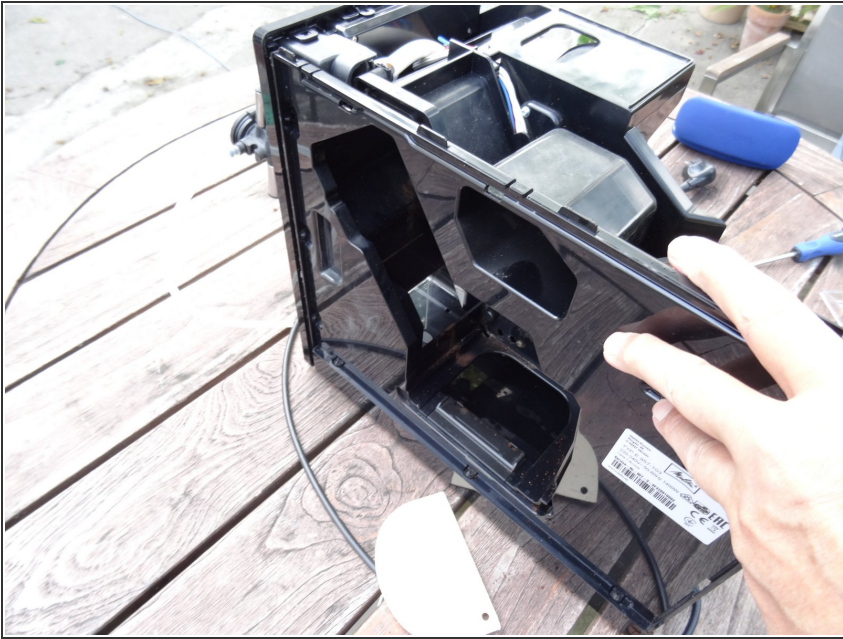
Step 5

- Place a plastic tool into the crack between the front panel and the right side panel and widen it. Then push the side panel to the back. This may be quite stuck and you may need to apply some force.
- Remove the side panel.

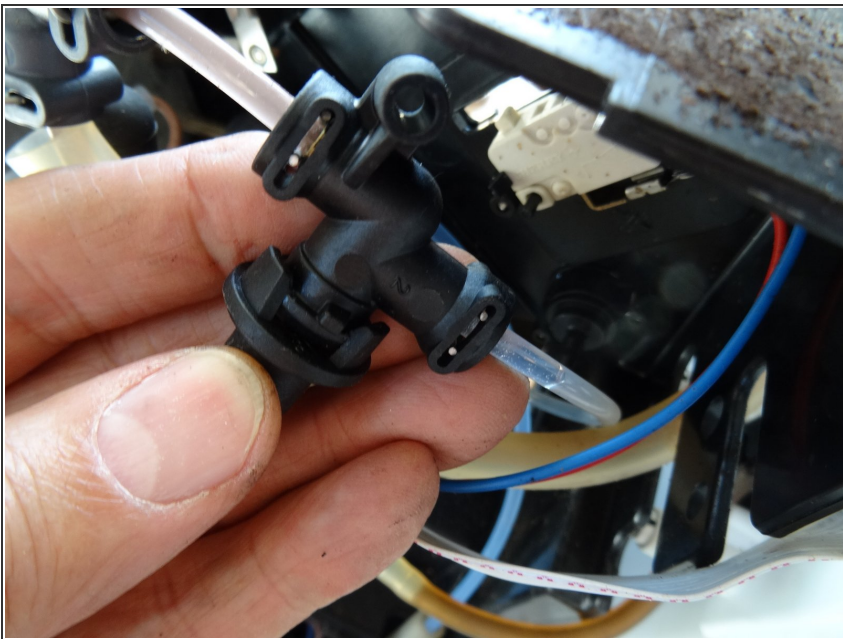
Step 6 — Outlet valve

- Look for the outlet valve on the top right of the device.

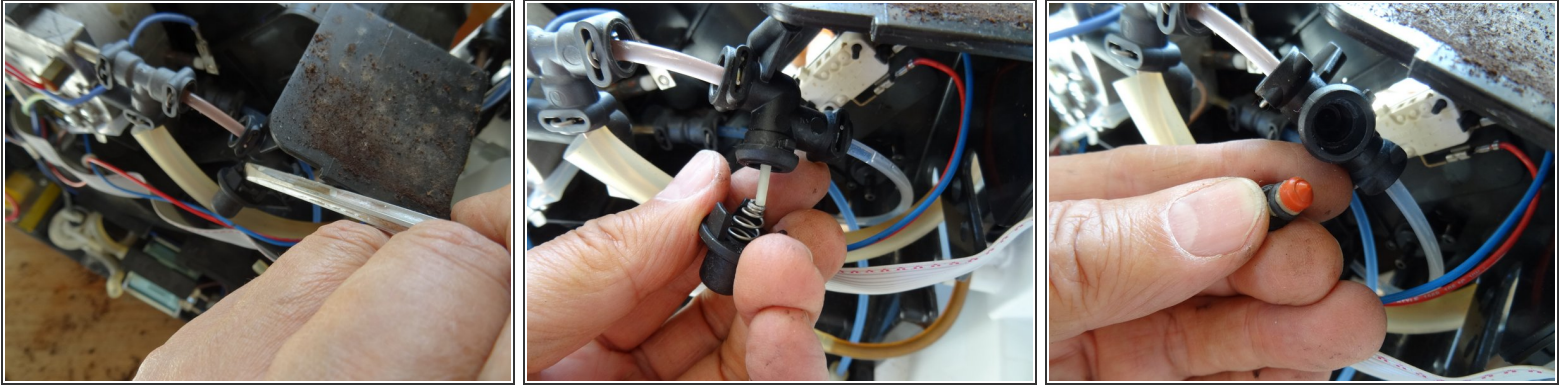
Step 7

- There are three latches securing the valve lid. Carefully lift the lid up using a metal spudger.
- Lifting the lid exposes a spring, a plunger and its holder, an O-ring and the seal of the plunger. The photo shows clearly the imprint of the valve seat, so the valve doesn't close properly. The plunger tends to break but the spare plunger in the repair kit is made of metal.
- ⓘ Note the order and orientation of the parts (photo).
- ⓘ Alternatively you can replace the complete valve, it's not too expensive.

Follow the steps in reverse order to reassemble the device.
