# Melitta Caffeo Solo brewing unit maintenance

### Step 1 — Brewing Unit maintenance

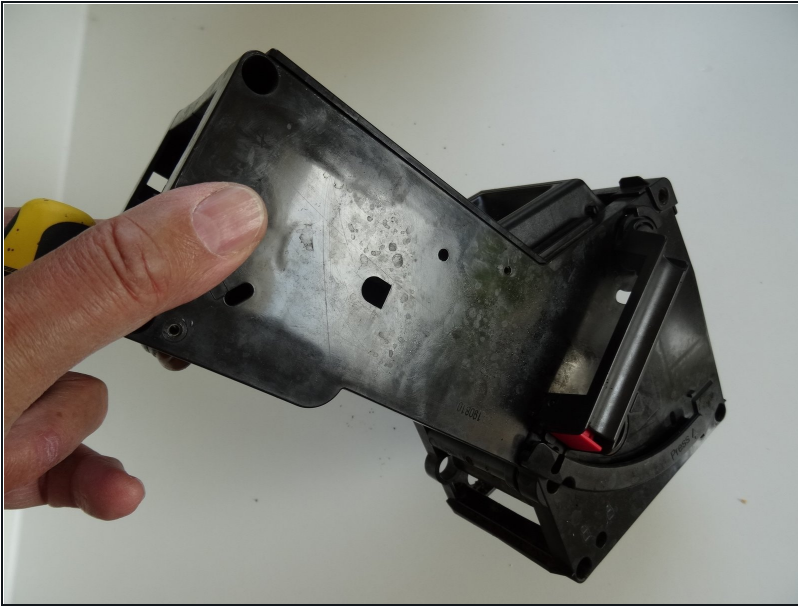
- Remove the brewing unit from the device.

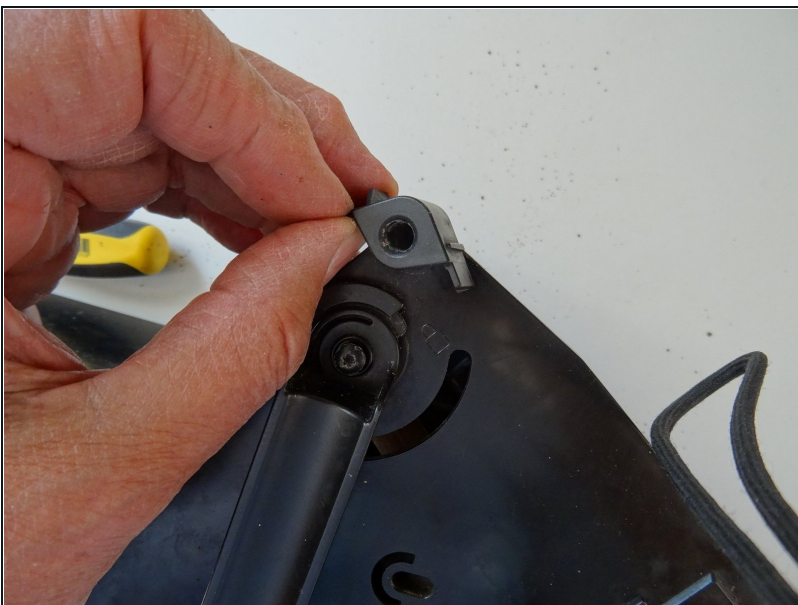
### Step 2

- Take off the cap covering the screw hole in one corner. The cap ensures a better fit of the brewing unit.
- Note: some versions of the brewing unit do not have this cap.

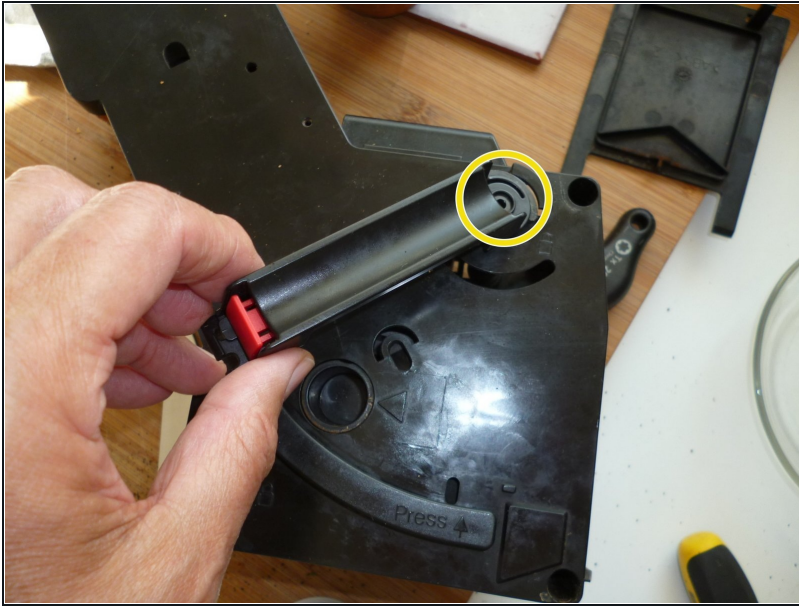
### Step 3

- Remove the single black Torx T10 screw fixing the opening handle.
- Using a certain amount of force pull the opening handle out of the guidance near the red button.
- Rotate the handle 90 degrees counterclockwise, then lift it off.

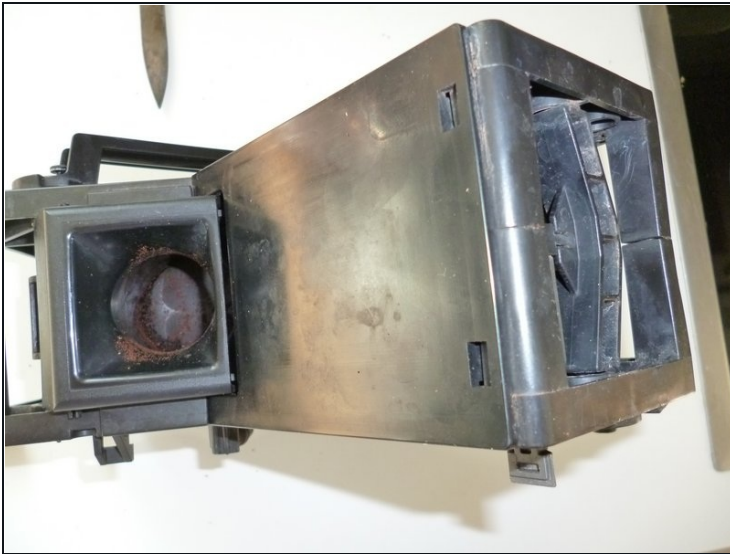
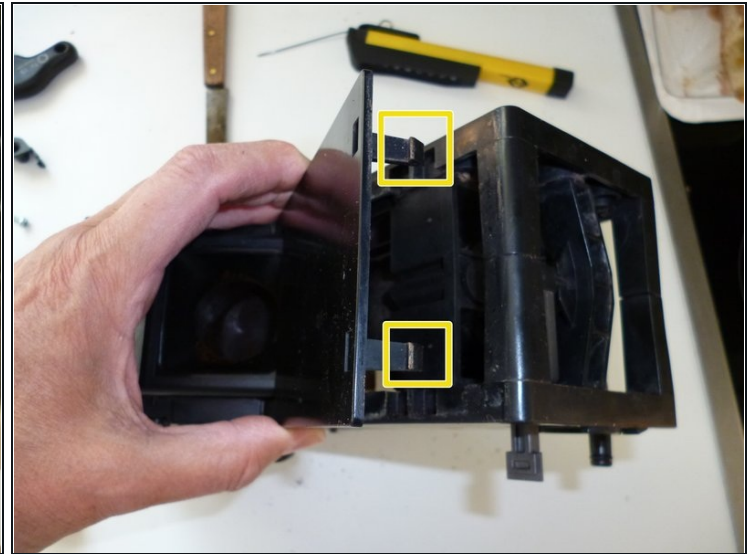
### Step 4

- Unclip the upper protection panel, then remove it by lifting it up.

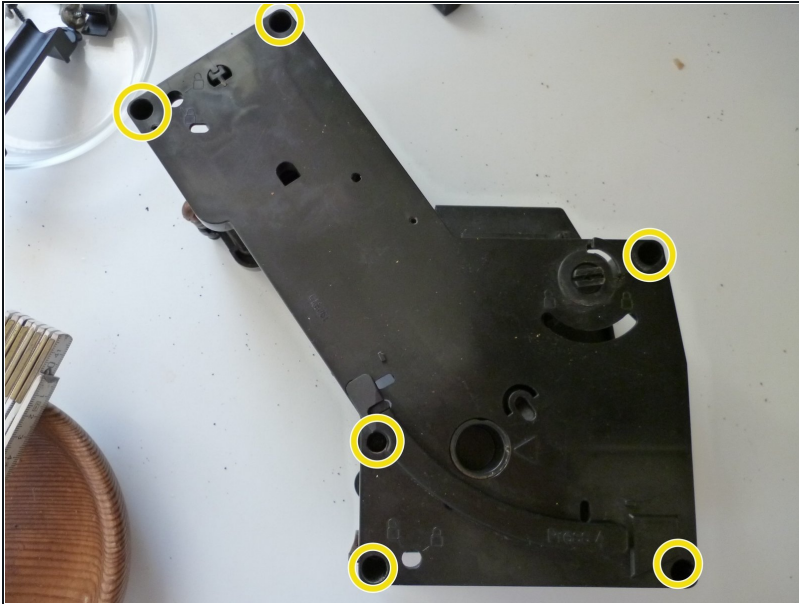
## Step 5

- Remove six Torx T15 screws holding together the brewing unit. The screwholes are rather deep.
- Lift the upper half of the brewing unit up.

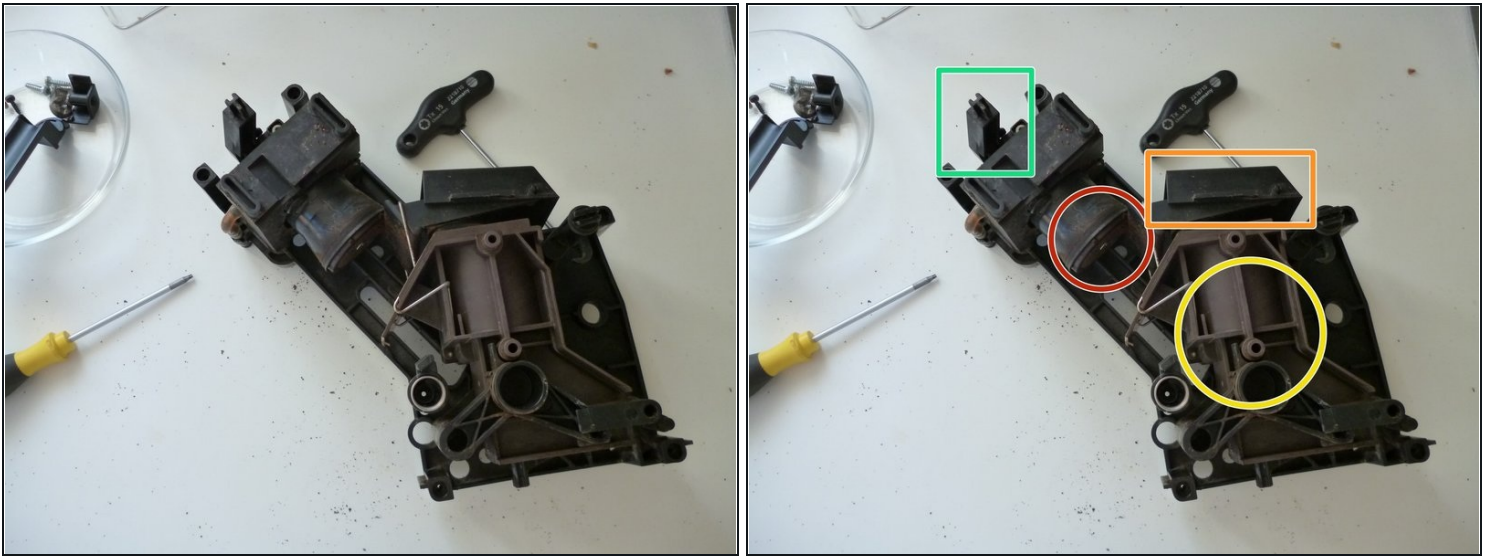
## Step 6

- The inside of the brewing unit is exposed. You can see:
- The upper piston and its gasket.
- The funnel for the coffee grounds
- The lower piston.
- The hold-down clamp
