# George Foreman GR-20 Top Lid Replacement

The [GR-20](#) is what we'll be working on today, with our focus on repairing and replacing the top lid to get your top grill working again if you're experiencing it not heating up and doing its job to grill.

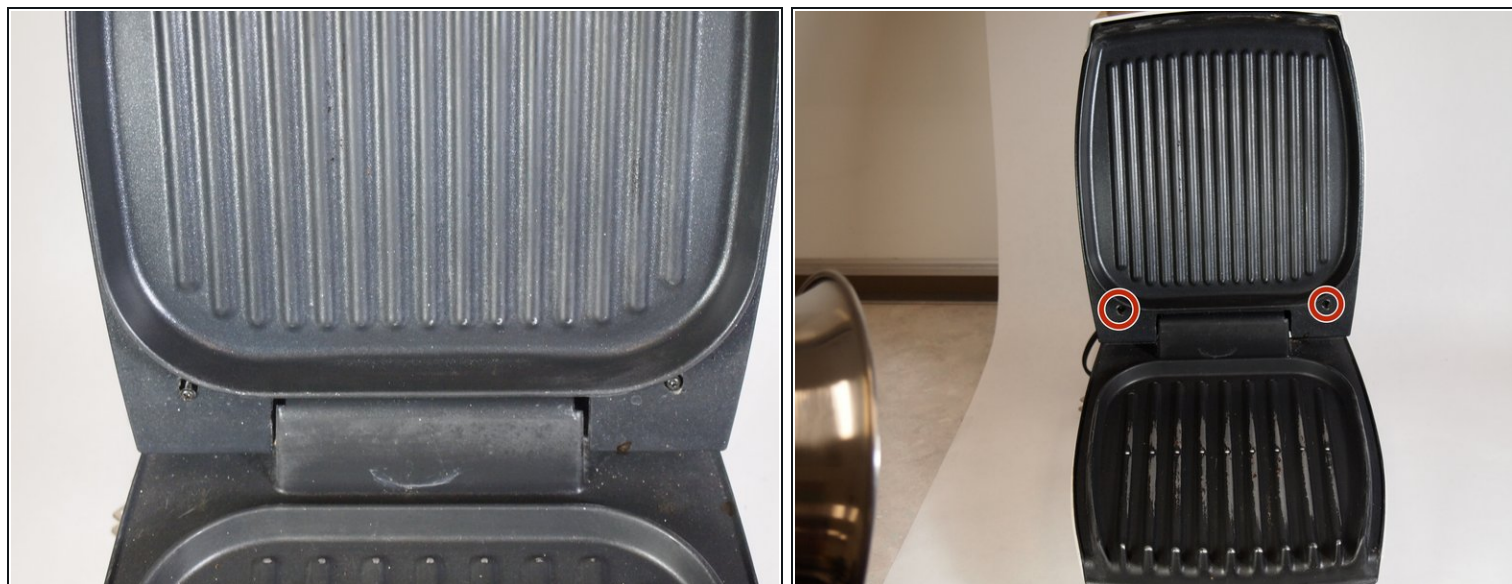
## Step 1 — Top Lid

- Open the grill and remove the two Phillips #2 screws from the top lid.

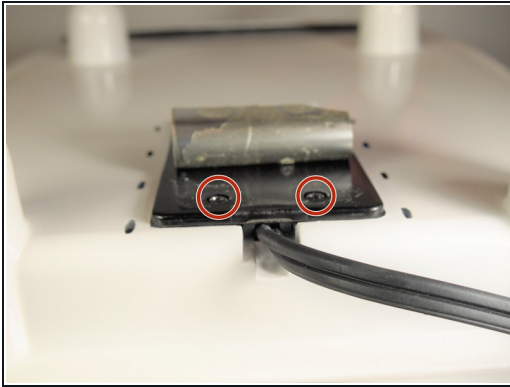
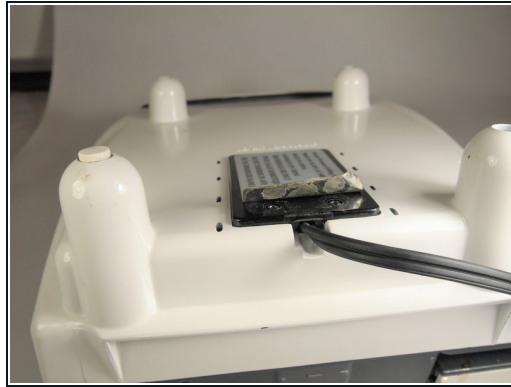
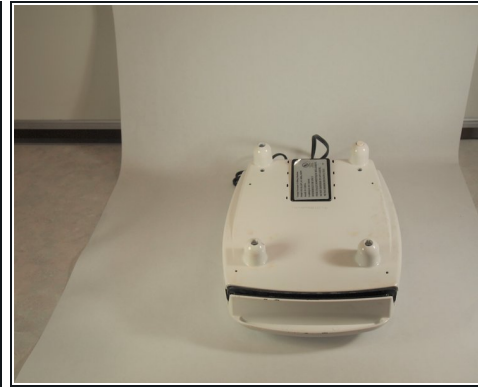
## Step 2

- Using a pick, peel off the model number sticker to expose the two screws underneath. Remove these screws using a Phillips #2 screwdriver.

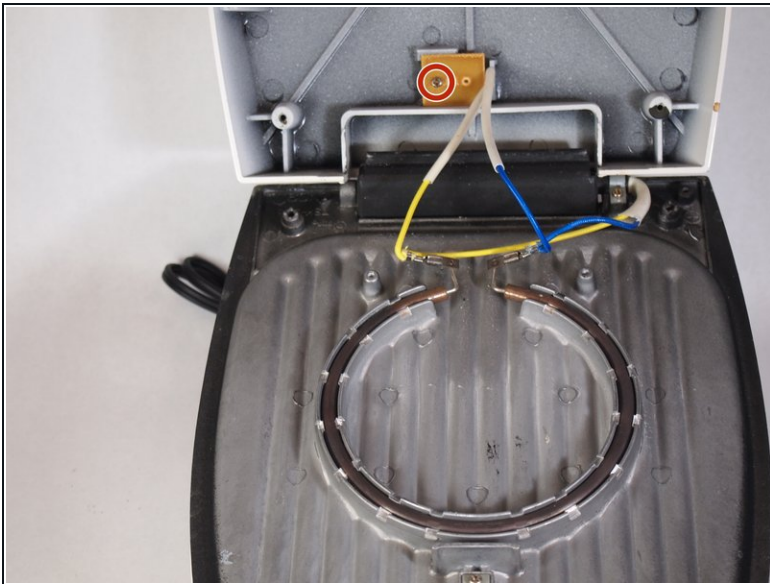
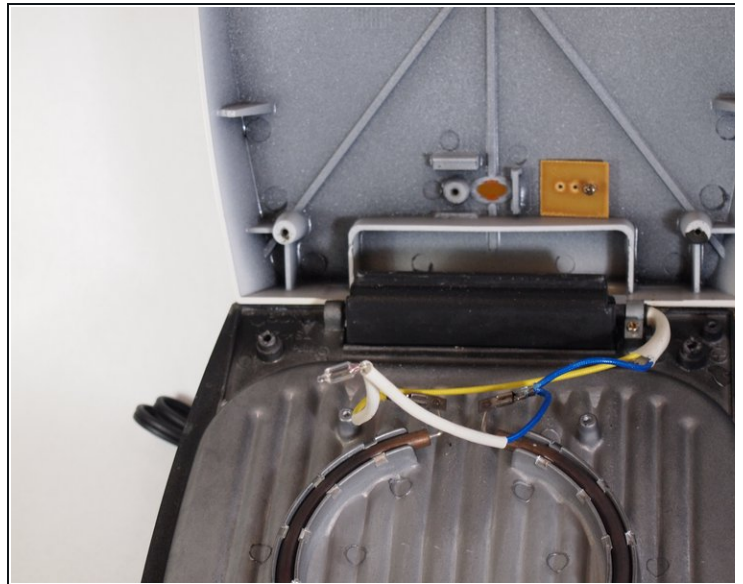
## Step 3

- Remove the Phillips #2 screw from the orange tab.
- Detach the top lid from the bottom of the grill.

To reassemble your device, follow these instructions in reverse order.
