Fisher and Paykel Aquasmart Washing Machine Suspension Rods Replacement

Kept getting an overbalance fault. Very heavy knocking sound during the rinse cycle.

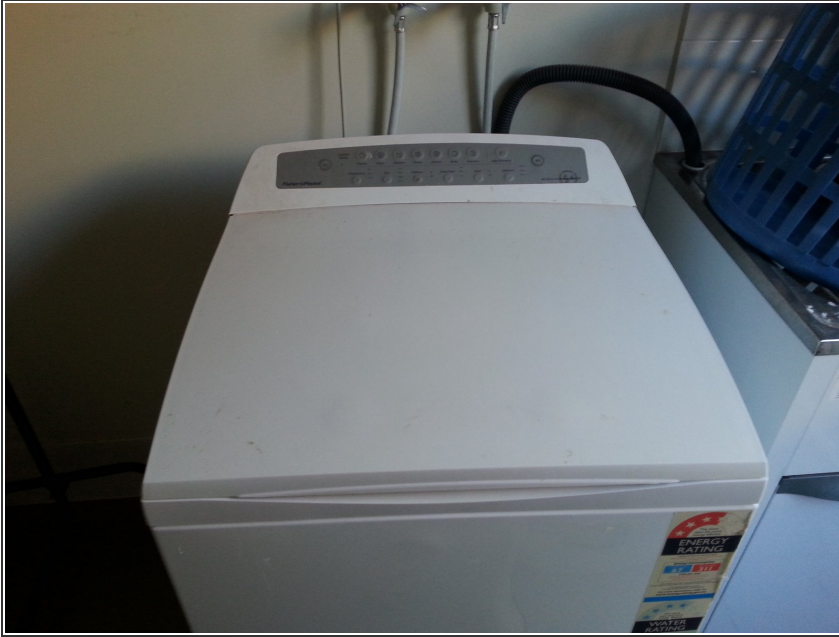
Step 1 — Getting Started

- First step is to disconnect power.
- Then disconnect all the hoses at the back and move the machine to a place where you have some room to work.

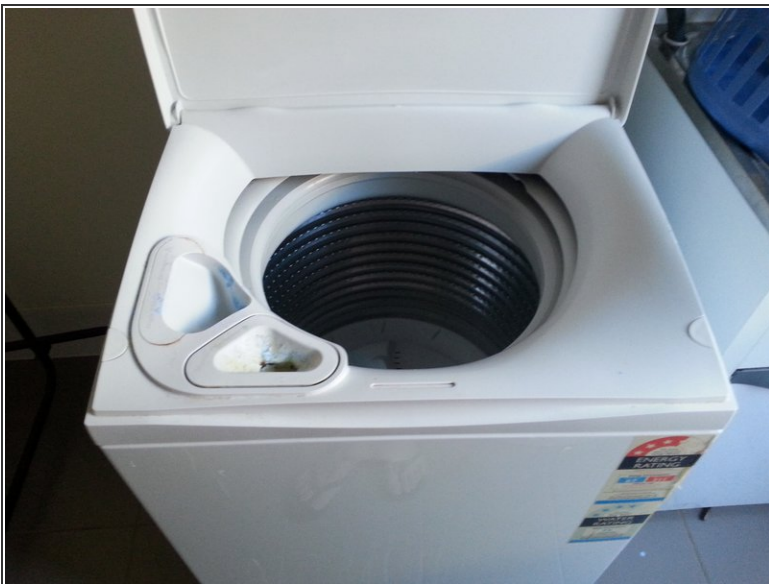
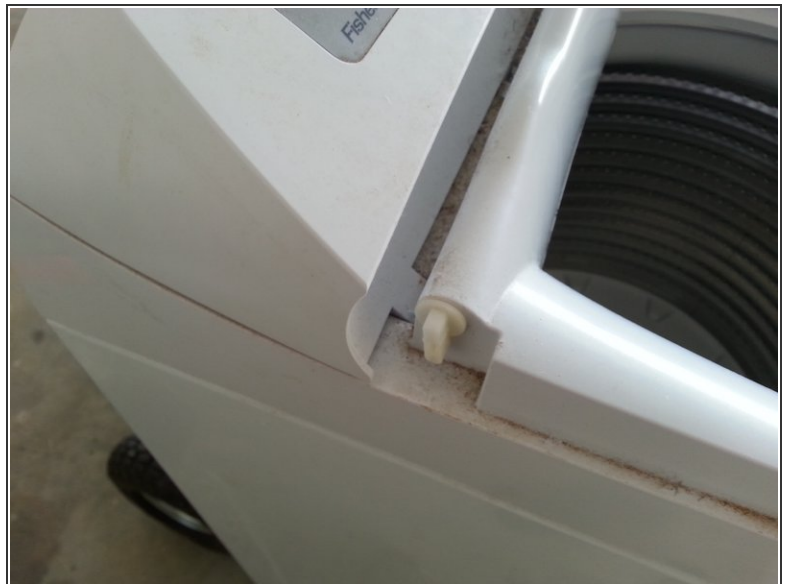
Step 2 — Remove the lid

- Removing the lid is the easiest part. Just push back until the lid is perpendicular with the top of the machine, then lift upwards and it will release.

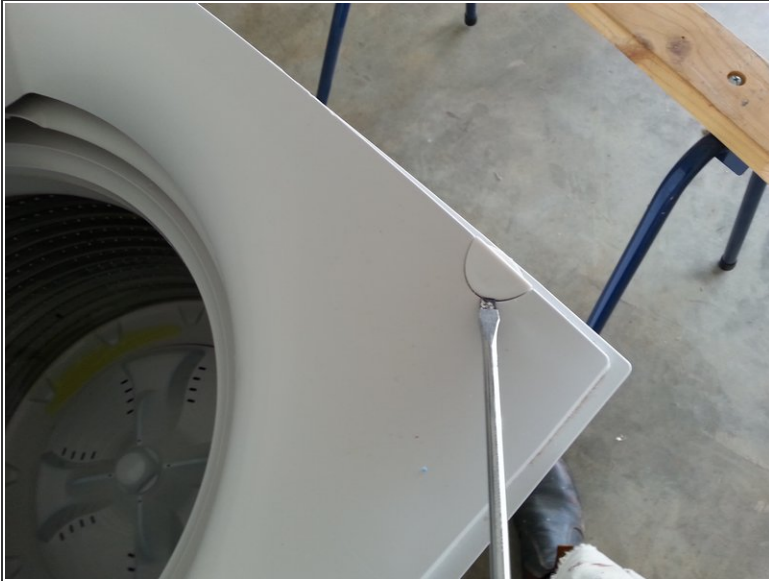
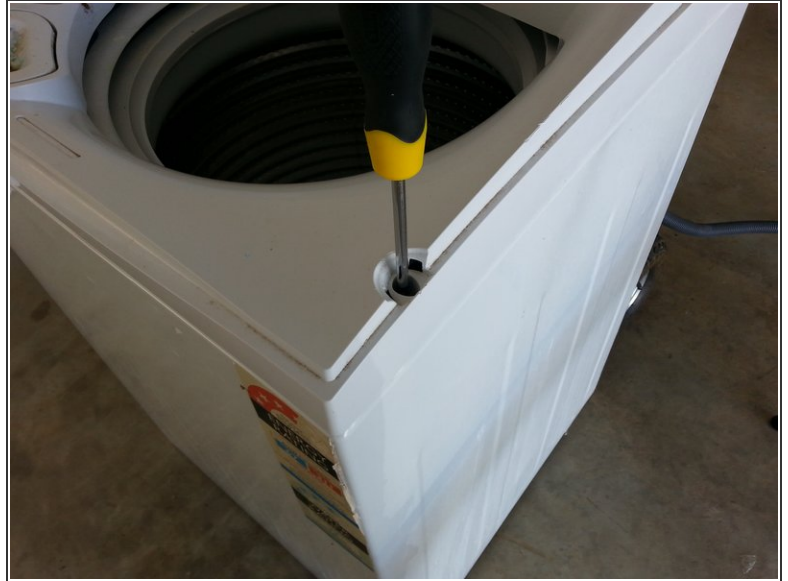
Step 3 — Unfasten the plastic cover

- Simply pry off the plastic screw covers then unscrew the two forward screws. Note there is no need to remove the cover, just tilt it backwards on its hinge to gain access. Be careful with hoses and electrical wires at the back of the cover.

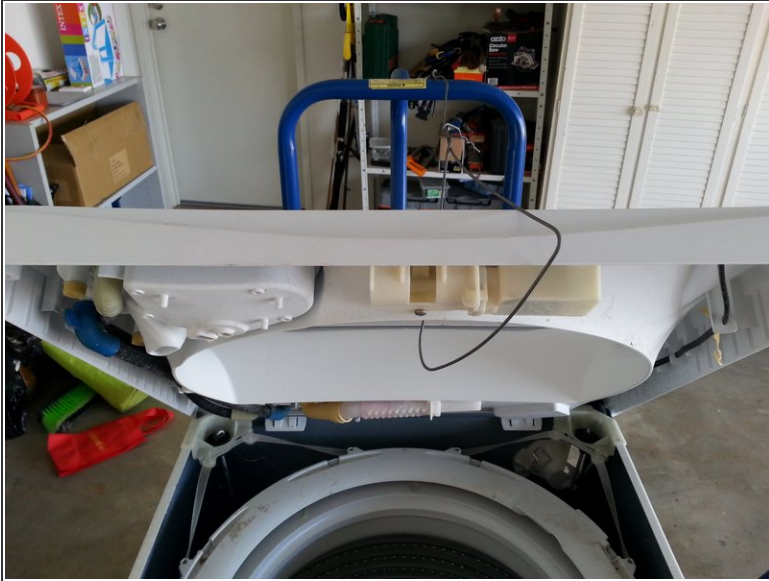
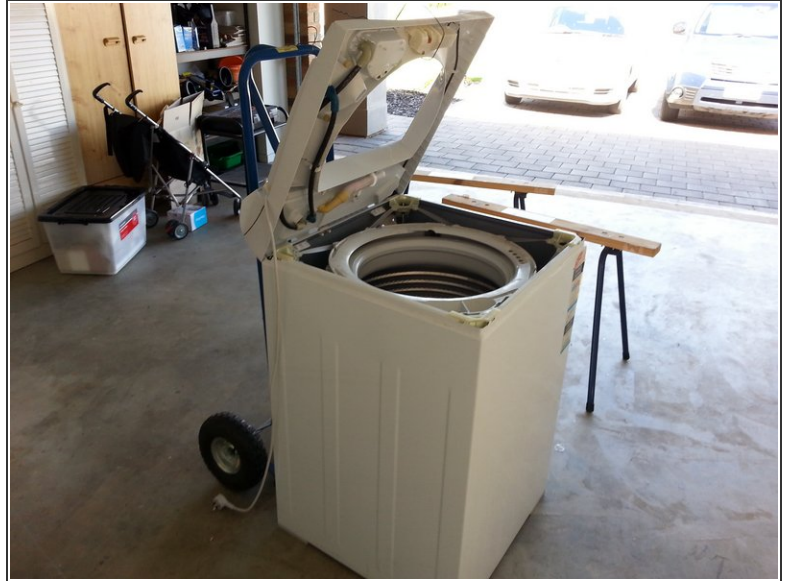
Step 4 — Suspend the cover out of the way

- I used an old coat hanger to suspend the plastic cover out of the way by hooking it onto the trolley that I used to move the washing machine. This gives you access to the 4 rubber straps and 4 suspension rods.

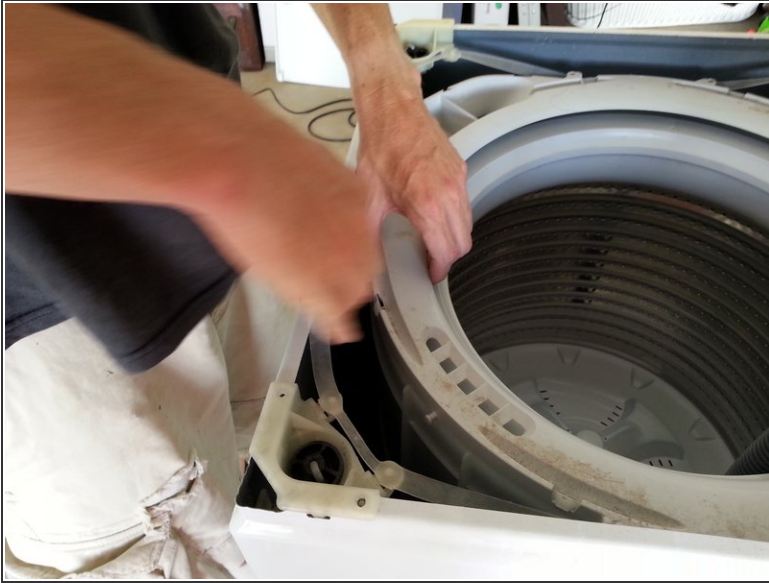
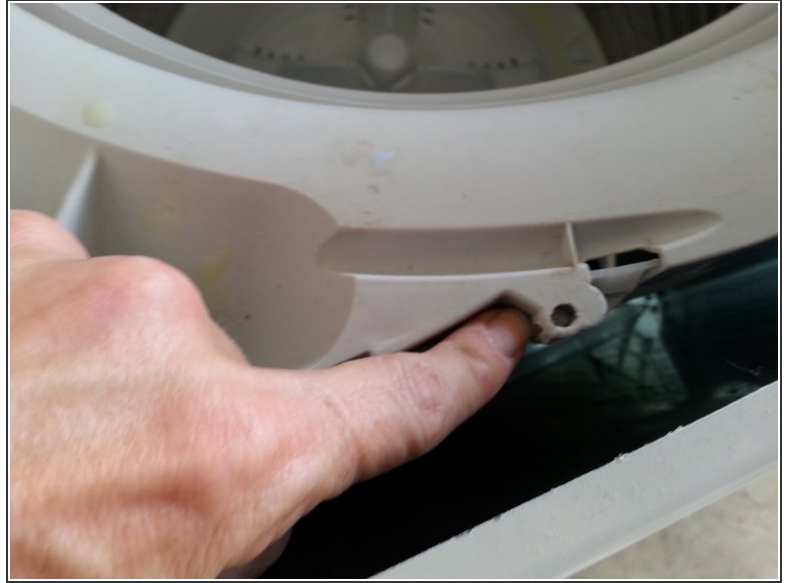
Step 5 — Replace the Rubber Hanger Straps

- You will see there are four rubber straps, one in each corner. I decided to replace these as well just to be on the safe side. When the old and new rubber straps were placed next to each other there was a significant difference in length. Just pull them straight off.

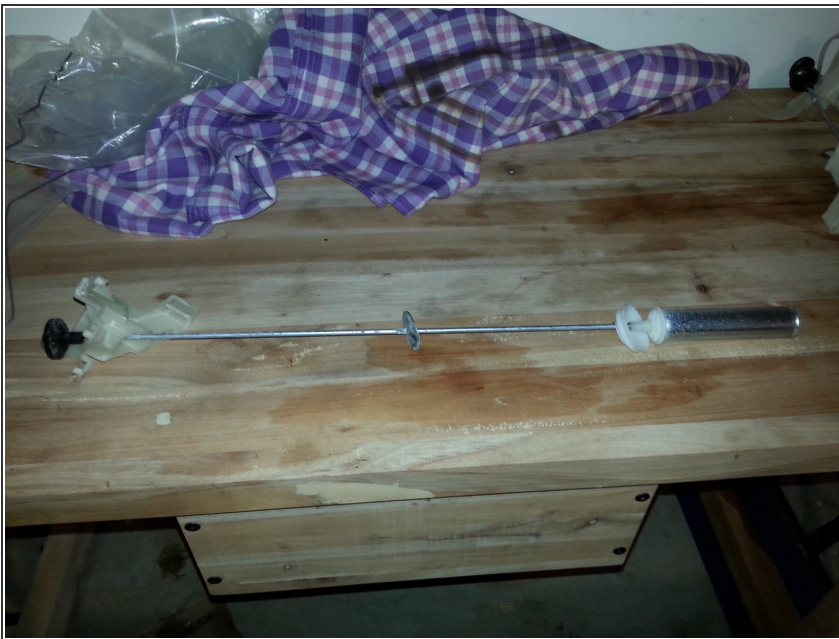
Step 6 — Removing the Suspension Rod

- The metal cylinder down the end is full of oil which leaks out over time. When I removed this one it was very greasy. Note: Im not sure if it was a defect or not, but my rear right rod appeared to have a bend in it and was unique to the other three.

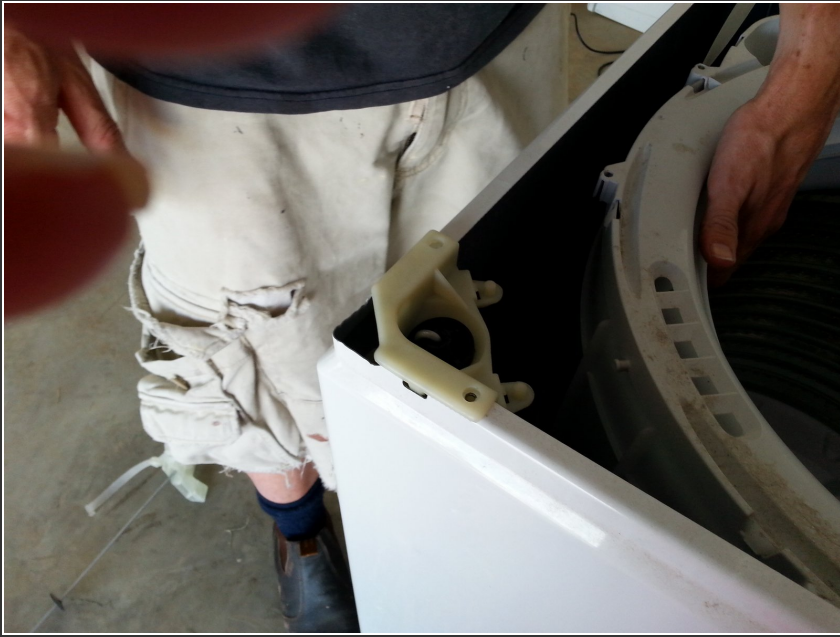
Step 7 — Lift out the Suspension Rods

- Place your left hand under the drum rim and support it. Remove and replace one rod at a time. You don't want the weight of the drum on the motor and pump below as you may break something underneath. By replacing them one at a time, the other three can help support the weight of the drum.

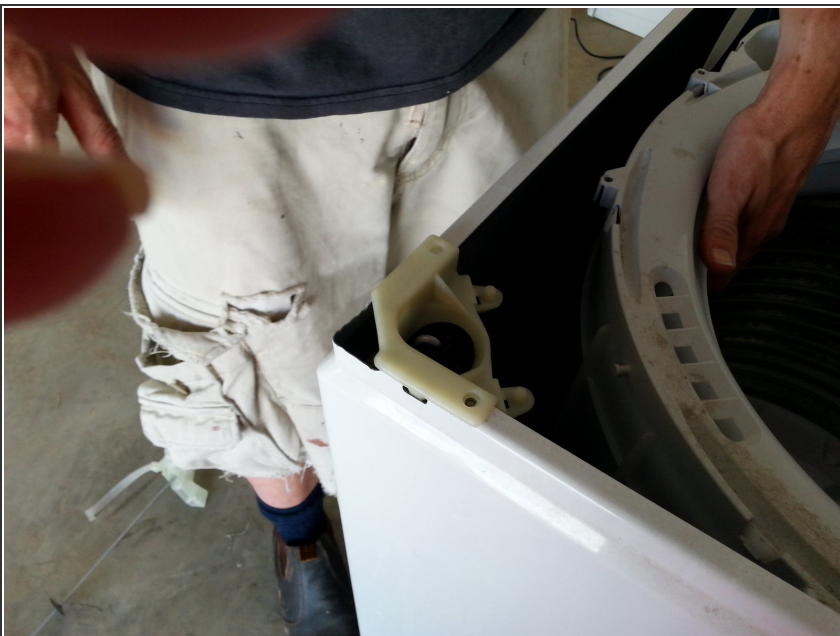
Step 8 — Removing the Suspension Rods

- To remove the rods lift the plastic hanger off the chassis and then jiggle the bottom part of the rod out of the slotted holder. There are no fasteners holding the rods in place. Its just the weight of the drum holding them in place.

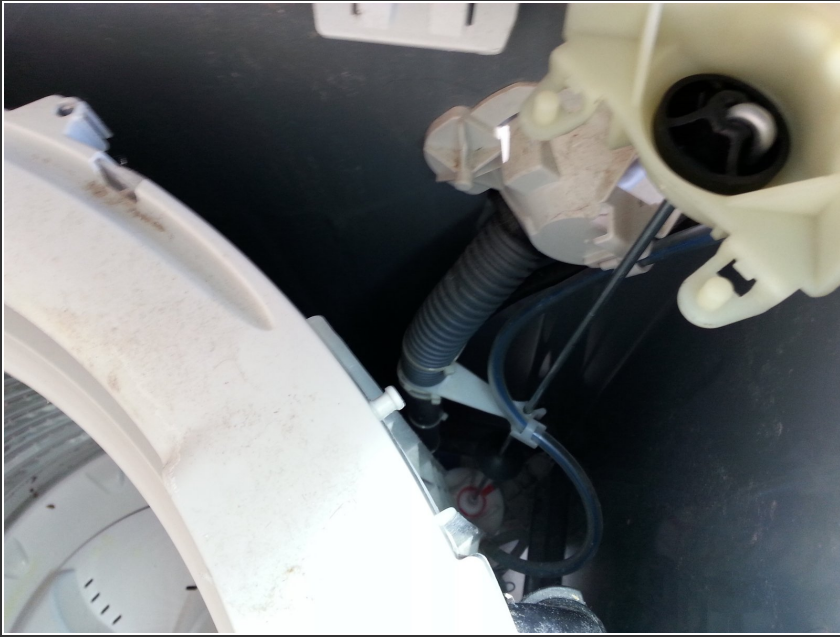
Step 9 — The Rear Right Rod is Different to the Others

- There is a clip half way down the rear right rod that needs to be undone. You also need to move the hoses and electrical looms out from under the plastic hanger prior to removing the rod. To remove the rods lift the plastic hanger off the chassis and then jiggle the bottom part of the rod out of the slotted holder.

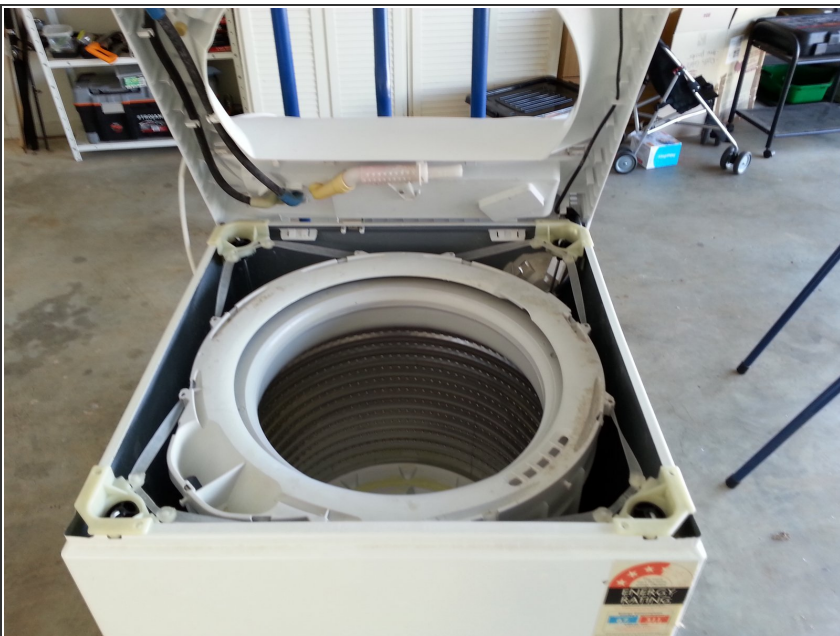
Step 10 — Reassembly

- Once you have replaced all of the suspension rods and rubber straps you can reassemble the washing machine cover and lid. Then you are finished. My washing machine ran beautifully after I completed this repair. Best of luck to you.
