Hamilton Beach 25460Z Top Heating Element Solders Replacement

Use this guide to replace damaged solder joint(s) that can be preventing your Panini Press from heating up.

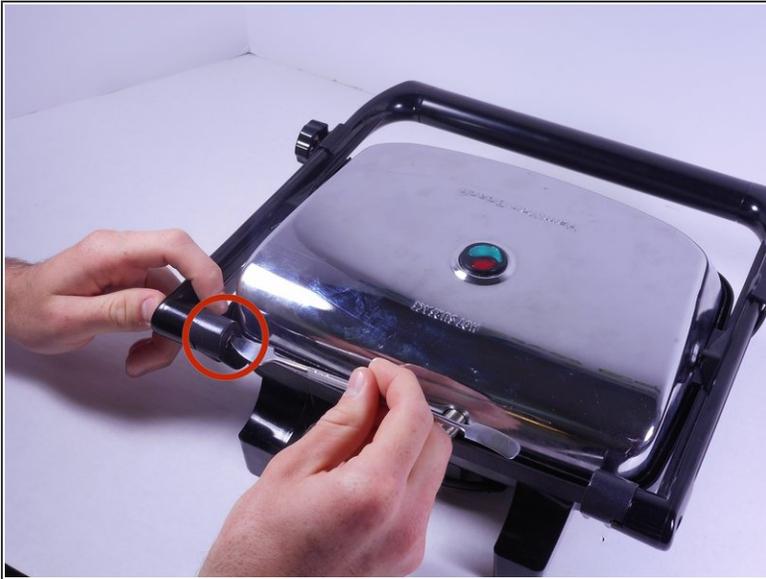
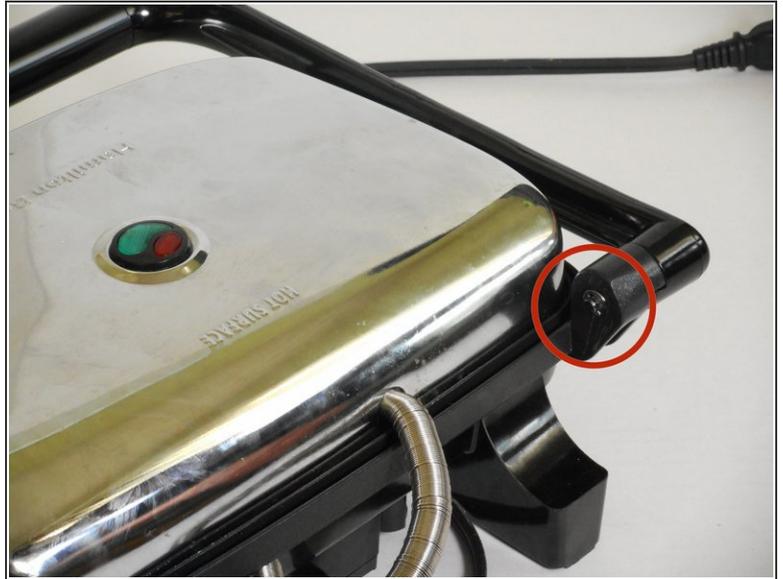
Step 1 — Handle

- On the back of the press, remove the locking washer by prying upwards with the nylon or metal spudger tool.
- Repeat for the other washer across from the first one.

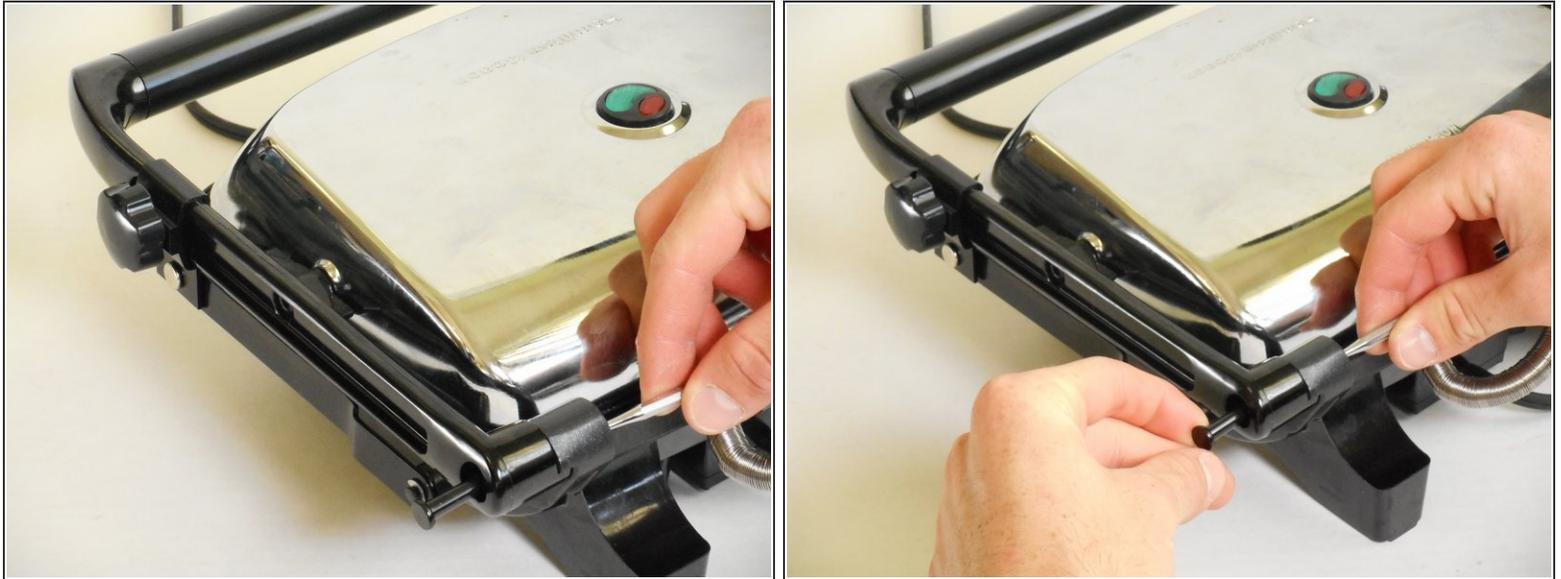
Step 2

- Using any long, thin object, push the 43mm bolt from the inside towards the outside to expose the end of the bolt.
- Pull the end of the bolt out to completely remove it.
- Repeat for the second bolt.

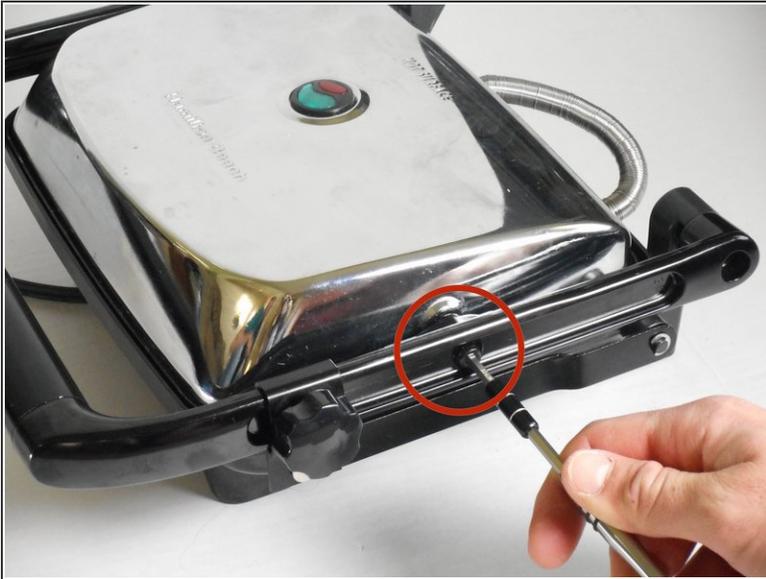
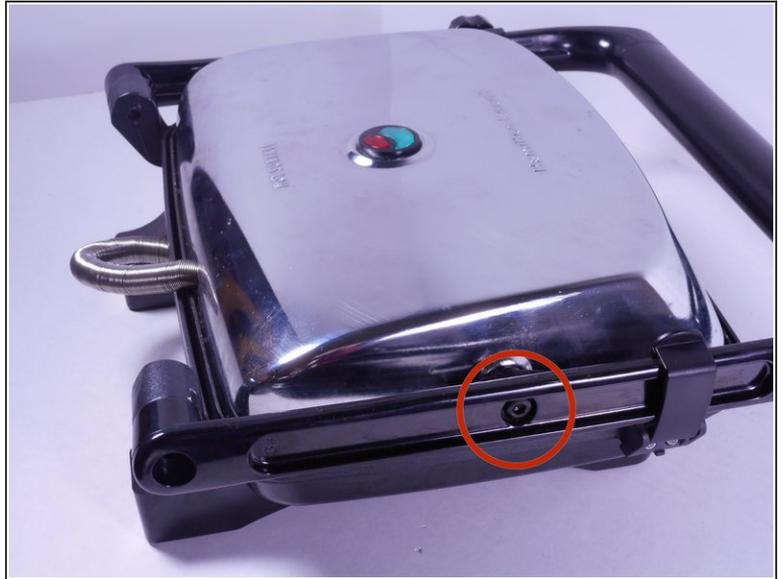
Step 3

- Using the 4.0mm Allen Wrench, unscrew the two 26mm bolts connecting the handle to the upper heating element housing on both sides.

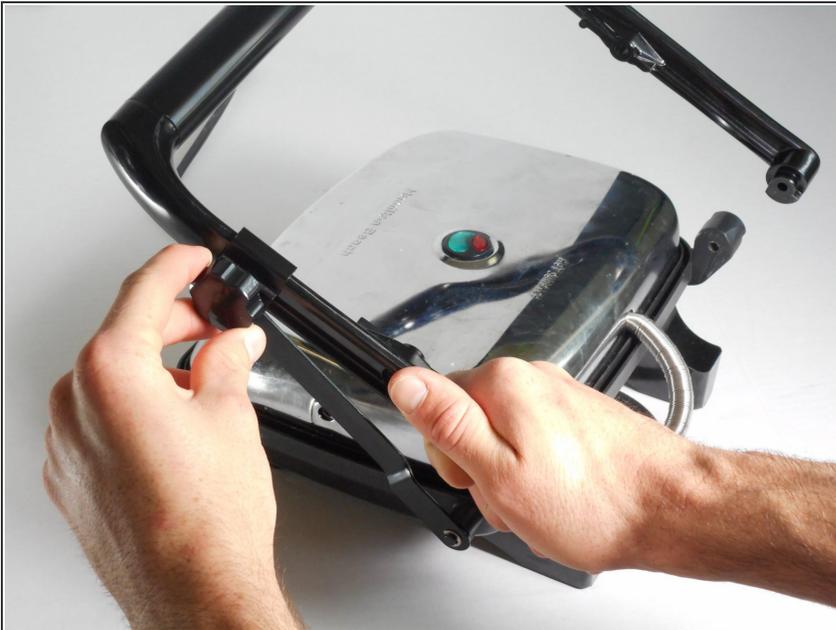
Step 4

- Unscrew the locking knob all the way to remove it.

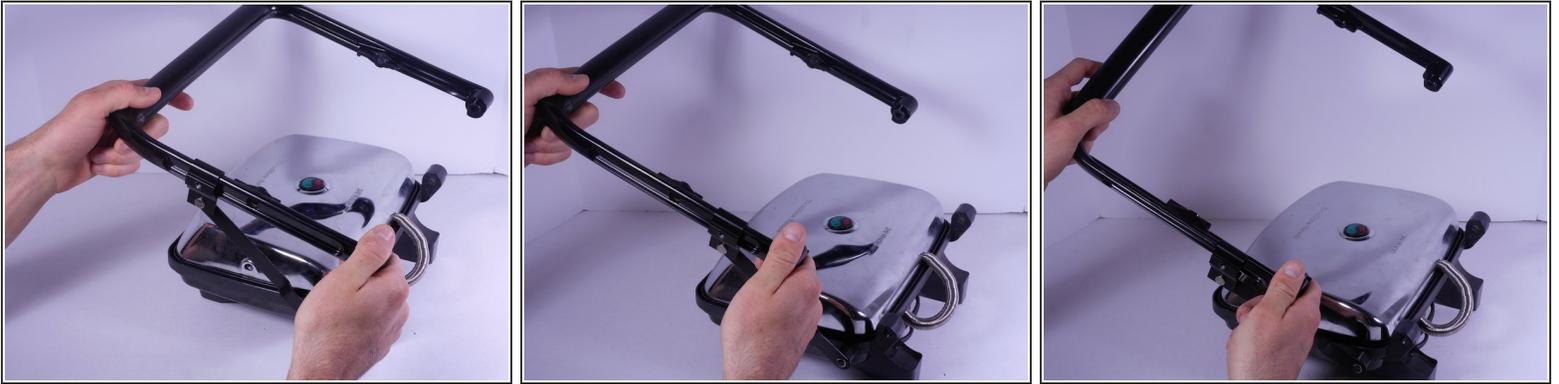
Step 5

- Slide the locking knob couple down to the base of the handle, then pull up on the free end of the handle. It will easily pop off.

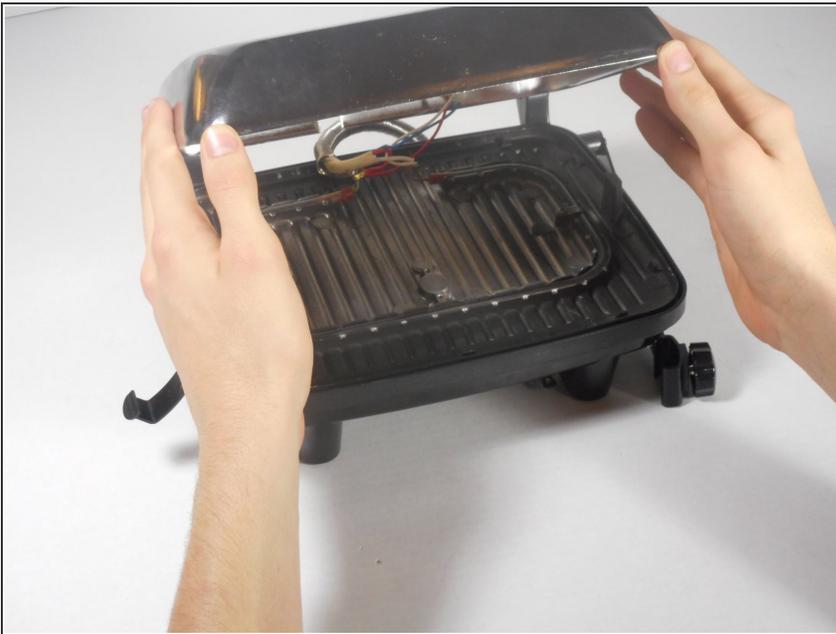
Step 6 — Top Heating Element Solders

- Gently separate the heating element housing from the cooking surface by pulling up on the housing and pushing down on the surface.
- ⚠ Pulling too far or too hard can break the delicate internal wiring.

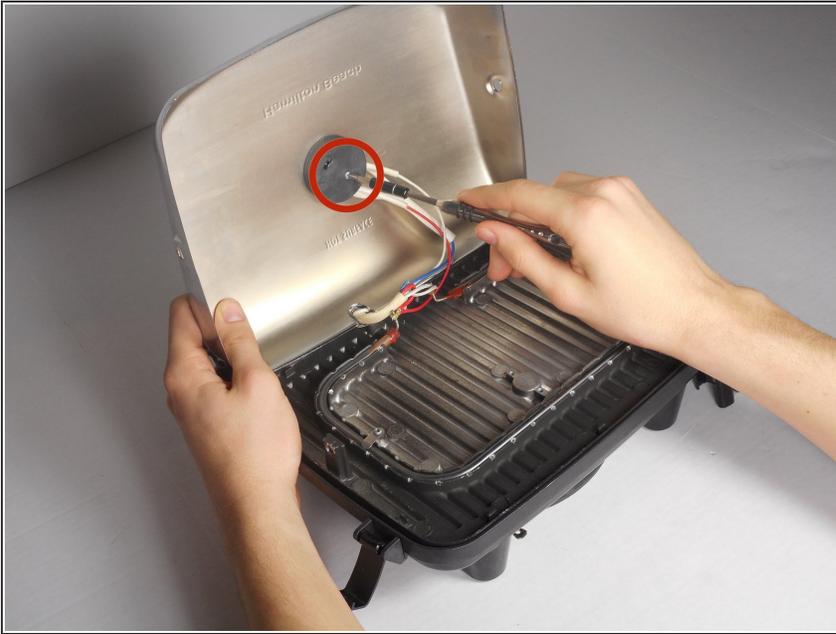
Step 7

- On the underside of the housing, use the PH2 Screwdriver to remove the single 12mm screw to disconnect the LED tray.
- The housing can now be completely removed.

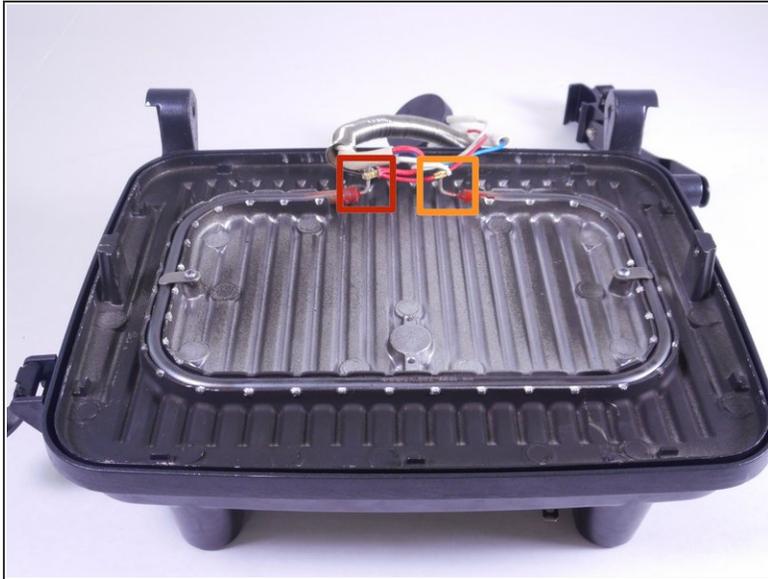
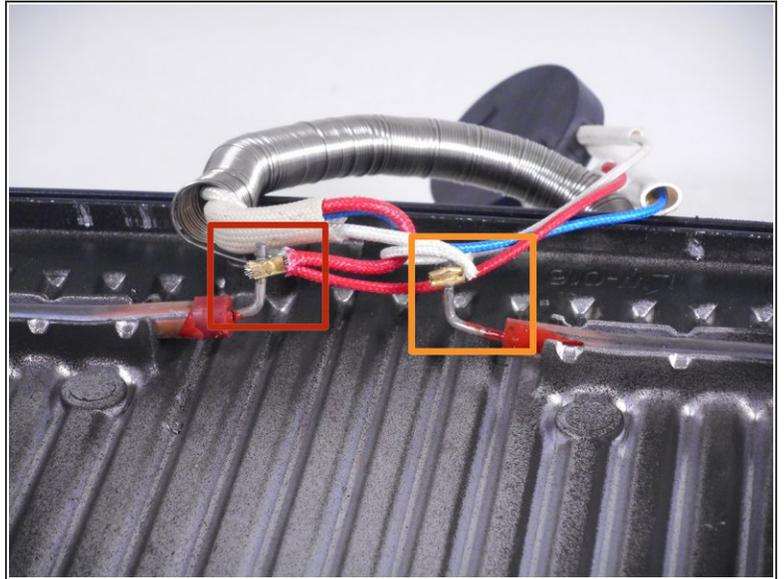
Step 8

- The left lead needs to be connected to the two red wires.
 - The right lead needs to be connected to the two white wires.
 - One or both of the leads can have damaged solder, resulting in poor connections between the lead and the wire ends.
 - De-solder the existing solder joints on the lead(s).
 - Solder the wire ends back to their corresponding leads.
- ⓘ Refer to this [page](#) if you need to brush up on your soldering skills.
