# APS Tech 101629 SCSI Connections Replacement

This guide gives instructions on how to remove the SCSI Ports on the APS Tech 101629 and then replace any that are faulty.

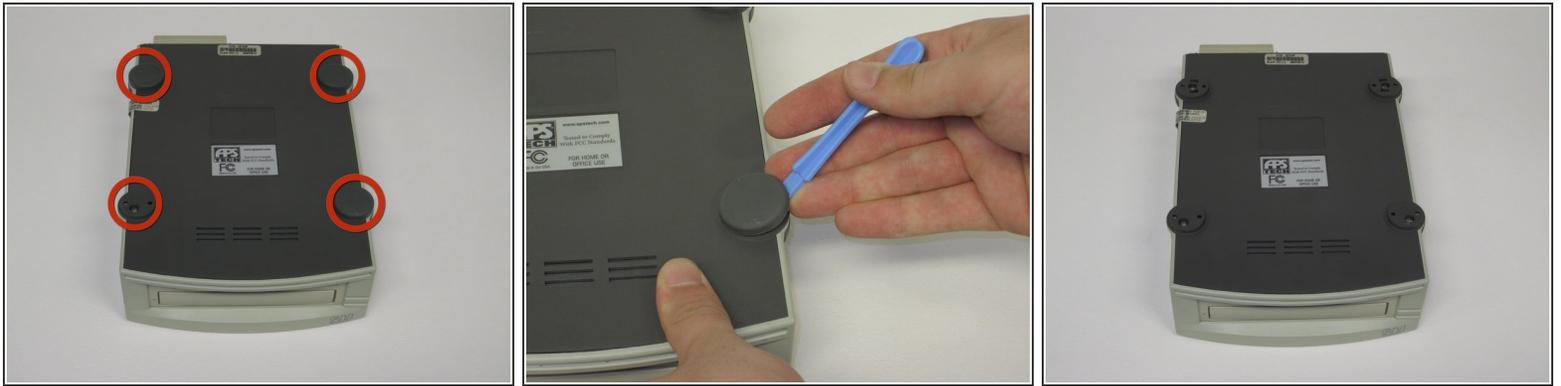
## Step 1 — External Casing

- Pry all four of the plastic feet off the bottom of the enclosure using the iPod opening tool.

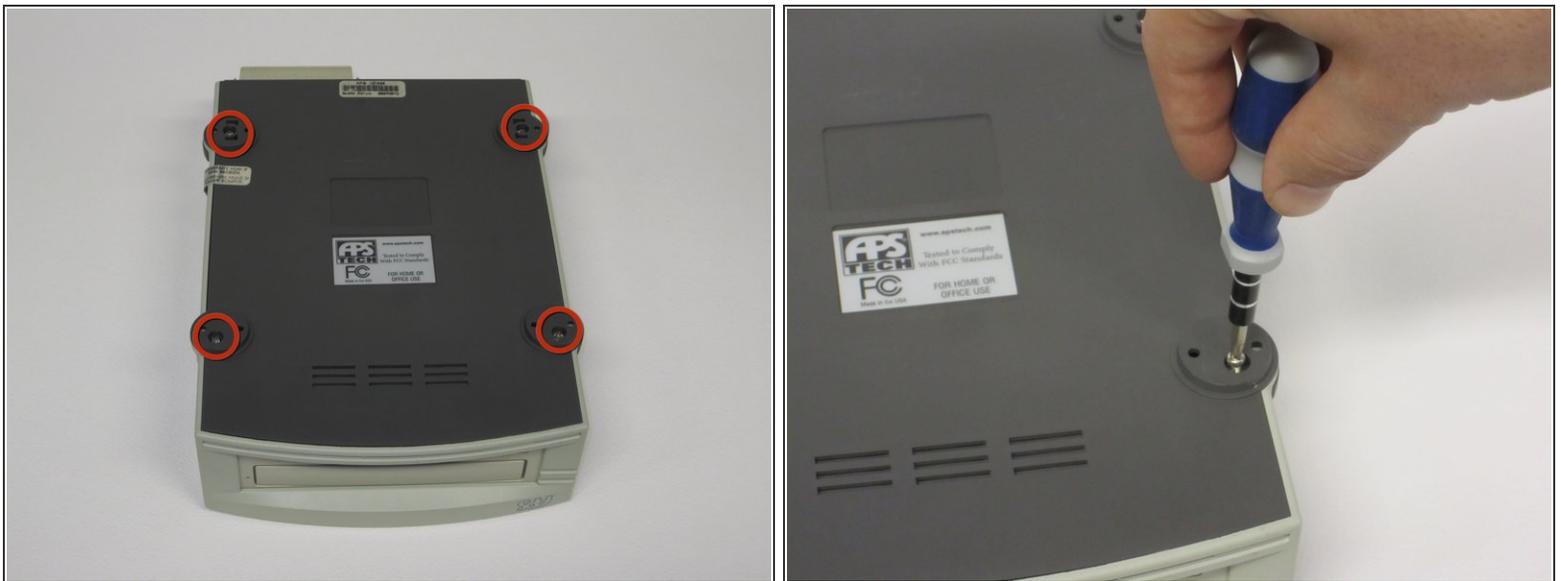
## Step 2

- Unscrew the four screws previously covered by the feet with a Phillips #1 screwdriver.

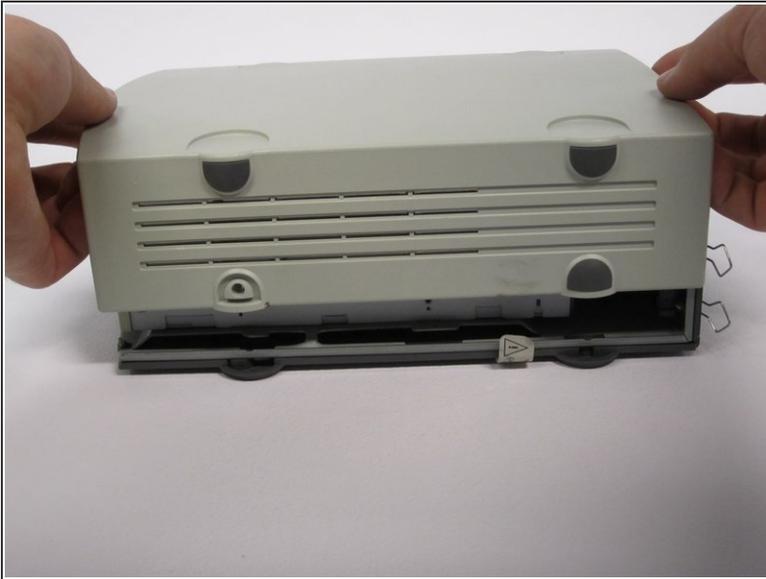
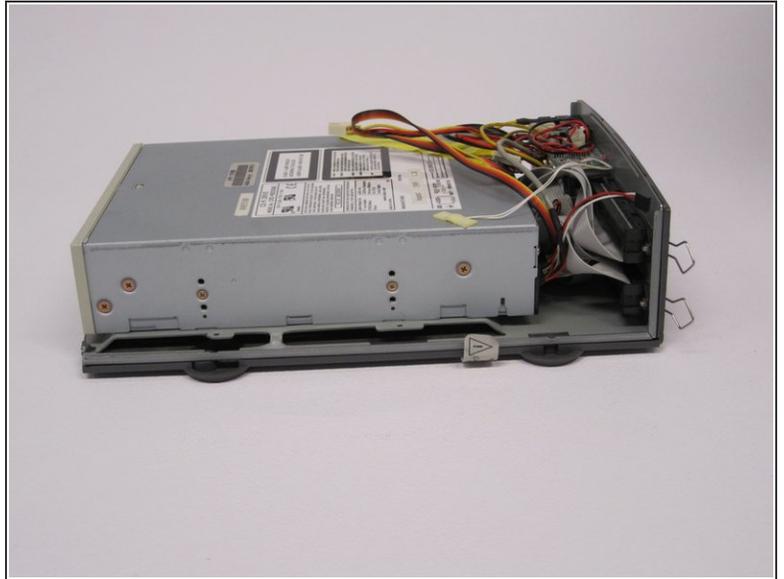
### Step 3

- Flip the device right side up.
- Gently slide the casing upwards and off the hard drive.

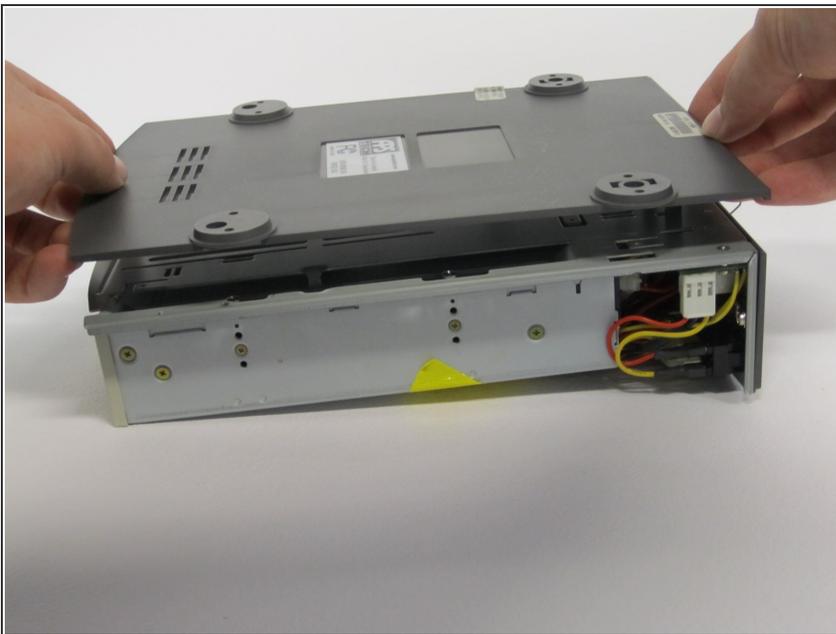
### Step 4

- Flip device upside down again.
- Gently pry the bottom gray casing away from the device.

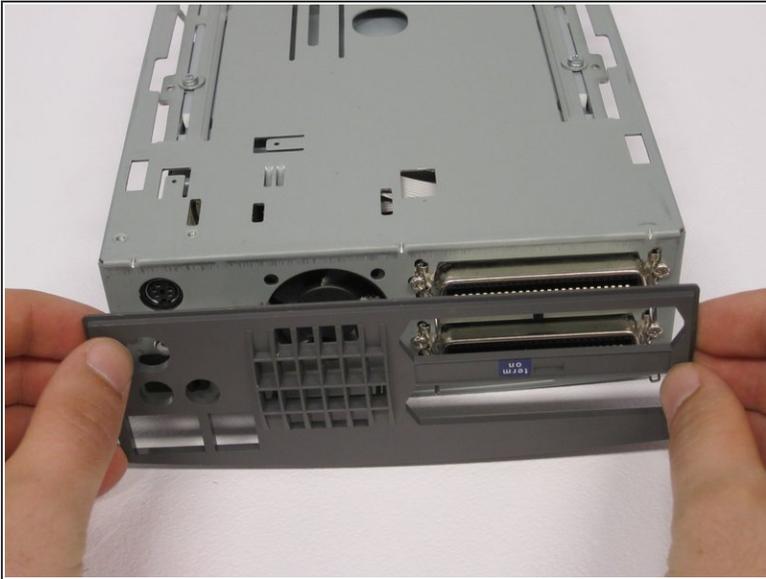
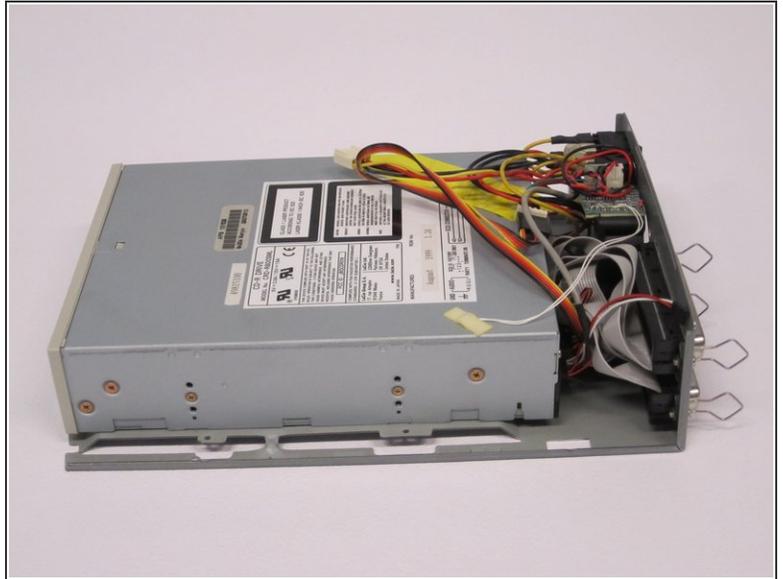
## Step 5

- Rotate so the back of the device is facing you.
- Gently pry the back casing away.
- When the back casing is removed, the fan will become loose.

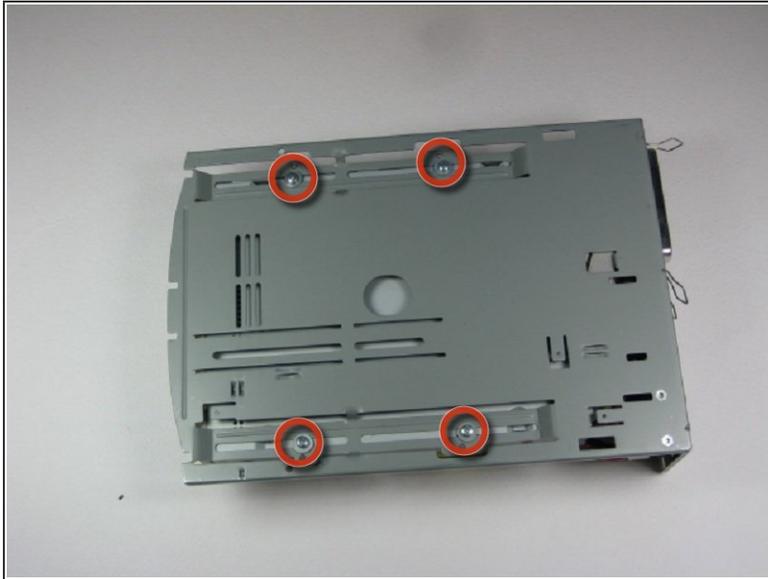
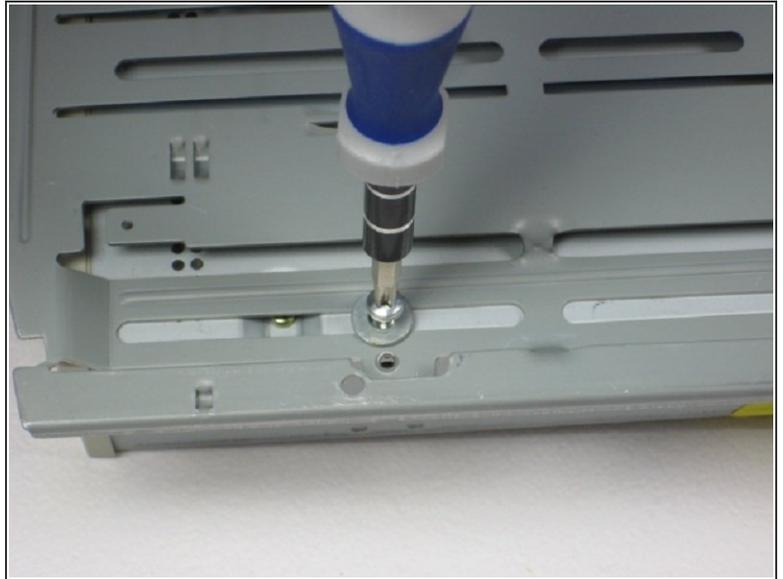
## Step 6 — Internal Drive Component

- Flip so device is upside down.
- Remove 4 screws with Phillips #1 screw driver.
- ⓘ Be sure to save the washers that separate the screws from the baseplate for reassembly.

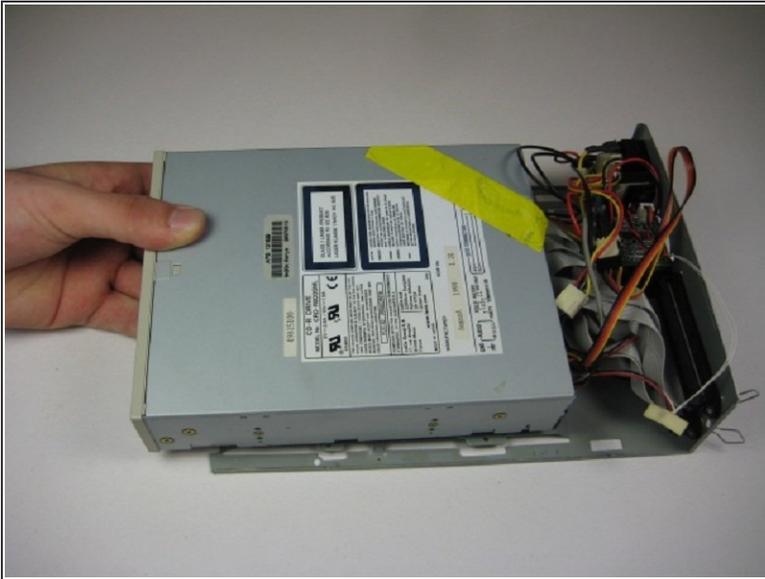
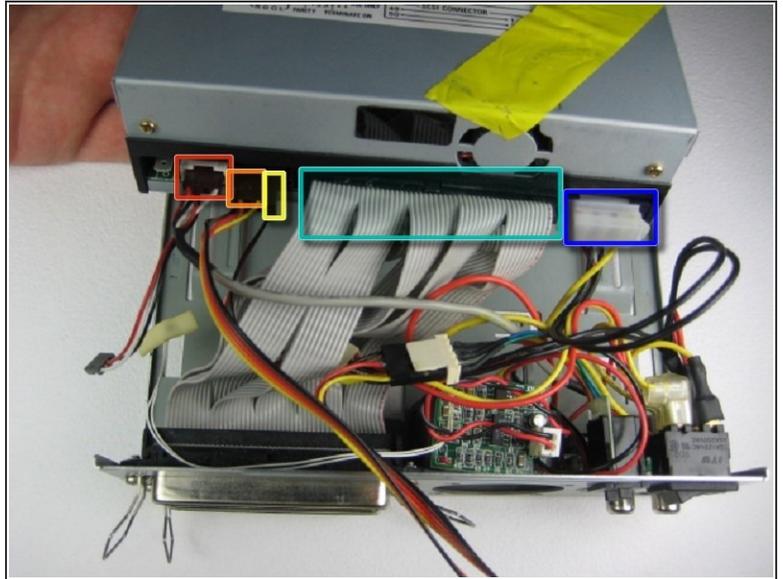
## Step 7

- Slide the internal drive component away from the back of the device.
- Remove the connections from the back of the internal component in the order of your choosing, we suggest left to right. The connections are:
  - Audio Connection
  - SCSI ID
  - Terminate On
  - SCSI Connection
  - DC Input (power)

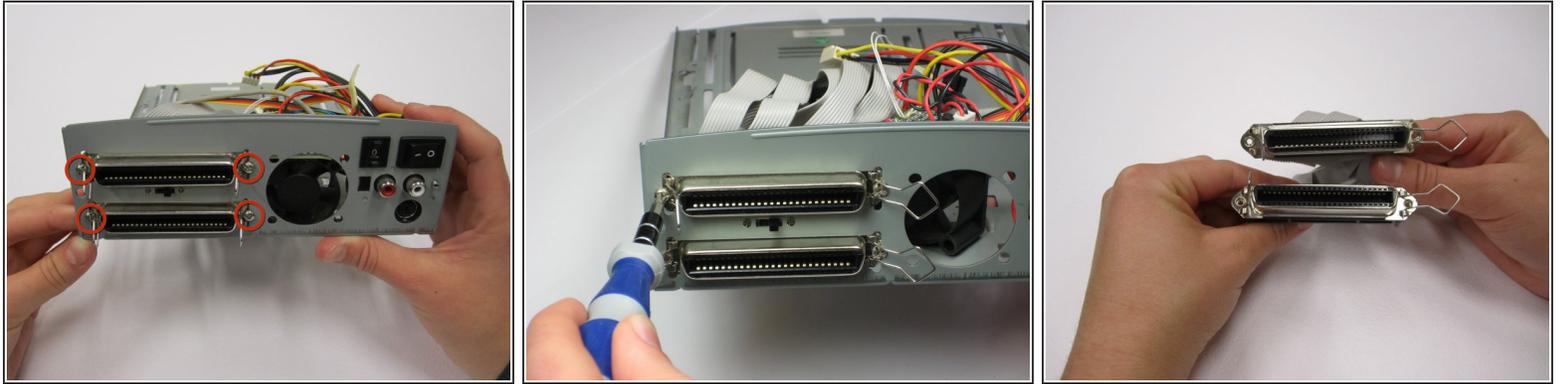
## Step 8 — SCSI Connections

- Remove the four Phillips #1 Screws from back panel.
- Once the screws are removed, the two connections are easily removed from the body.
