# LG Optimus Exceed 2 Rear Camera Replacement

The removal of the stock Rear facing camera on an LG Optimus Exceed 2.

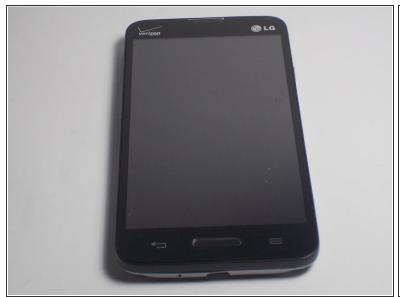
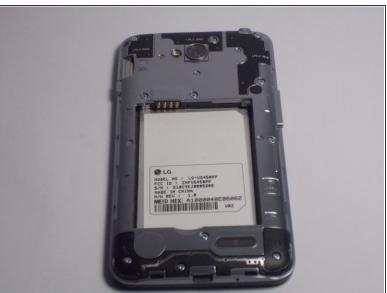
## Step 1 — Battery

Flip the device over and remove the back covering.

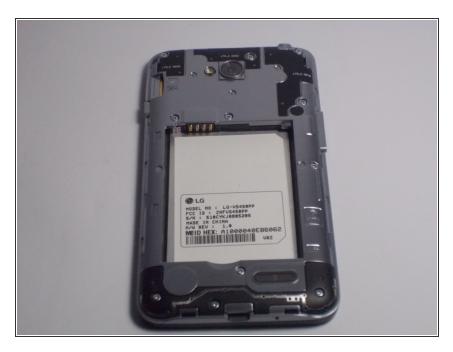
# Step 2

Push on the top of the battery downward and pull the battery off of the device.

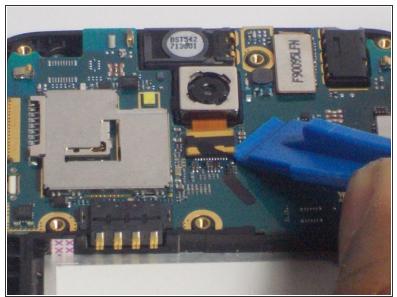
# Step 5

- Using the prying tool detach the connector on the device.
- Insert the plastic opening tool underneath the connector and push tool down to lift the connector from the device.
