Olevia LT23HVX Power supply repair

It is apparently a common problem with the Olevia LT23HVX that the power supply fails. The condenser on the power supply PCB are very frequently failing.

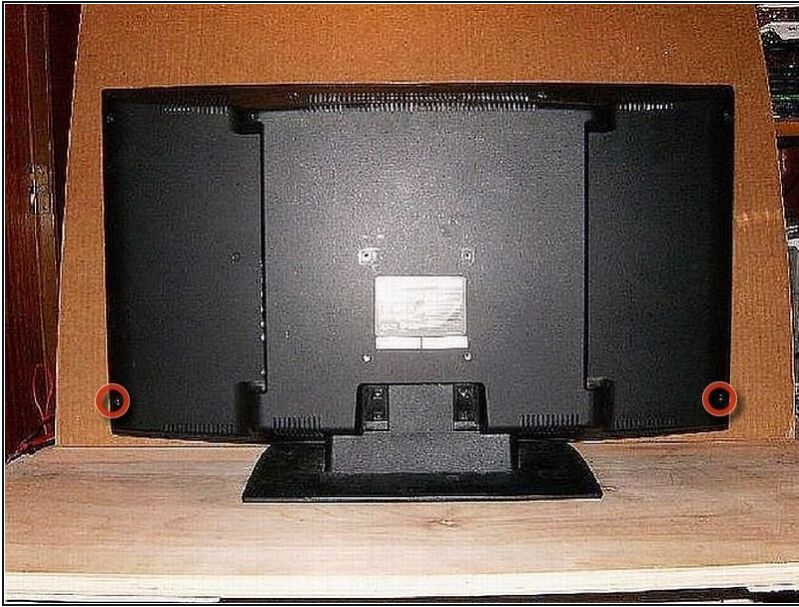
Step 2

- The first thing to do is to remove the screws that hold the back on. There are arrows on the plastic that show which screws to remove. Word of wisdom, if you have some screws missing, it is because somebody already opened it. This was the case with my TV monitor. So, you never know what surprise is going to await you.
- Also remove the 4 small bolts that hold the stand to the back.

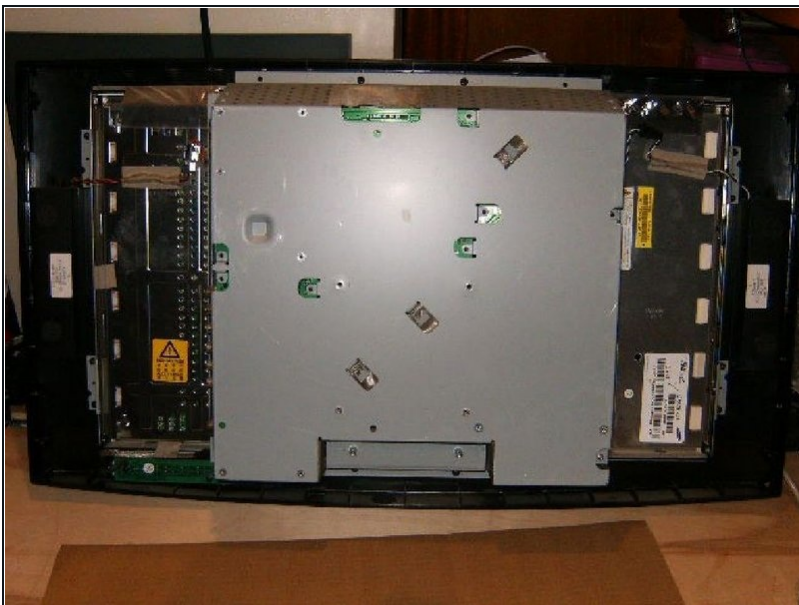
Step 3

- Once the back is unscrewed it can be separated. It is only pressed to the front part slightly and should come off pretty easy. There is now a grey metal box that holds the printed circuit boards.
- At the top left and right, are two sets of cables that enter the metal box. Those are the speaker wires. Unclip the connectors.

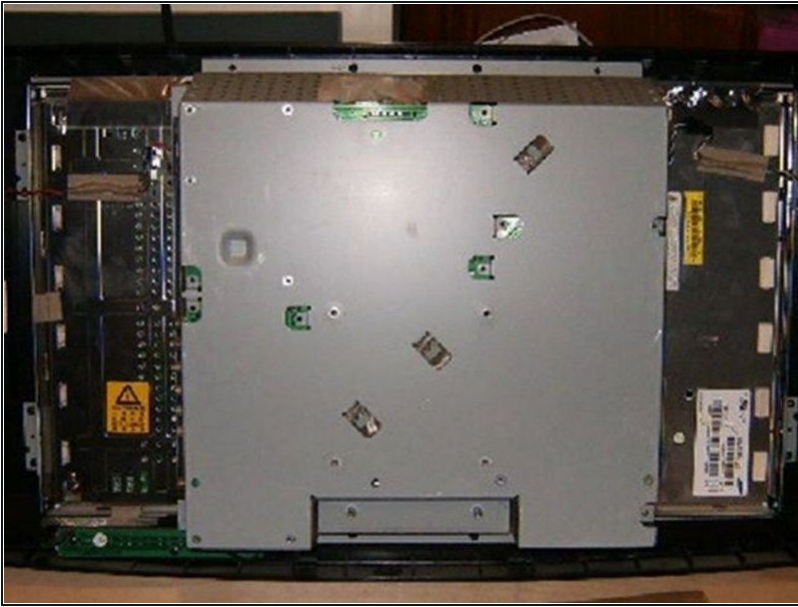
Step 4

- The grey metal box is held in place with at least 4 screws. Again, there are arrows pointing to the screws that need to be removed.
- On the bottom left is a ground wire that is wrapped around a shielded cable. Ensure that it is not binding with the metal case.

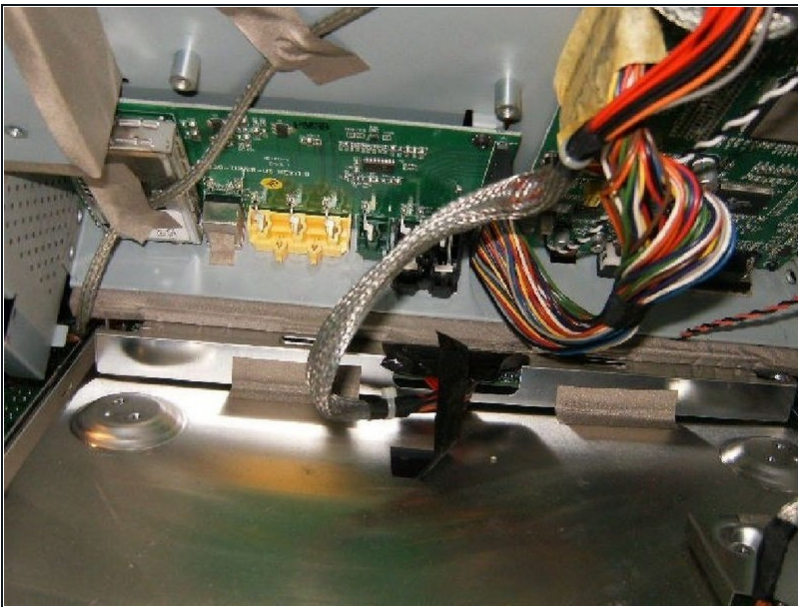
Step 5

- Tilt the gray metal box from the left to the right. Do not try to pull it off.
- Once you tilt it, you will see a wiring harness that is connected to the box via some tabs. Pull those gently apart, remove the shielded cable.
- The harness is terminated via a connector to the side. Unplug the connector by GENTLY pulling on the side of the plastic. Do not pull on the wires.

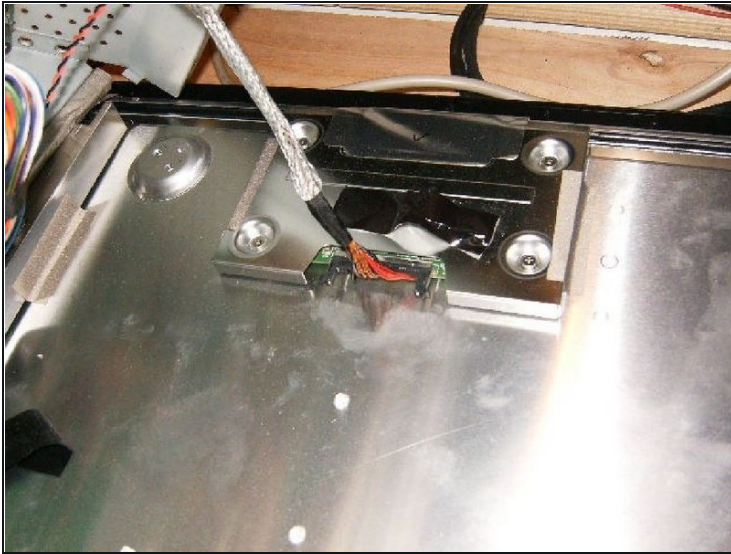
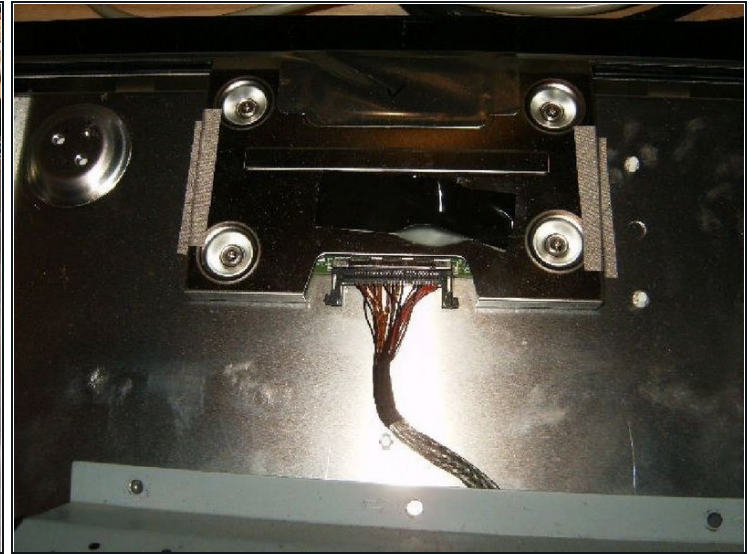
Step 6

- The next wiring to remove terminates to the top to another connector. This one is a little trickier and must be removed by squeezing the tabs on the side while pulling the connector.
- In my case, due to a broken clip on the side of this connector I opted to leave it connected. That way, I can not totally remove the metal cover, but will have to turn it over.
- Once the wiring harnesses are disconnected and they are off the metal tabs, tilt the metal cover to the left. Check continuously that all the wires are off and nothing gets hung up.

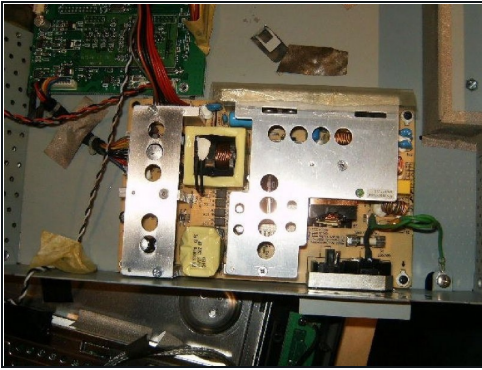
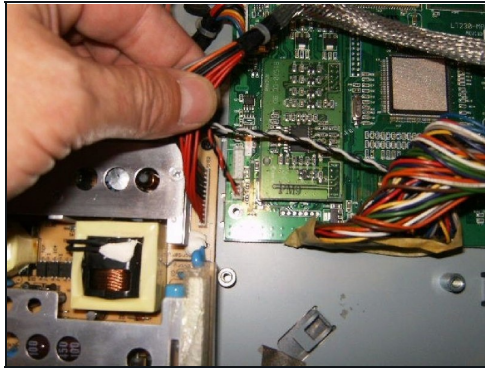
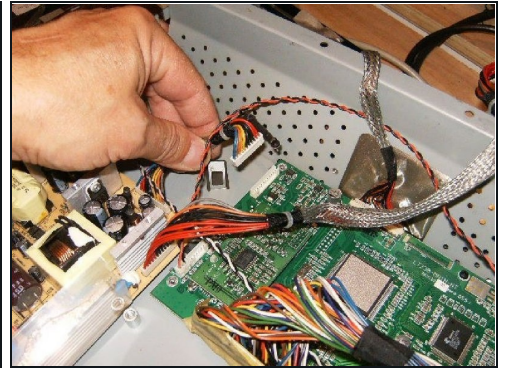
Step 7

- You should now be looking at the PCB's The power board is the one that has the switch on it, as well as two heatsinks.
- Remove the wiring harness on the top right side.
- Remove the connector from the inverter board, as well as the ground wire.
- Remove the green cable from the power board to the housing.
- Remove the connector from the top right and top side. They will only fit one way. No reason to mark the location.
- The two heatsinks can be removed either now or later.

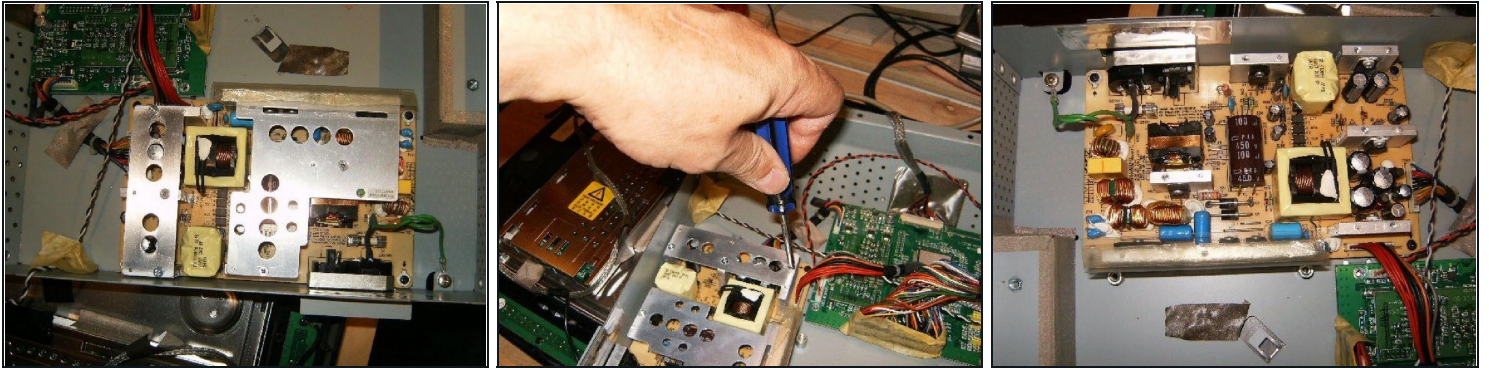
Step 8

- Once all wiring harnesses are removed, and the green ground cable is off the chassis, remove the powerboard. It is held in place with four small screws, one on each corner.
- The power board should now be disconnected from the monitor. On the side furthest away from the switch, is a transformer. Next to it, there are a total of 7 condensers and 3 heatsinks. It is those condensers that are failing due to heat.

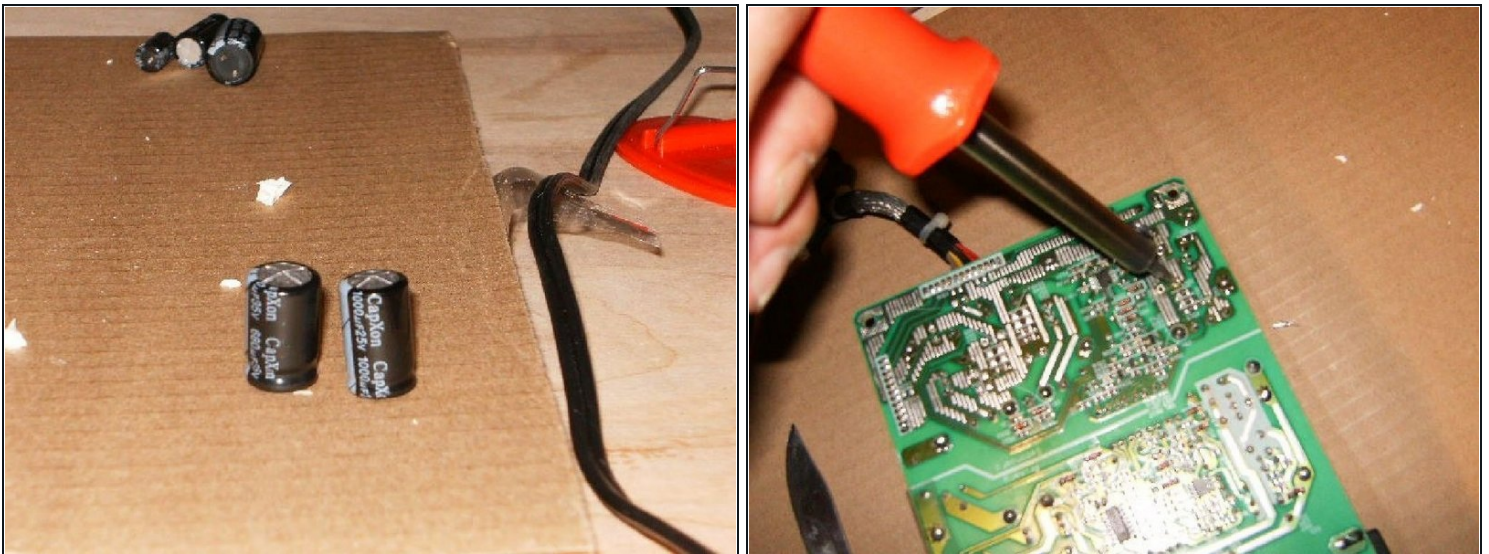
Step 9

- Take a closer look at the tops of the condensers (here is the view of one that was removed) The tops are most likely bulging on at least 5 of them. Plan to replace all 7 on that side.
- Unsolder the condensers from the board. In this repair a 30watt soldering iron and [solder sucker](#) was used. The solder sucker can be substituted with soldering wick.

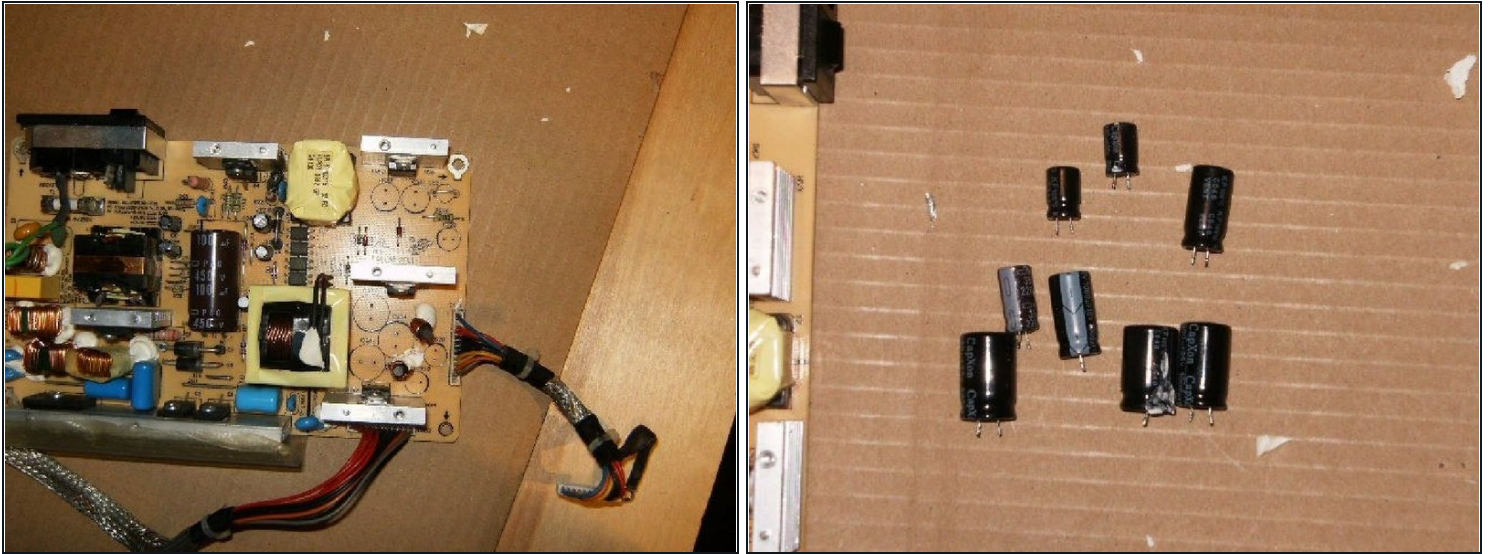
Step 10

- This is what the board looks like with the faulty condensers removed.
- Here are the faulty condensers. Replace those with new ones. For this repair, new ones were obtained through Mouser.com.
- CS19 = 220uF 35V CS20 = 220UF 25V CS21 = 1000uF 16V CS22 = 1000uF 16V CS23 = 1000uF 25V CS24 = 680uF 35V CS25 = 680uF 35V All are radial lead electrolytic capacitors.

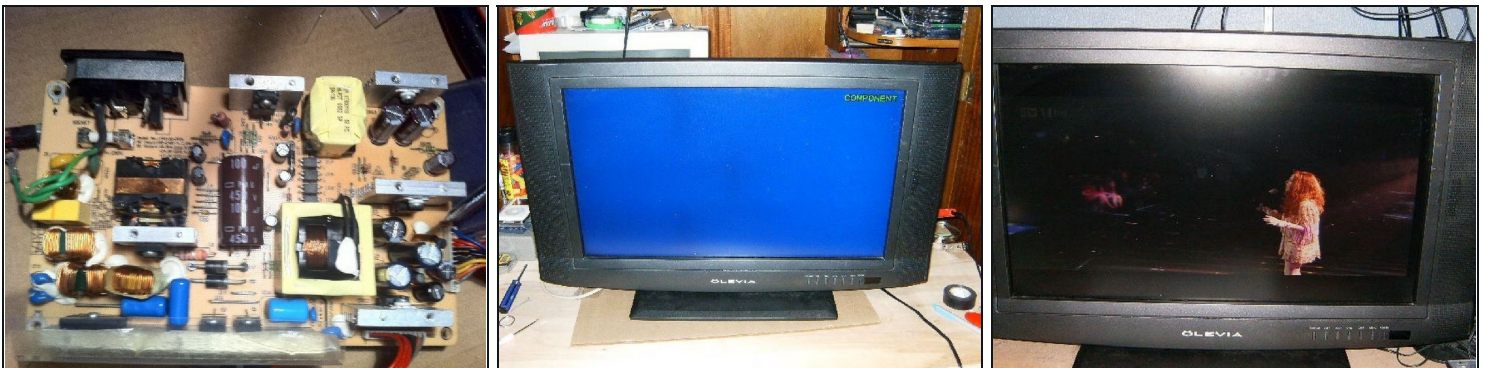
Step 12

- Once reassembled, connect your TV monitor either as TV or a computer monitor. This is what the final result should look like.
