PlayStation VR Processor Unit Cooling Fan Replacement

Written By: Sarah Shand

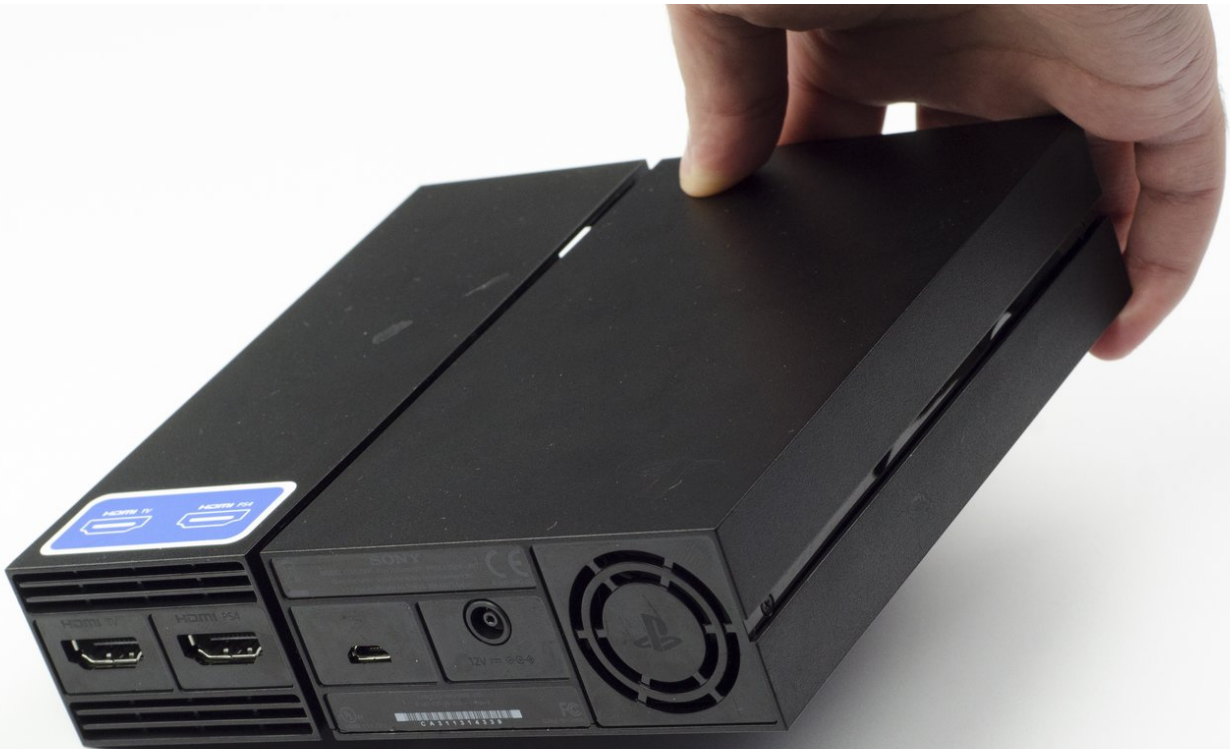
A damaged or broken cooling fan can make your system overheat so it is important to replace it if that happens in order to prevent any further damage to the system.

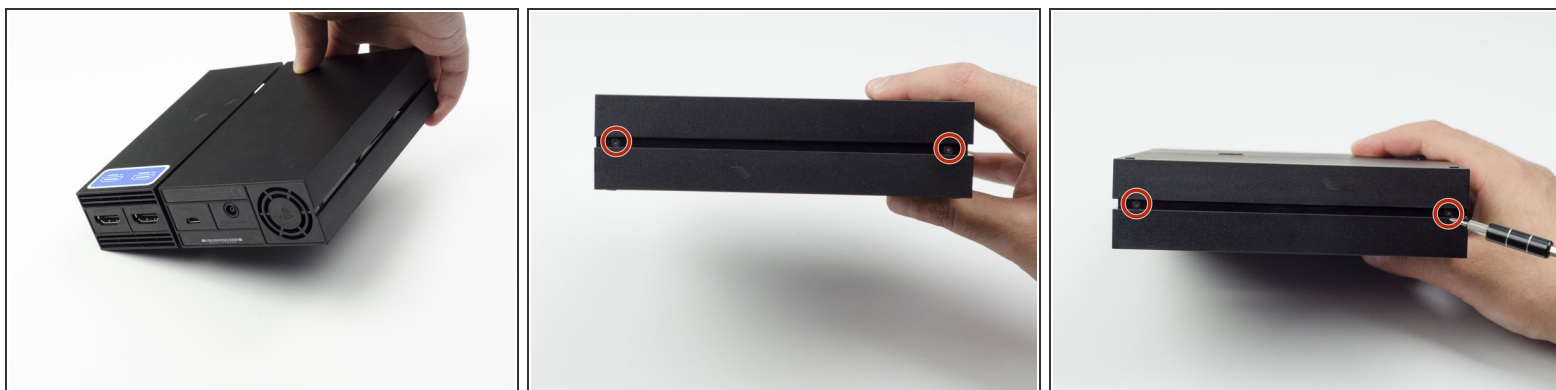
Step 1 — Processor Unit Cooling Fan

- On one side of the console (the side adjacent to the fan vent), there will be two 6 mm screws. Unscrew them with a PH #000 screwdriver.

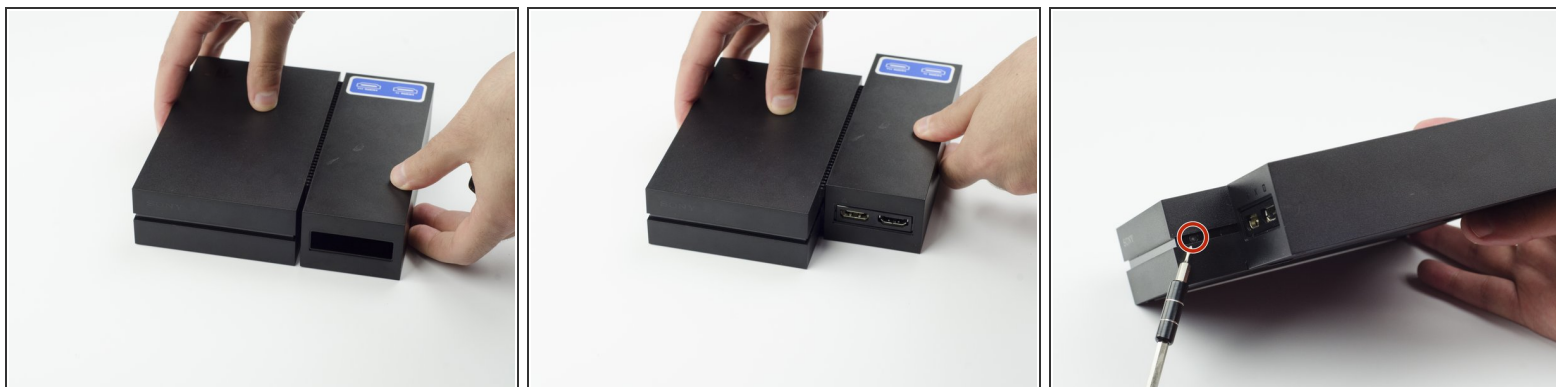
Step 2

- Press and slide the side panel (it will have the two ports) back to reveal an additional 6 mm screw.
- Unscrew the 6mm screw with a PH #000 screwdriver.

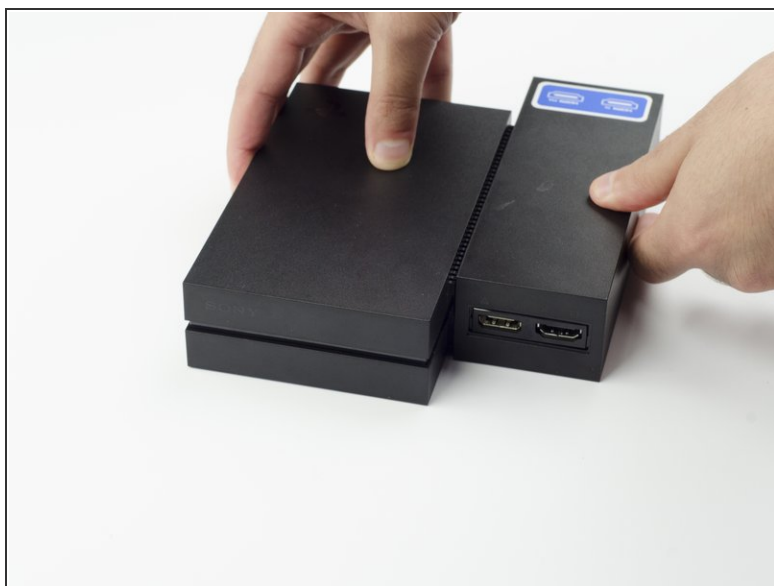
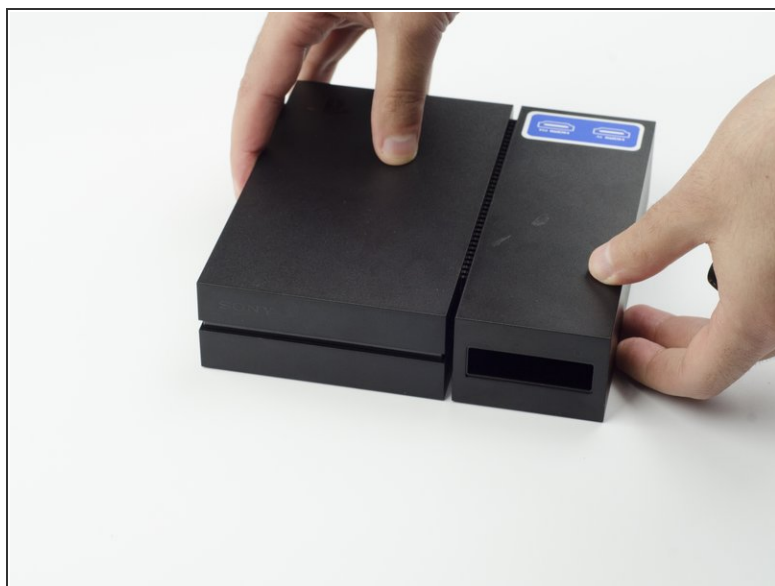
Step 3

- Slide the panel back into place.

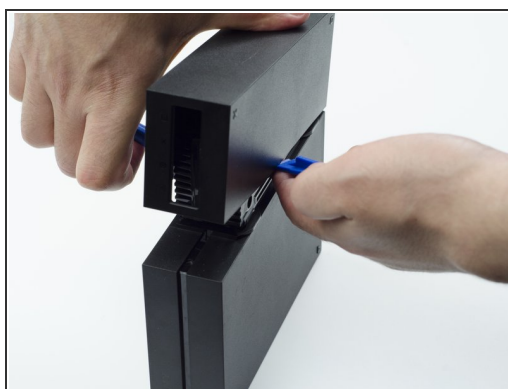
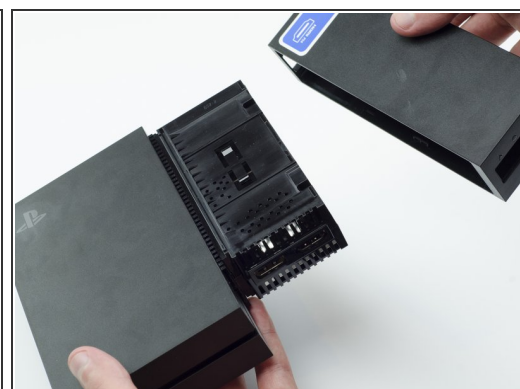
Step 4

- Using a plastic opening tool, carefully pry the panel from the main console to reveal the HDMI ports.

You will probably need to lift it on both sides in order for the panel to come loose.

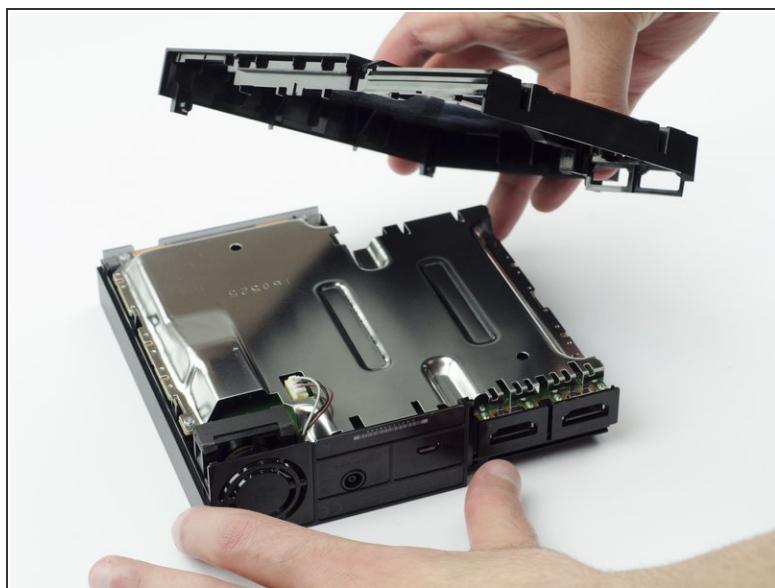
Step 6

- With the plastic opening tool, carefully pry the console shell panel free and lift it away.
