Microsoft Band 2 defective battery connection/ribbon Replacement

Fix for Band 2 power loss or failure to charge. More details & commentary at <https://band2repair.wordpress.com/>

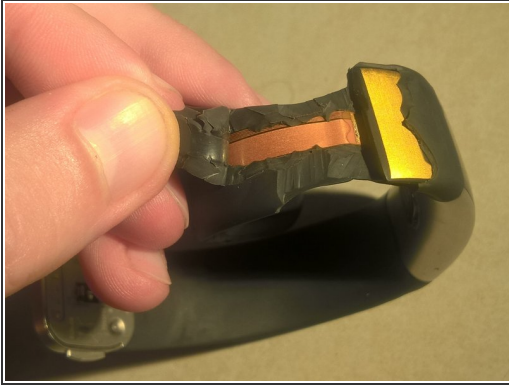
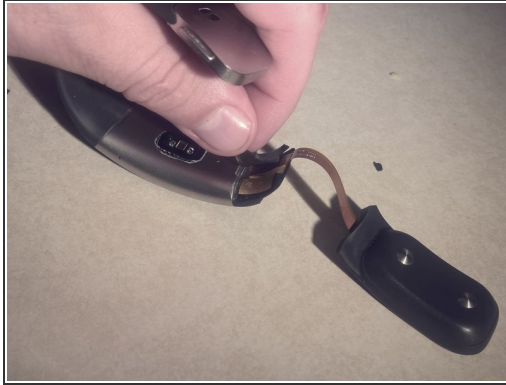
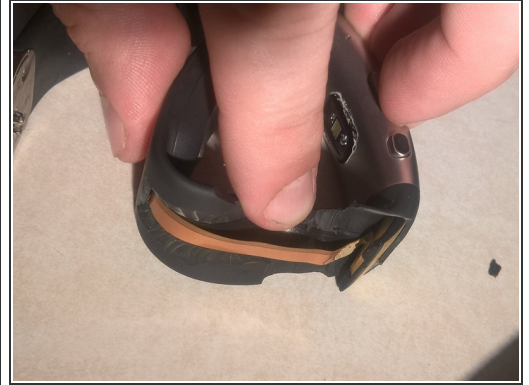
Step 1 — defective battery connection/ribbon

- Carve away **almost** all of the rubber of the straps. (Leave the rubber surrounding the battery/heart rate clasp end.)

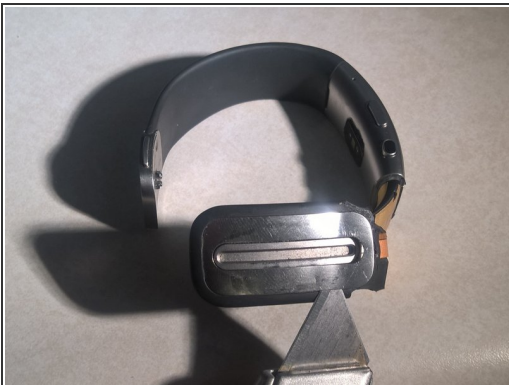
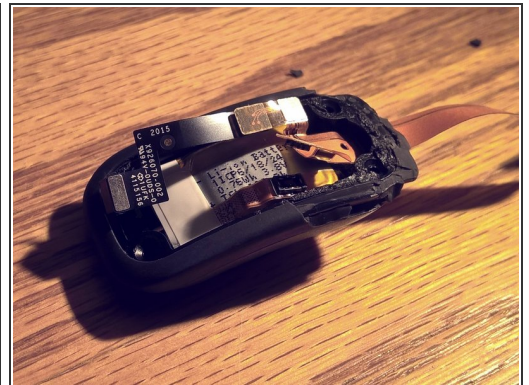
Step 2

- Partly disassemble the battery clasp end: pry up the silver clasp face that is taped down, unscrew the four T3 Torx , remove that cover, remove the battery

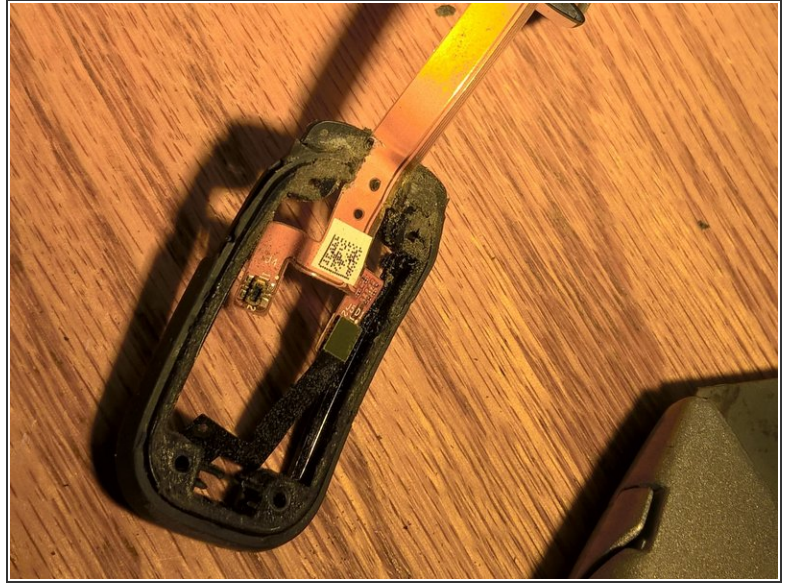
Step 3

- Remove the plastic 'sandwiching' the ribbon as it travels into the clasp end, with a Dremel or knife. (Picture 2 illustrates the removed plastic.)

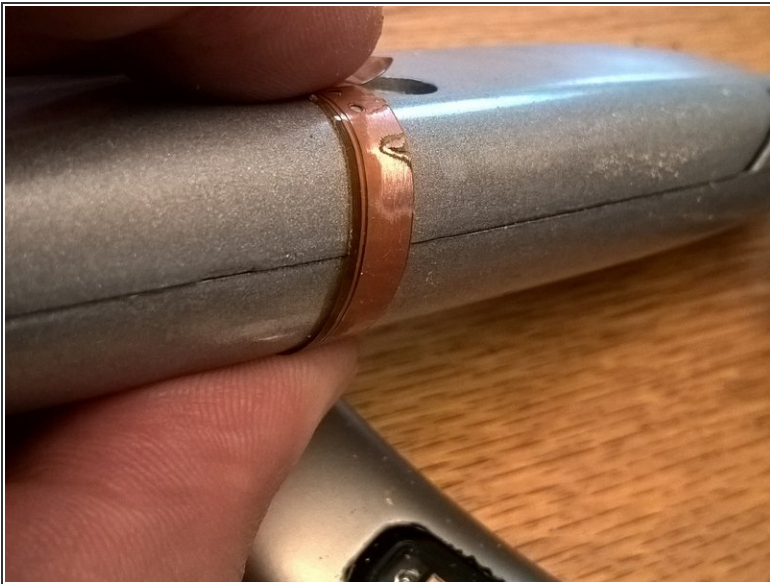
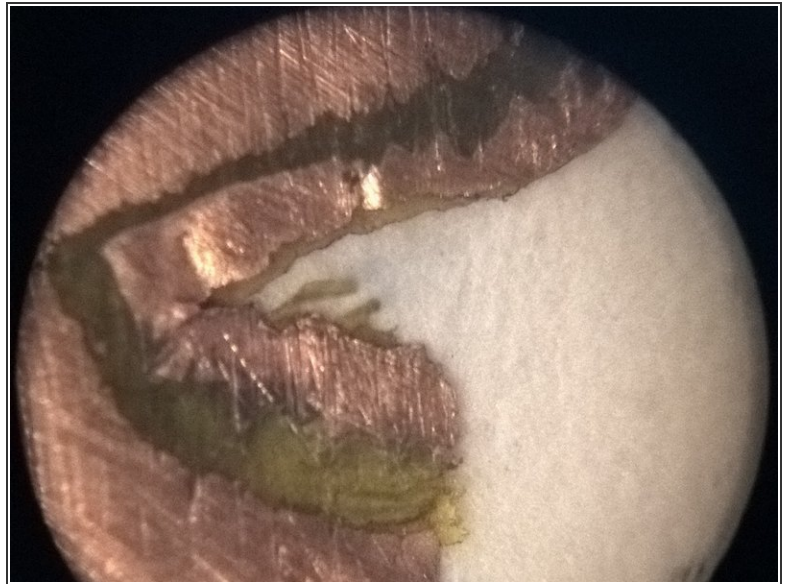
Step 4

- Sand the ribbon to expose the conductors on both sides. Be careful to keep the insulator in between the two conductors intact, so they don't short. The second picture shows a 10x image of the layers of copper and insulator.

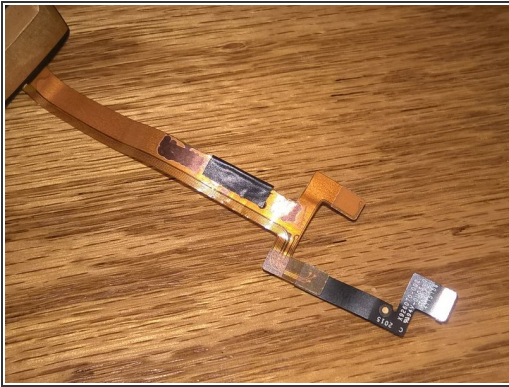
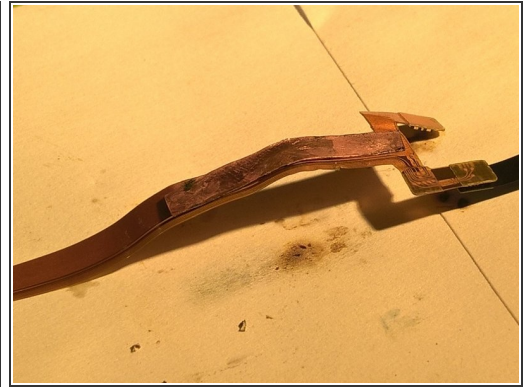
Step 5

- Wrap the repaired break with insulating tape. Sand away outer insulator on both sides to make soldering locations for jumper strips.

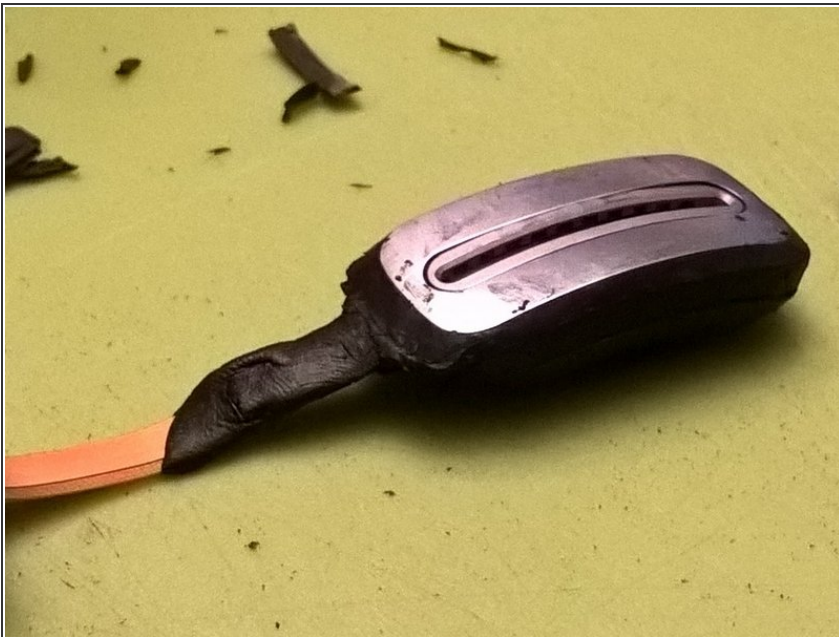
Step 6

- Use Sugru to wrap/stabilize the repair and integrate it into the clasp end's rubber.

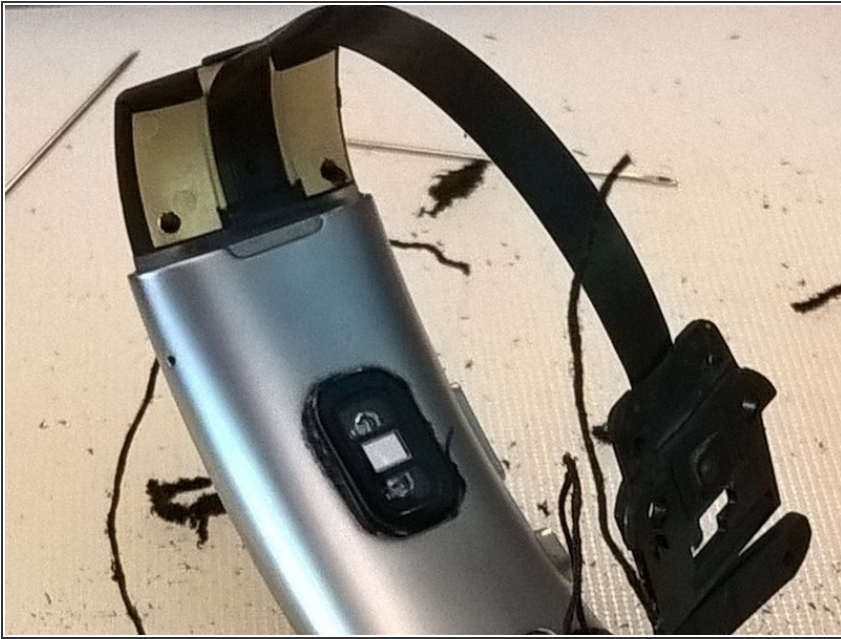
Step 7

- Drill two holes into clasp-end plastic tabs, and two holes on each side of watch face's 'shoulders', as anchor points for thread to fasten strap leather. (Hole locations are the black dots on the gold metal near the silver casing.)

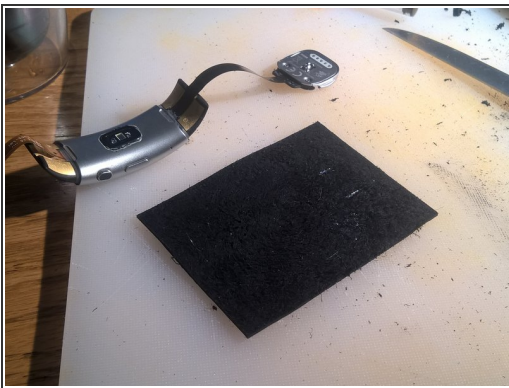
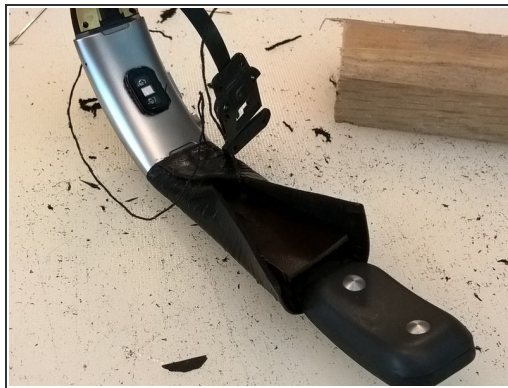
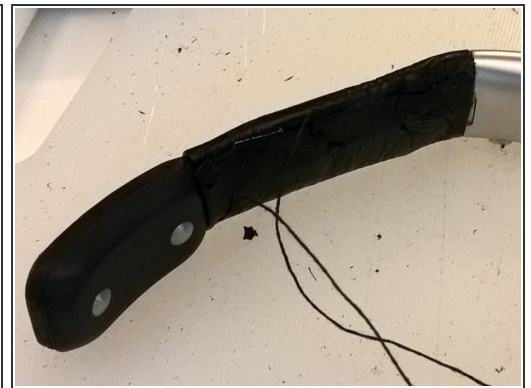
Step 8

- Build new leather straps; fasten using thread through holes & glue.
