Acer One 10 S1003-19GY WiFi Antenna Replacement

Use this guide to replace the Acer One 10 S1003-19GY.

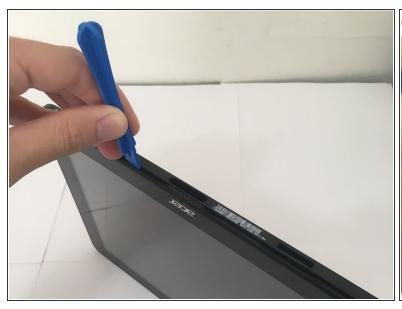
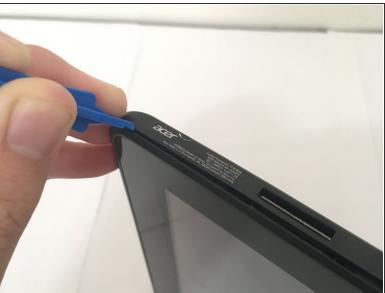
Step 1 — Back Panel

- Power off the device and make sure it is disconnected from any external devices.
- Use a plastic opening tool to create a gap between the front and back casing of the device.
- Slowly maneuver the plastic tool around the entire perimeter of the tablet to separate the front and back.

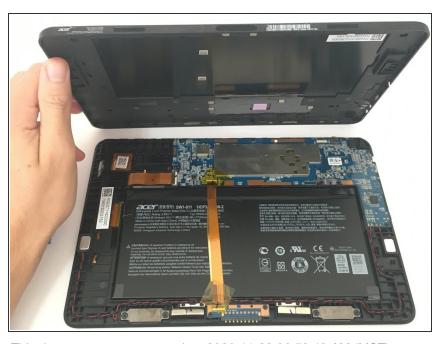
Step 2

Set the device screen side down and remove the back casing.
