# Ryobi RJ1861V Saw Bar Assembly Replacement

This guide demonstrates how to remove and replace the saw bar assembly in a Ryobi RJ1861V reciprocating saw.

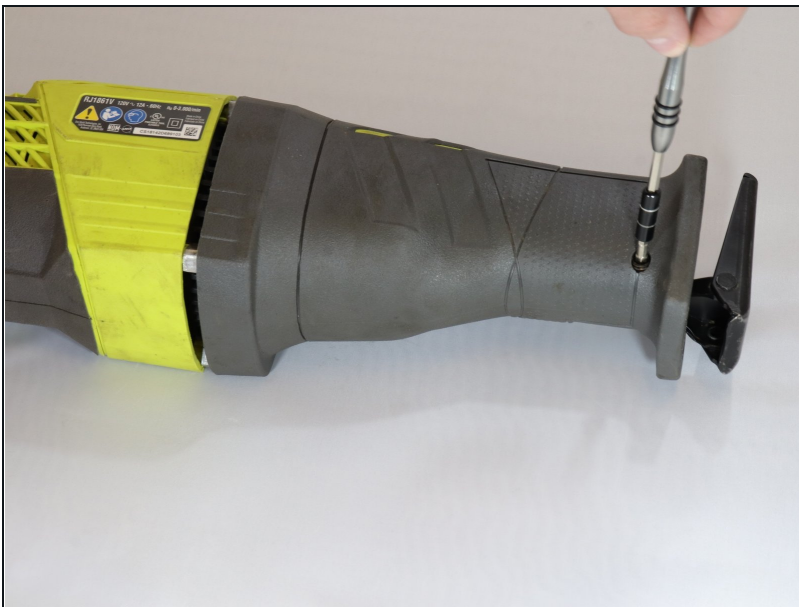
## Step 1 — Saw Bar Assembly

- Use a Torx T5 screwdriver to remove the single 8 mm screw securing the shoe.

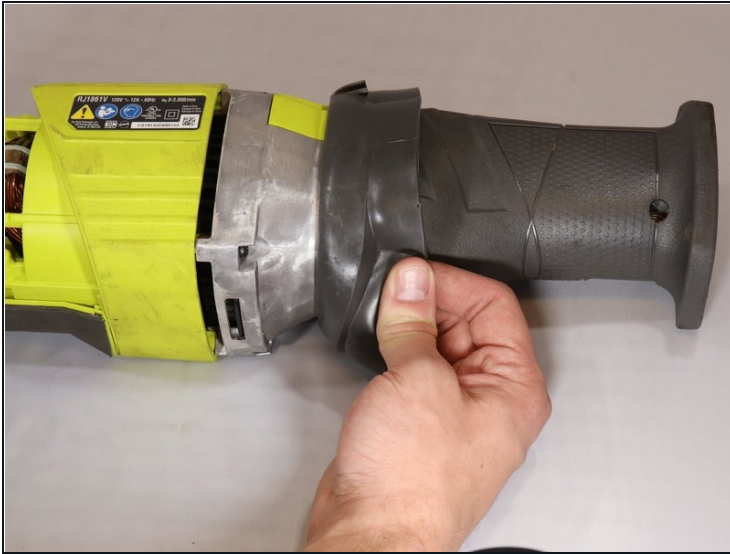
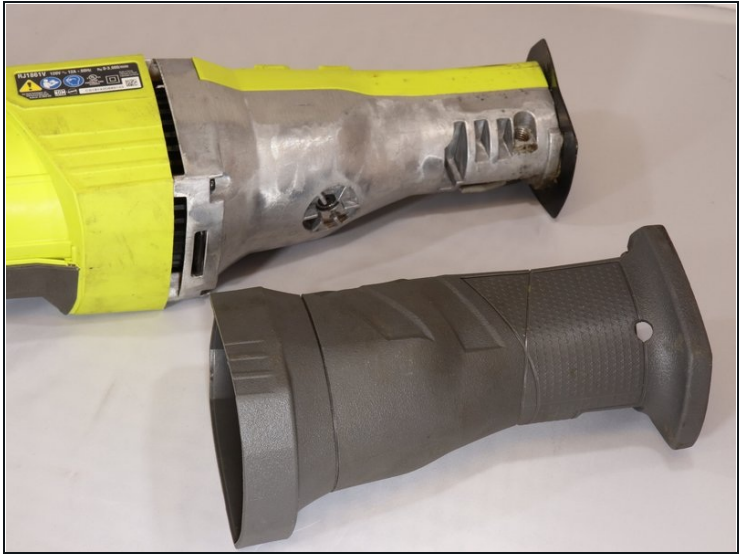
## Step 2

- Remove the rubber sleeve.
  - ① You may have to use some force as it has a tight fit.

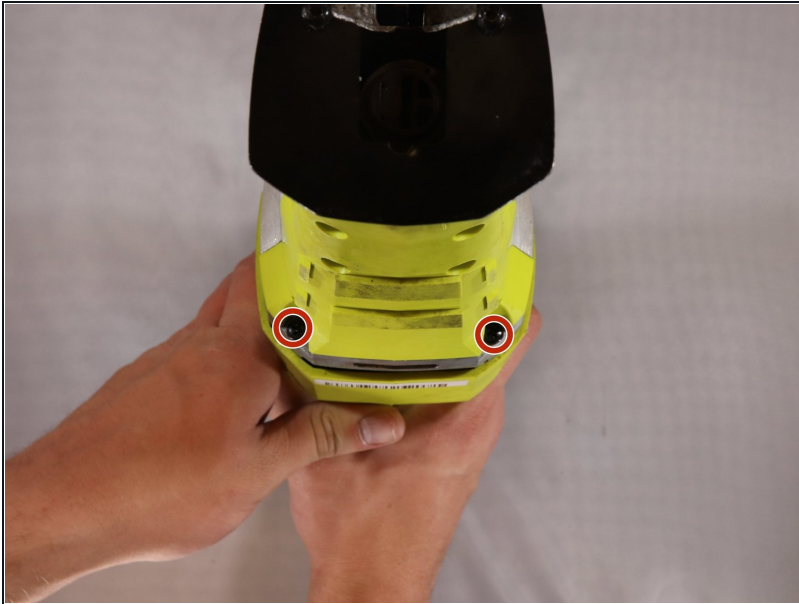
## Step 4

- Use a Torx T5 screwdriver to remove the four screws on the top of the gear case.
- ① There are two screws on each side of the device.

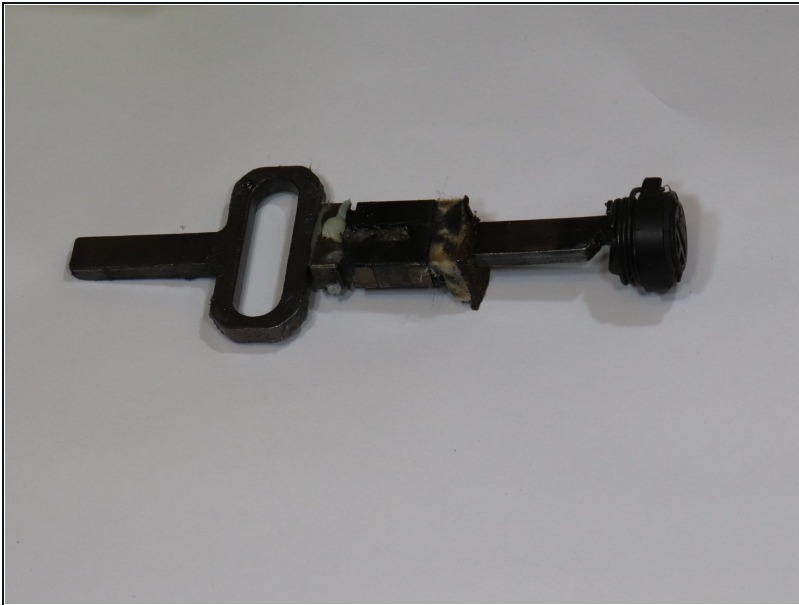
## Step 7

- Lift the assembly bar up and out of the chassis.
