Acer TravelMate P653-V-6882 RAM Replacement

This guide will help you in replacing the RAM in your Acer TravelMate P653-V-6882.

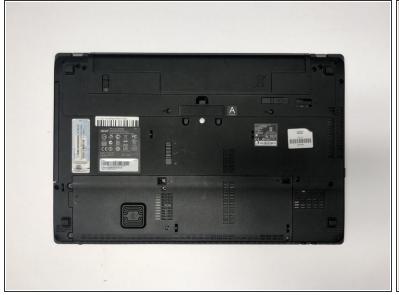
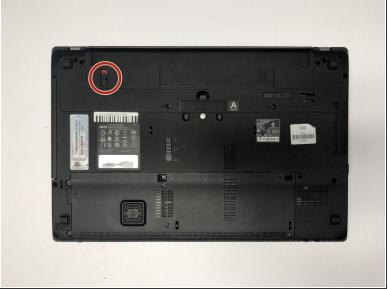
Step 1 — Battery Pack

- Turn the computer over so the base is facing up.
- Slide the battery lock to unlock position.

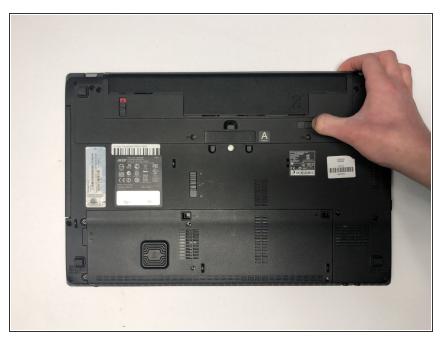
Step 2

- Slide the battery release latch to the right.
- (i) The battery pack will pop out.

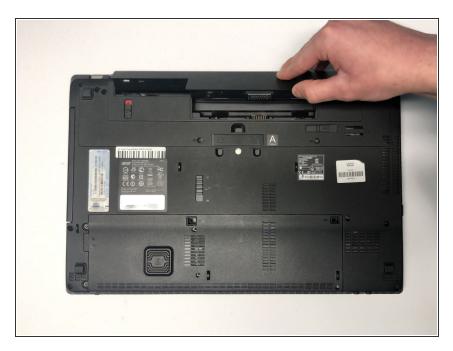
Step 3

- Lift the battery up.
- Pull out the battery.

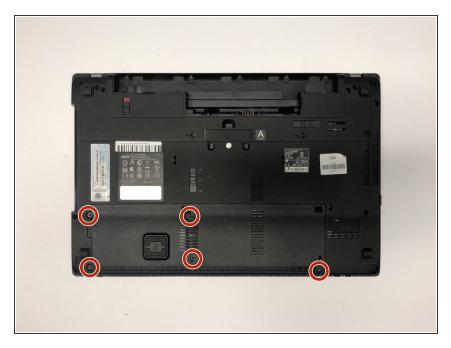
Step 4 — Base Door

Remove the five 7mm Phillips #1 screws.

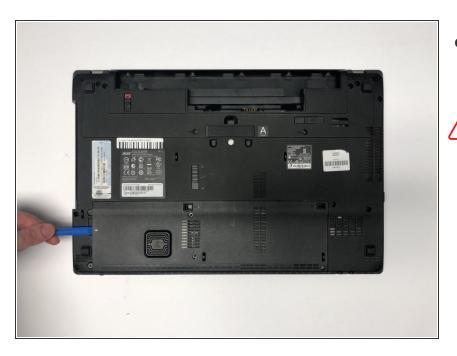
Step 5

- Use the opening tool to separate base door from the bottom of the laptop.
- Be careful not to bend or crack the plastic back cover.

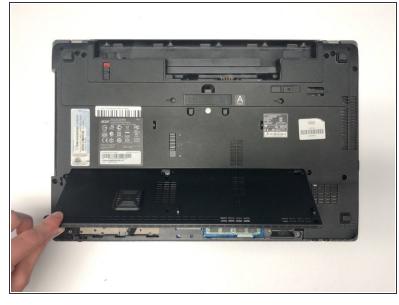
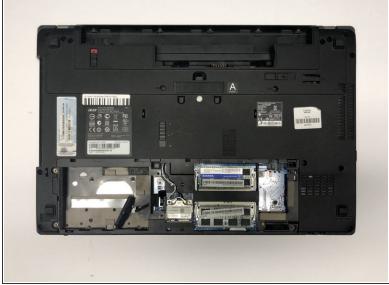
Step 6

- Gently pry open the base door by pushing up.
- Pull out the base door.
- A Be careful not to bend or crack the plastic back cover.

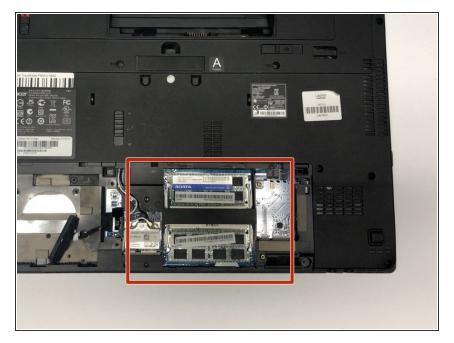
Step 7 — RAM

Locate the two RAM sticks on the bottom of the laptop.
