Acer Aspire 5750Z-4566 Hard Drive Replacement

How to replace the hard drive of my Acer Aspire 5750Z-4566.

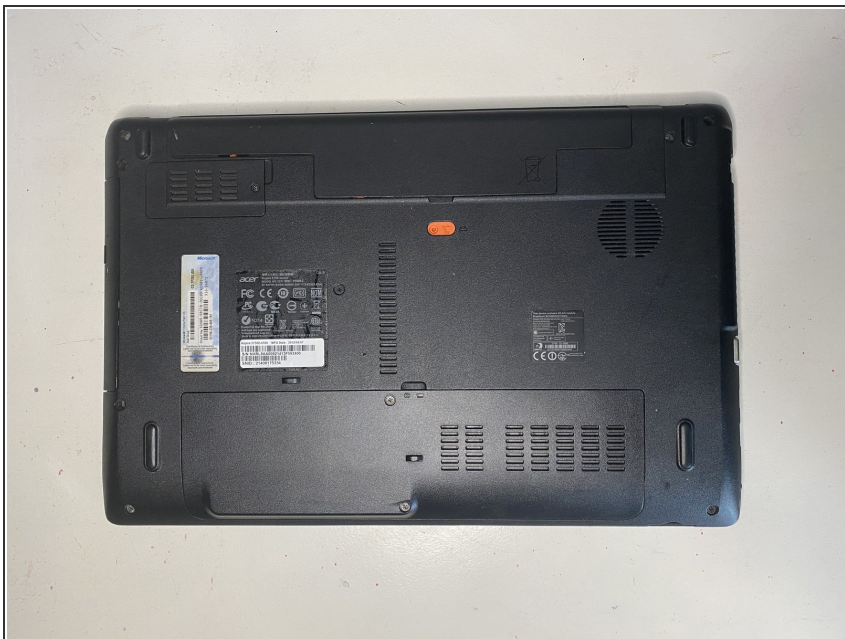
Step 1 — Hard Drive

- ❗ Power off your laptop before beginning disassembly.
- Flip the laptop over.

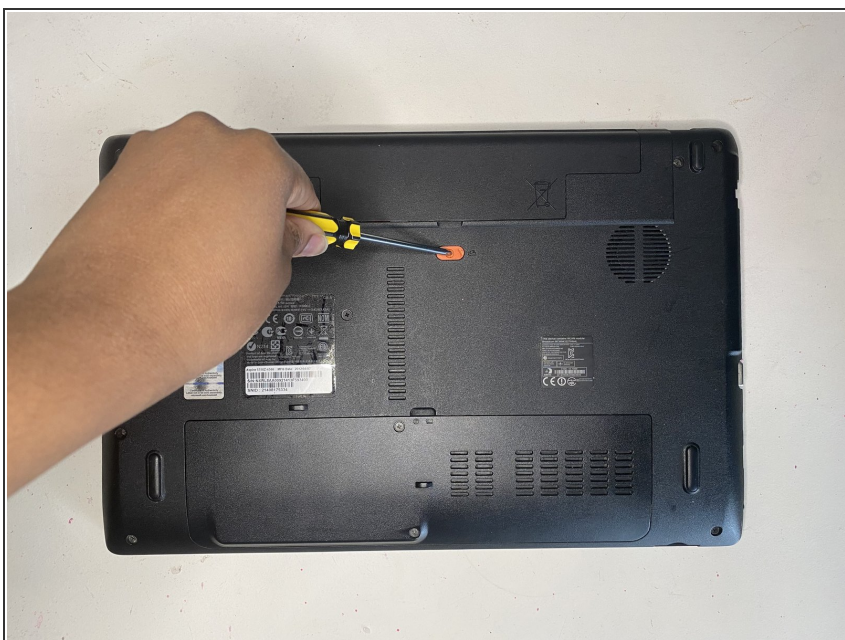
Step 2

- Place a screwdriver or a pen in the orange tab, then slide it to the right.

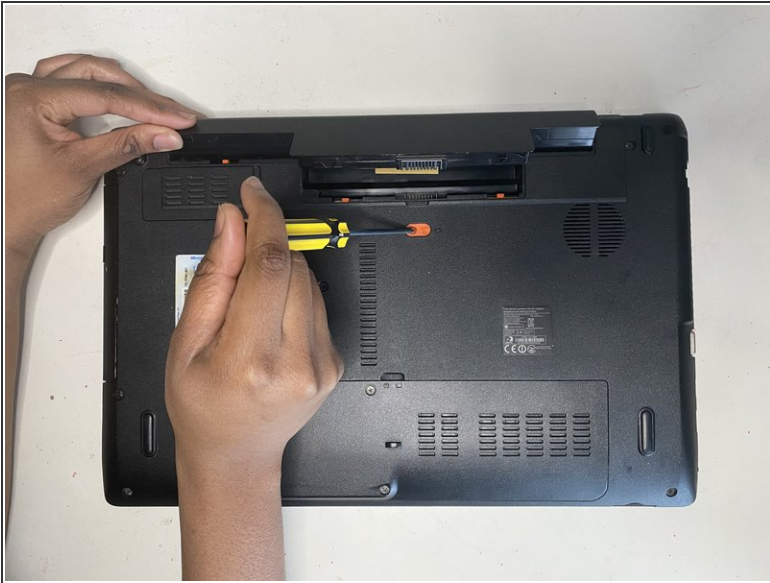
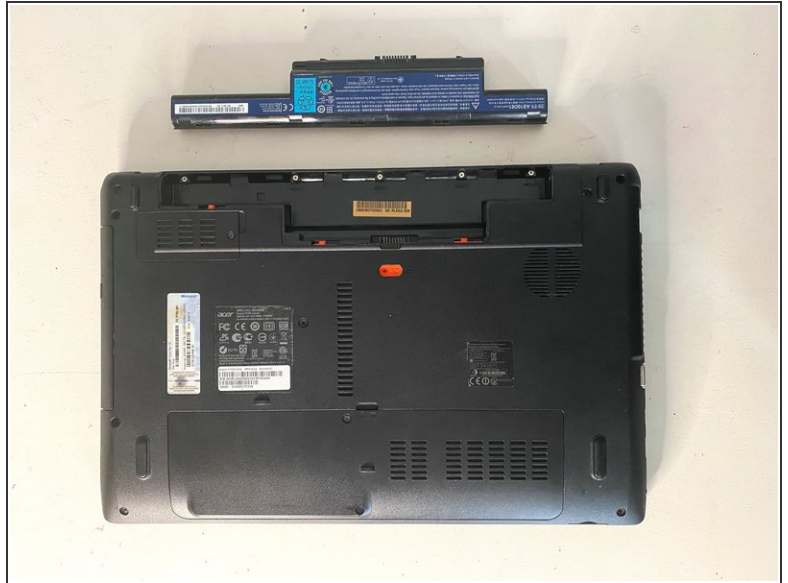
Step 3

- Slide the battery out and remove it.

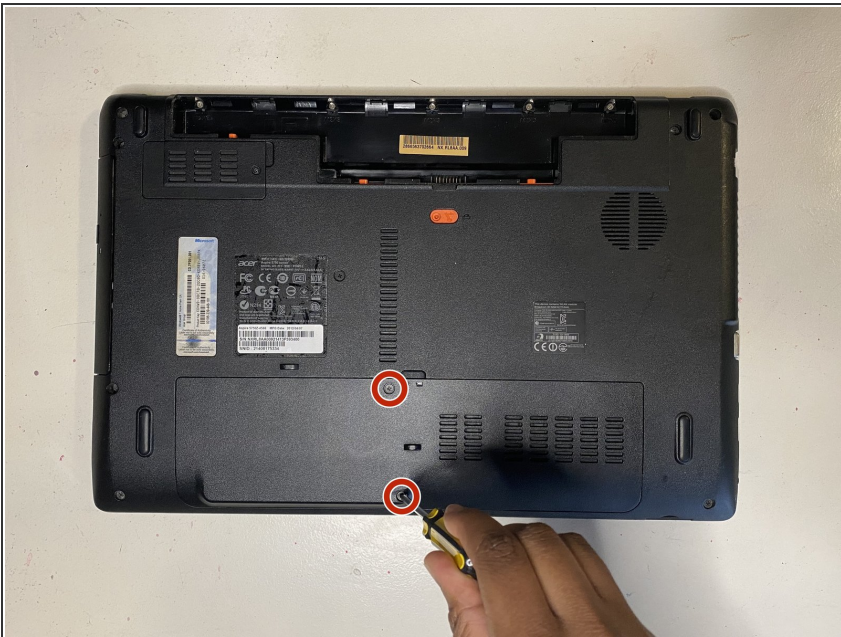
Step 4

- Remove the two M2.5X8 screws using the Phillips #0 screwdriver.

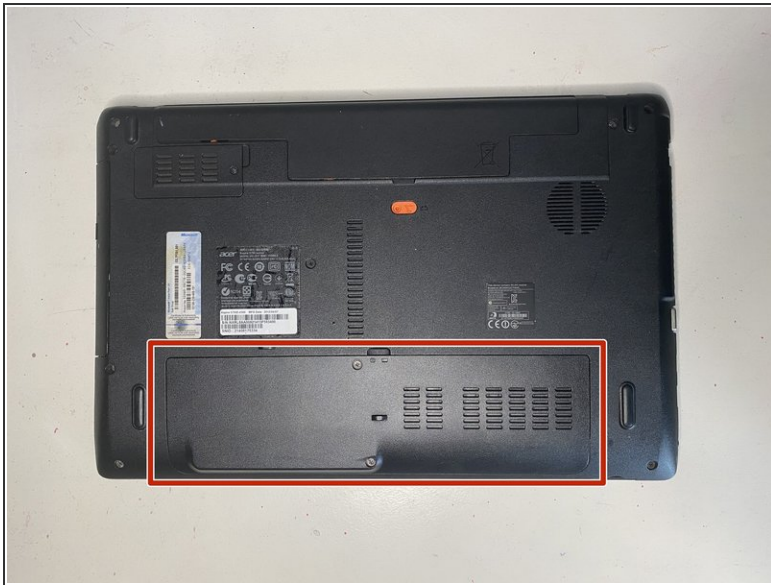
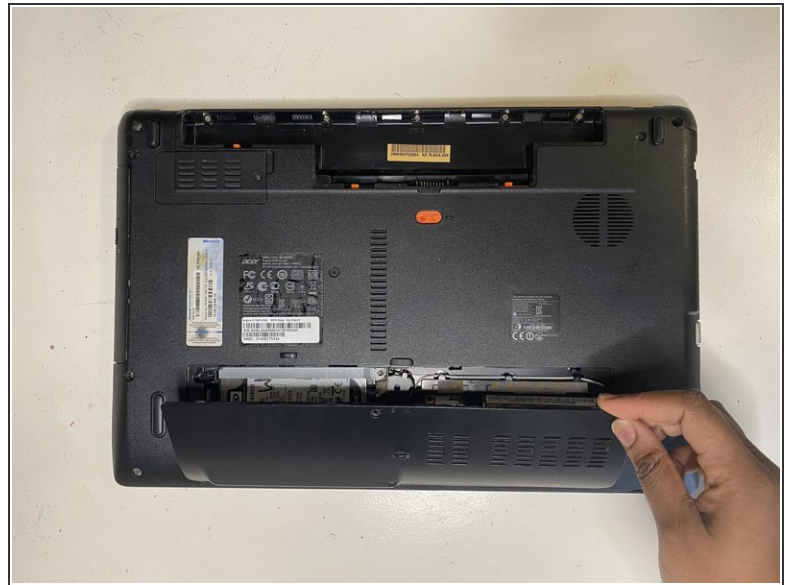
Step 5

- Remove the cover to access the hard drive.

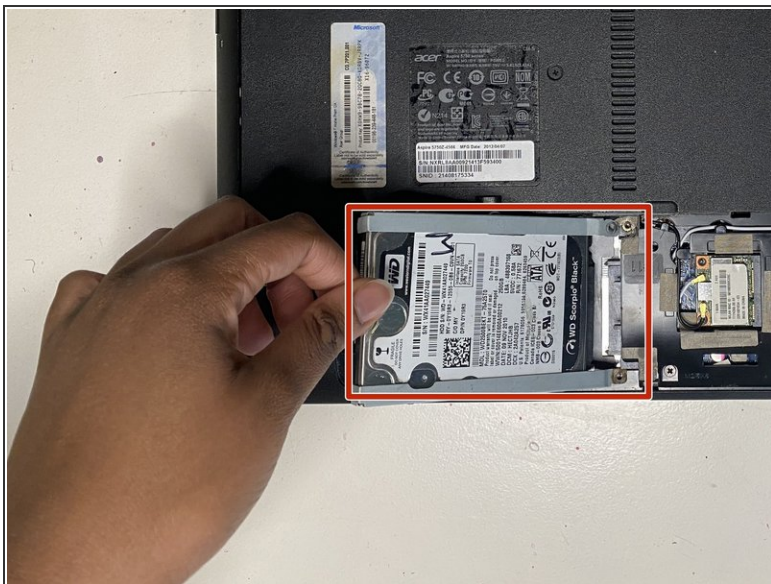
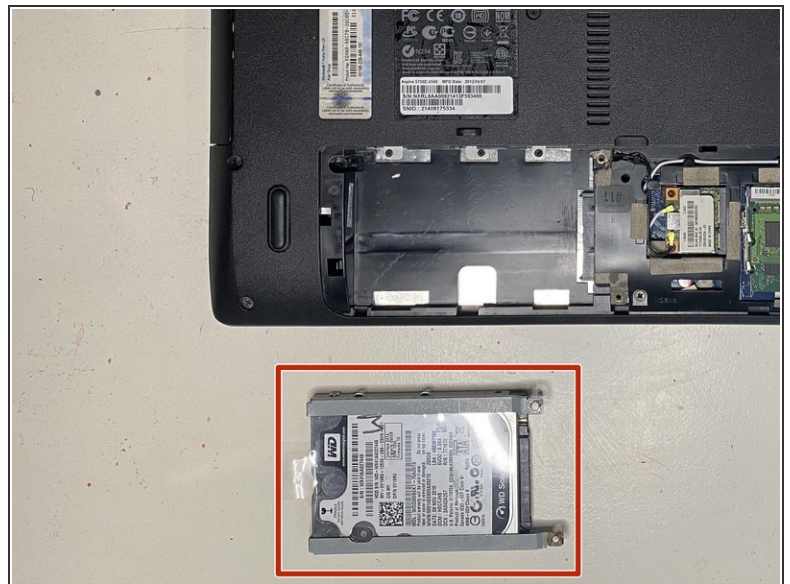
Step 6

- Pull the tab and lift up to remove the hard drive.

To reassemble your device, follow these instructions in reverse order.
