Nokia Lumia 900 Front Camera Replacement

A guide for removing the front camera of your Nokia Lumia 900 Windows Phone.

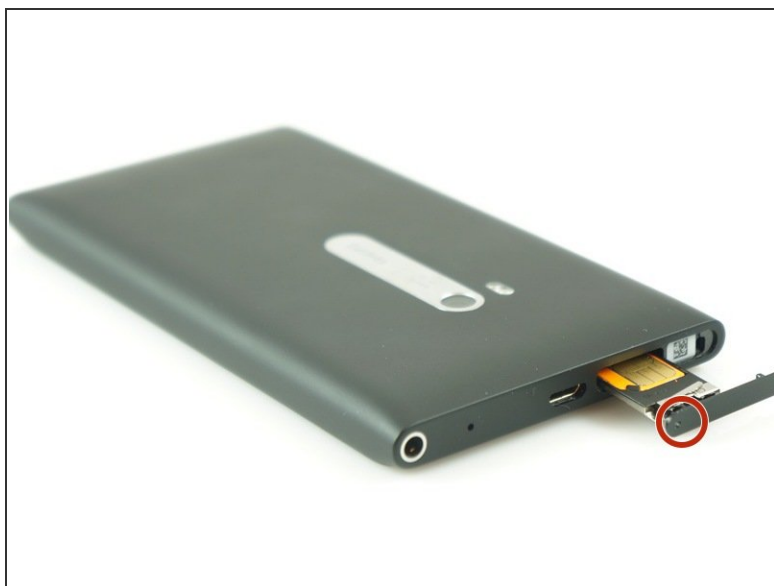
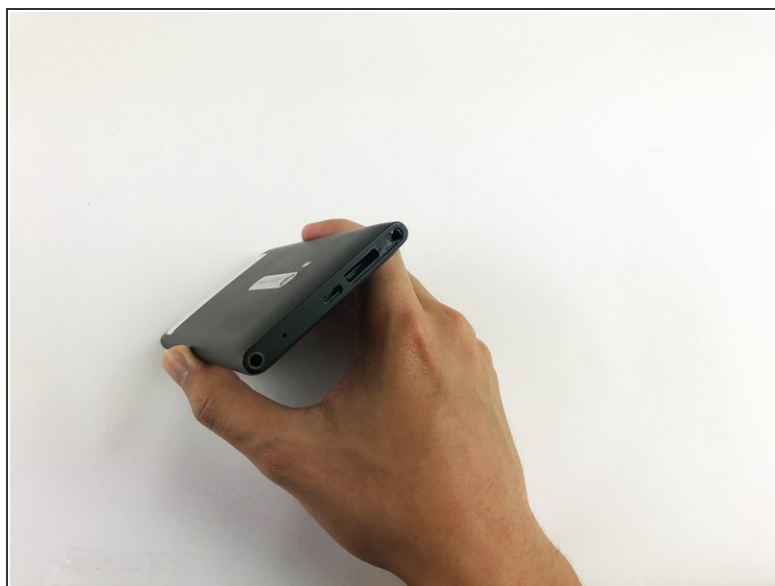
Step 1 — Screen

- Insert the pointed end of the spudger into the sim card port indicated by the picture. Then proceed to remove the sim card port entirely.

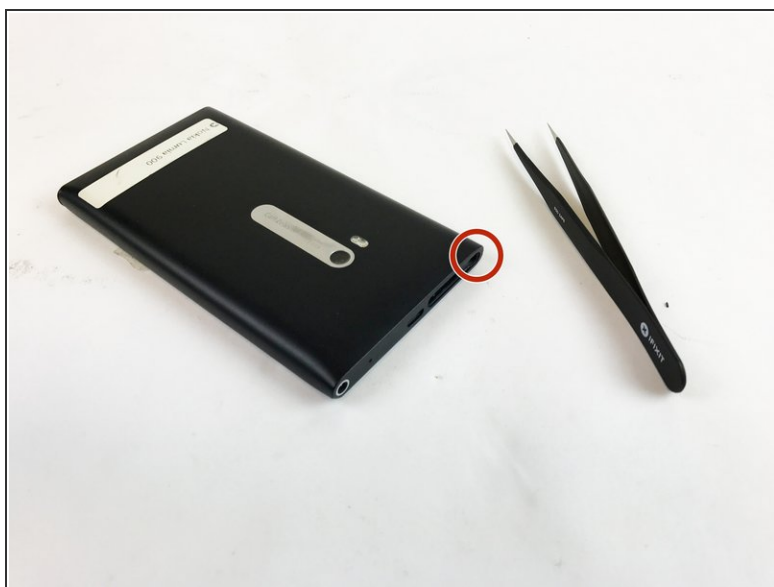
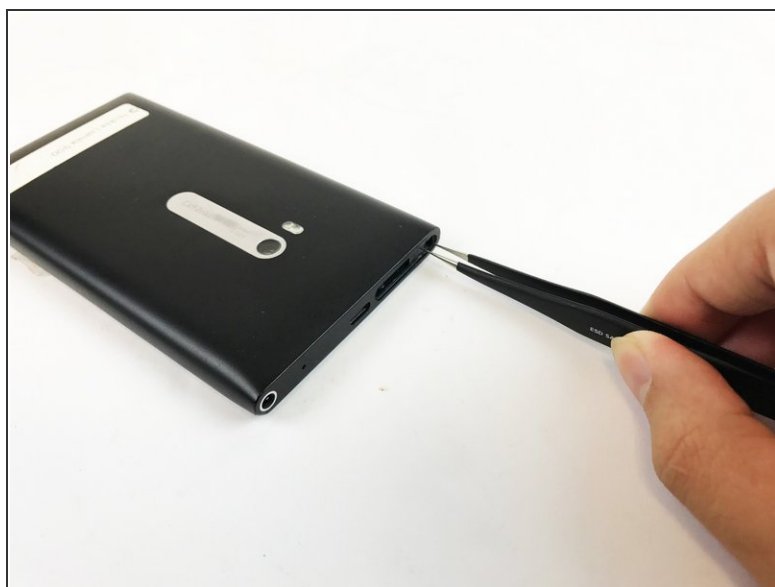
Step 2

- Use tweezers to remove the small rod in the port indicated in the picture.

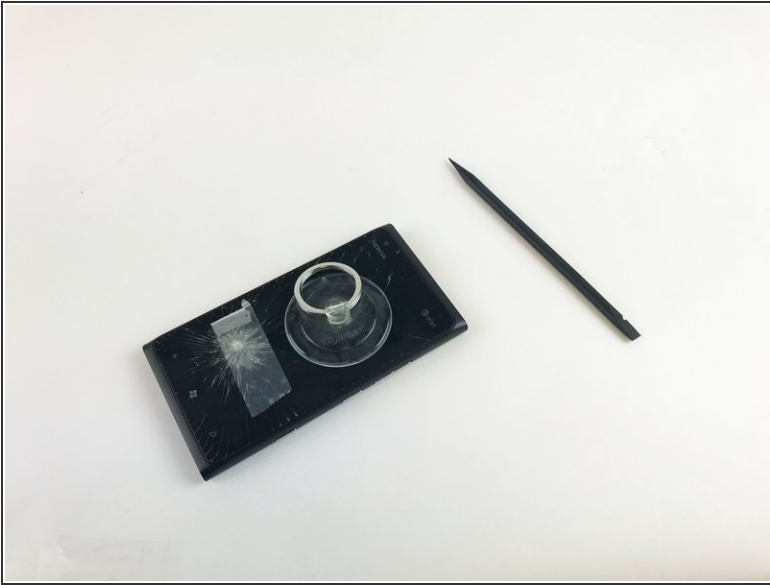
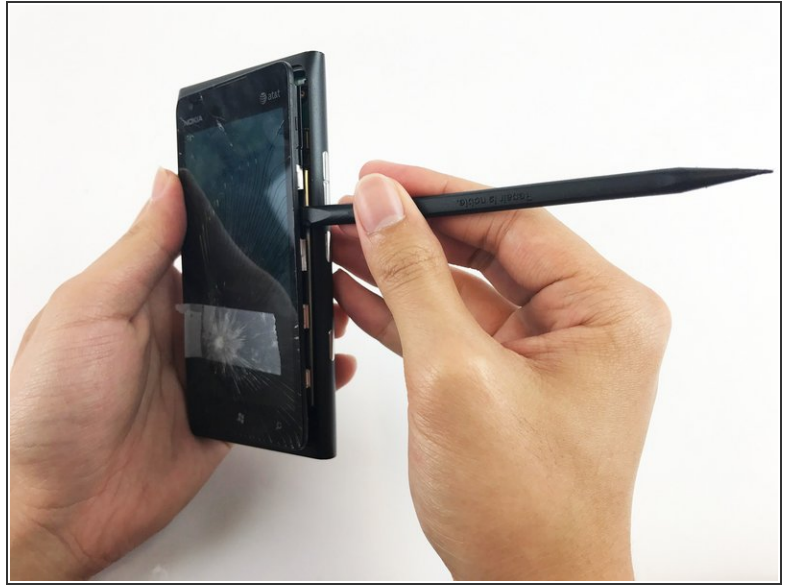
Step 3

- Separate the screen from the motherboard by prying it open with the spudger along with pulling upwards with the suction cup.

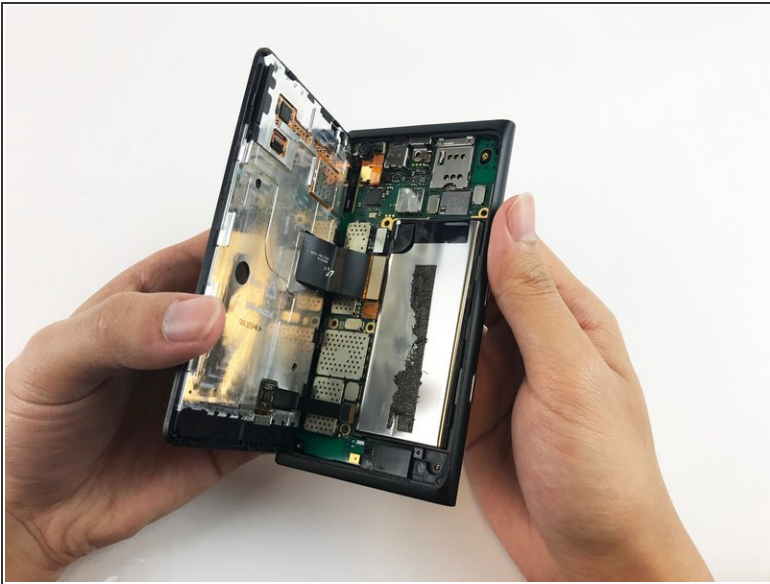
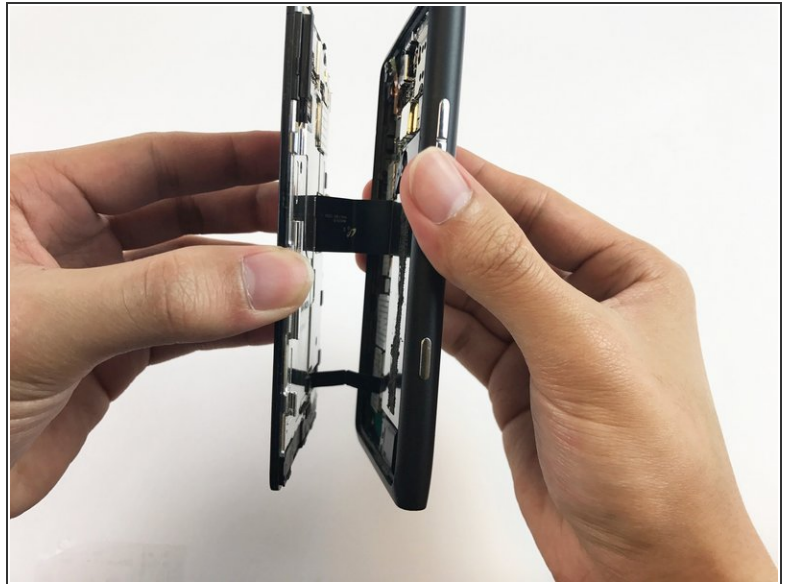
Step 4

- Gently pull apart the screen from the motherboard, with only the ribbons connected from the motherboard to the screen.

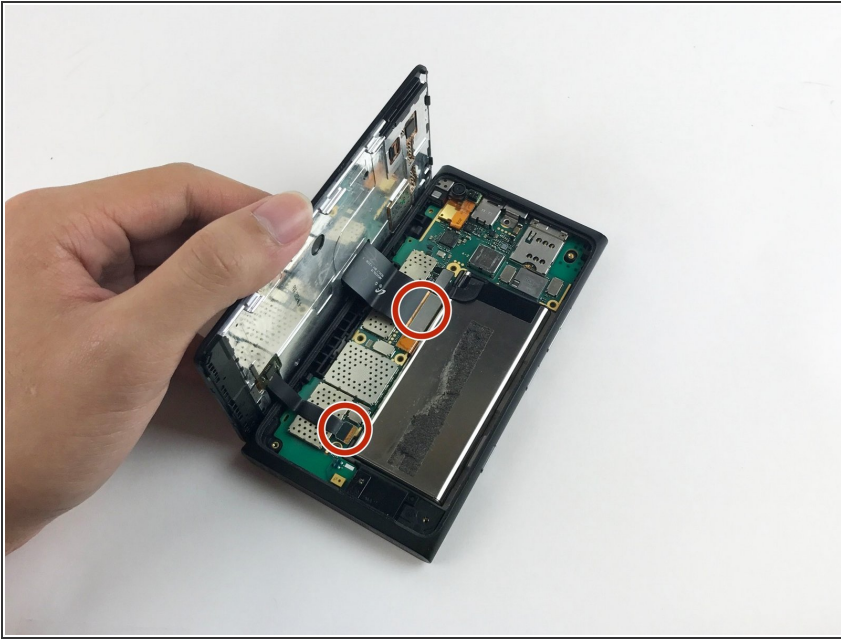
Step 5

- Disconnect the No-fuss cables from the motherboard by gently prying them up using the flat end of the black stick spudger. Make sure not to bend or crease the cable.
- Remove the screen.

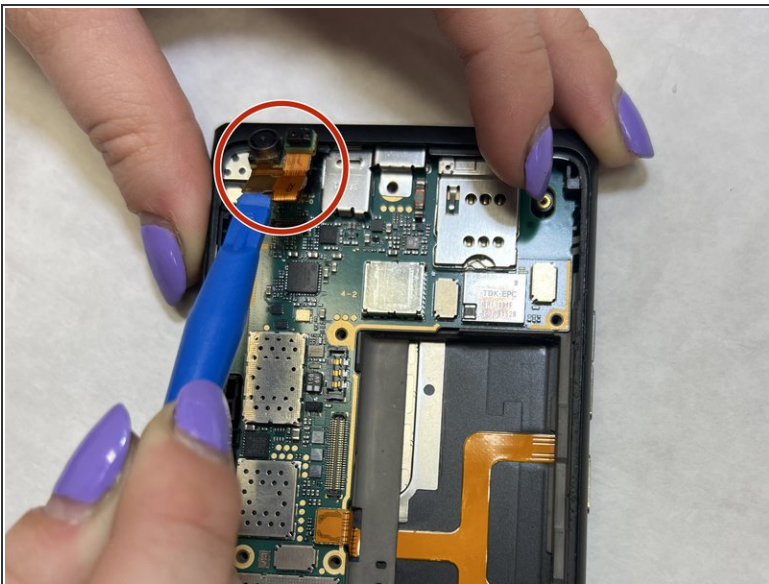
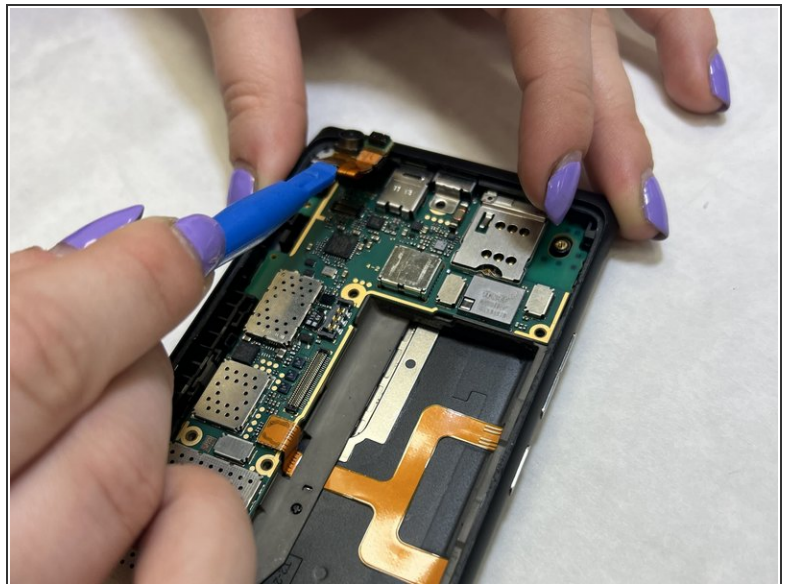
Step 6 — Front Camera

- Use the iFixit iOpener or another heat source to gently heat the top left corner until the adhesive under the camera softens.
- Use the plastic opening tools to carefully lift the front camera from the motherboard.
