Mac mini Late 2014 SSD Replacement

Replace the blade-style PCIe SSD in a Mac mini Late 2014.

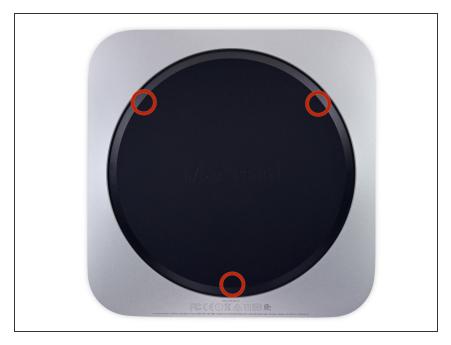
Step 1 — Bottom Cover

- The bottom cover is clipped onto three screw posts.
- Pry near, but not right on the screw posts.

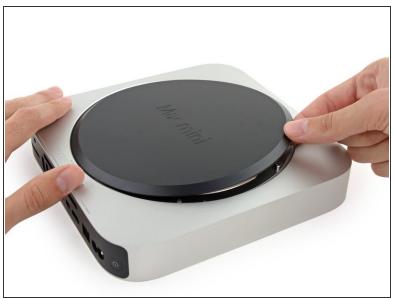
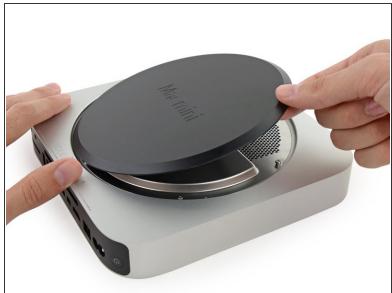
Step 2

Use the plastic opening tool to pry the bottom cover up off of the Mac mini.

Lift and remove the bottom cover.

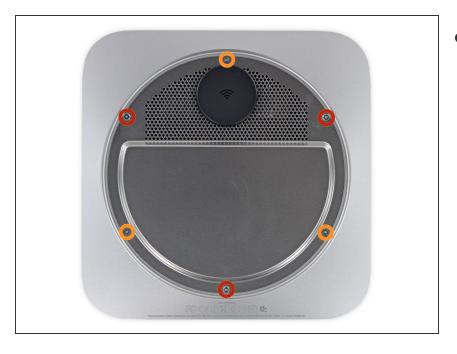
Step 4 — Antenna Plate

- Remove the following TR6 screws from the antenna plate:
 - Three 4.1 mm screws
 - Three 1.9 mm screws

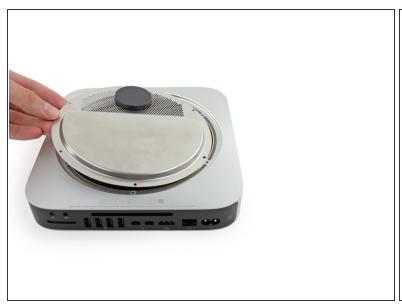
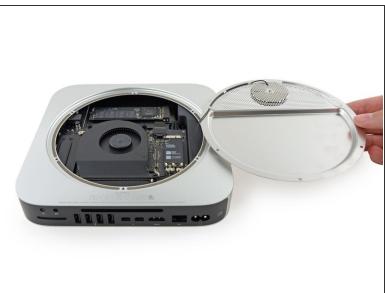
- ⚠ Do not completely remove the antenna plate; it is still connected to the Mac mini by an antenna cable.
- With the I/O ports facing you, flip the antenna plate to the right to allow access to the antenna cable connector.

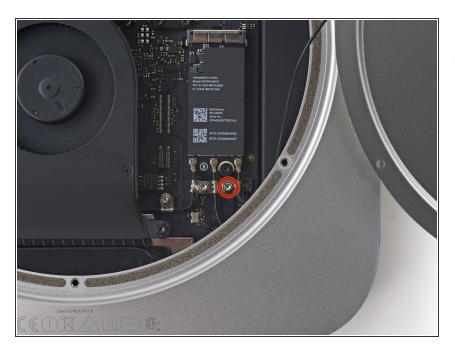
Step 6

- Remove the single 3.4 mm T6 screw and washer from the antenna cable.
 - Be careful not to lose the washer when removing the screw.

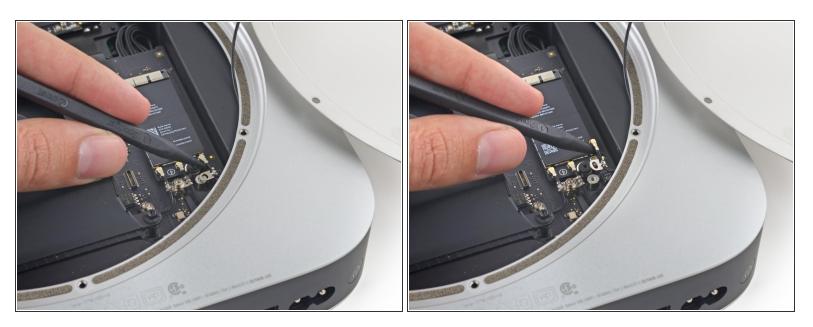
Use the point of a spudger to lift the antenna connector straight up off its socket on the airport card.

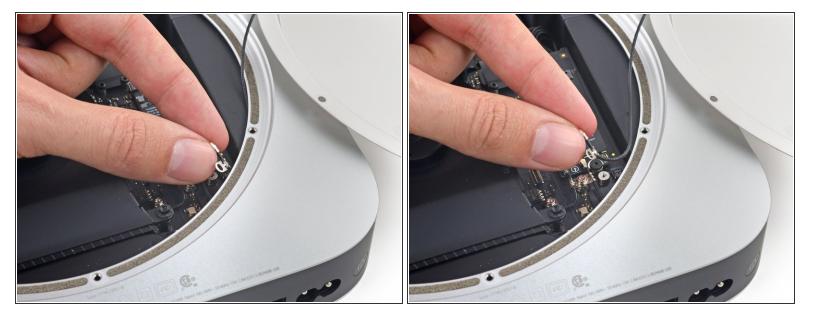
Step 8

Carefully pull the antenna cable out from the gap between the power supply and case.

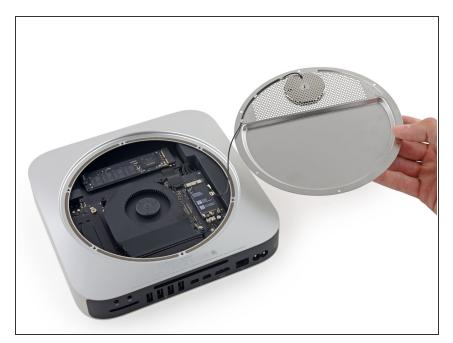
Remove the antenna plate from the Mac mini.

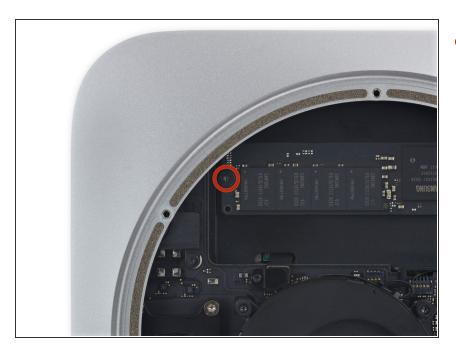
Step 10 — SSD

Remove the 5 mm T5 screw securing the SSD.
