# Sony Xperia T2 Ultra Dual Audio Jack Replacement

No audio? Replace the headphone jack!

This guide can be used to replace the headphone jack.

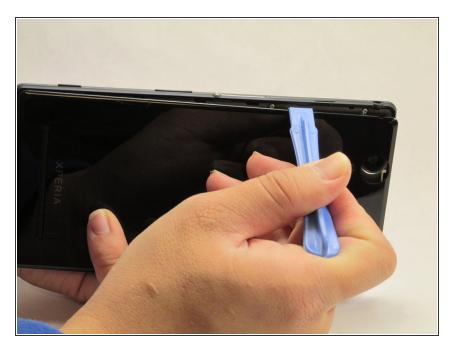
## Step 1 — Rear Case

Using the spudger, pry open the back cover by starting alongside the edge of the back cover.

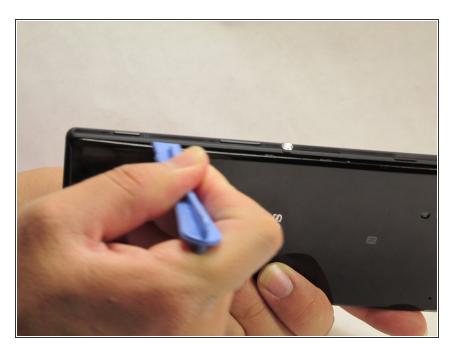
## Step 2

Once the part of the back cover has been opened up. Slide the spudger to pry completely detach the cover from the phone.

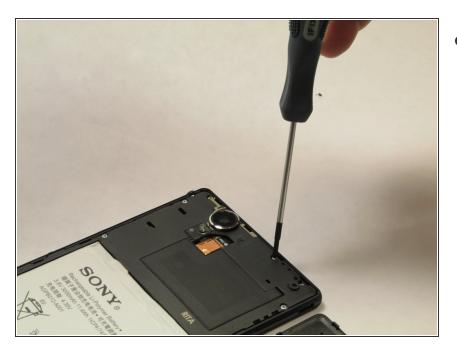
## Step 3 — Removing the internal cover

Using the Phillips #00 Precision screwdriver, take out 8 silver screws (3.15mm) and 5 gold screws (3.9mm) for a total of all the screws attached to the flat plate. 3 of the gold screws are located at the top of the phone and the other 2 screws are located at the bottom of the phone.

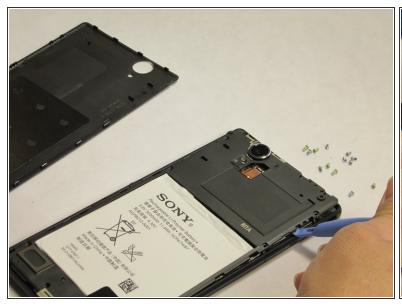
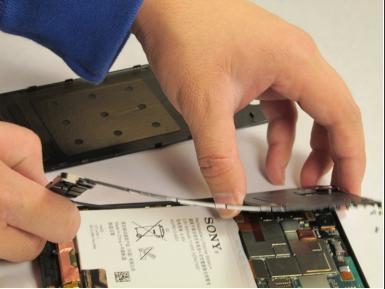
## Step 4

To remove the internal cover, use the plastic spudger tool and pry the cover from the phone as shown in the picture.

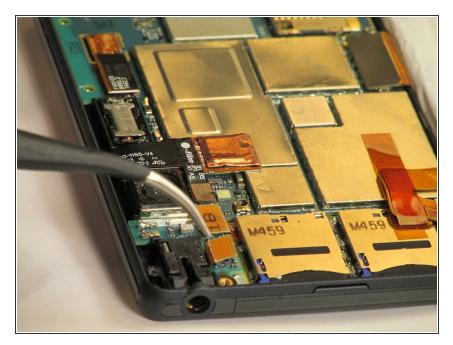
## Step 5 — Removing chip

Using tweezer, locate the audio jack as shown and pull out the chip connected to the motherboard.

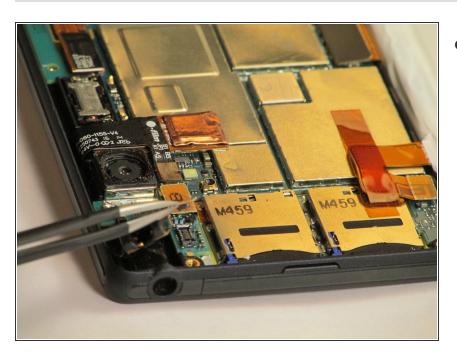
## Step 6 — Remove audio jack

Carefully remove the audio jack by using the tweezers and pull firmly straight out of the motherboard.

To reassemble your device, follow these instructions in reverse order.
