Philips Norelco 5801XL Front and Back Housing Replacement

This guide outlines how to remove and replace the device housing of a Philips Norelco 5801XL.

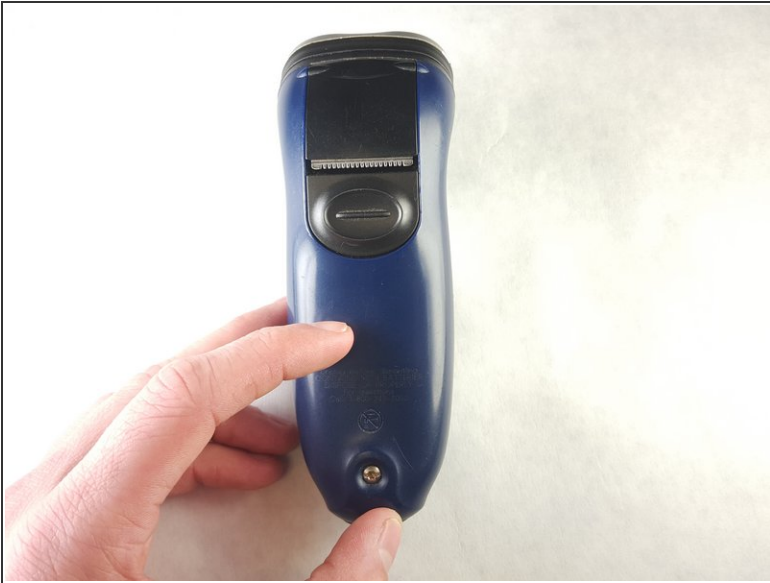
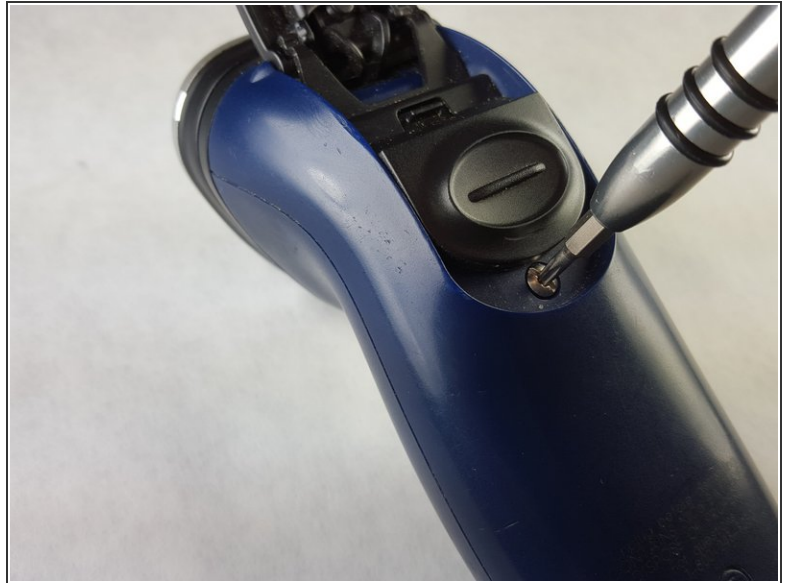
Step 1 — Front and/or back housing

- Remove the two T8 2 mm Phillips screws on the back housing.

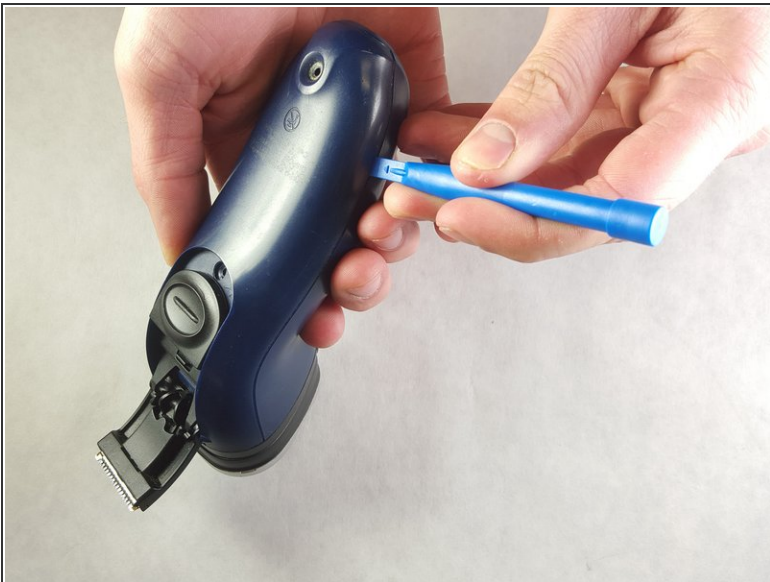
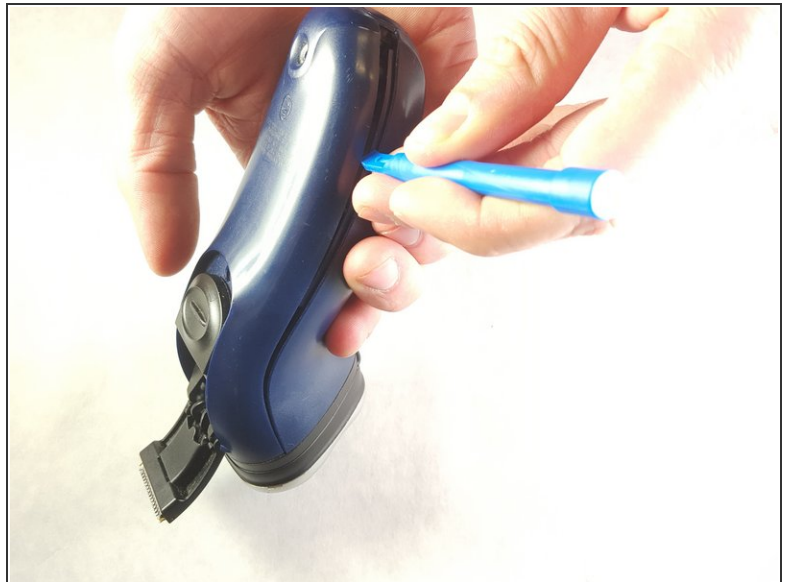
Step 2

- Separate the back housing and the front housing using the plastic opening tool.

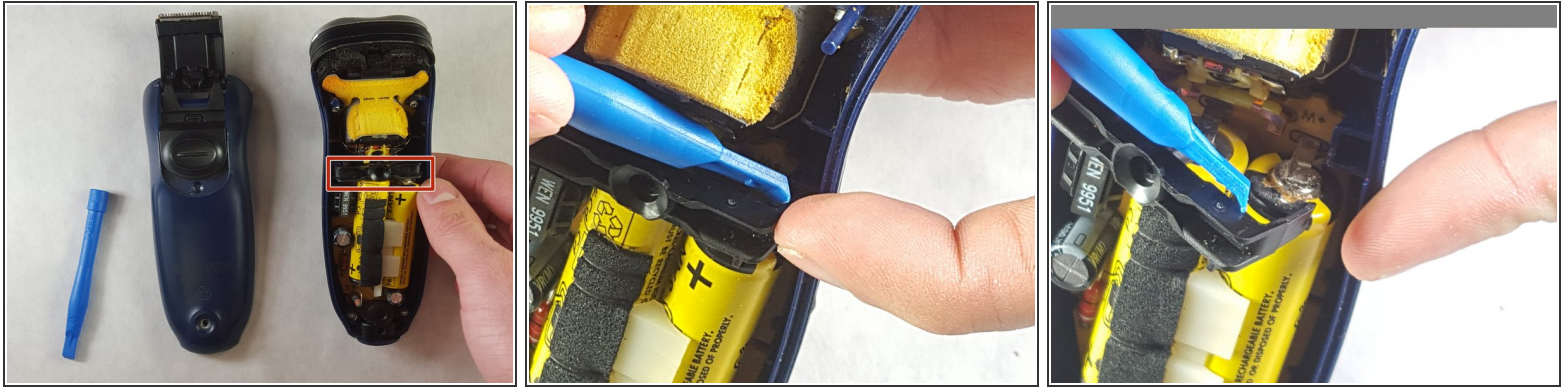
Step 3

- Using the plastic opening tool, carefully pry the inside of the middle bracket towards the outside of the housing in order to remove it.

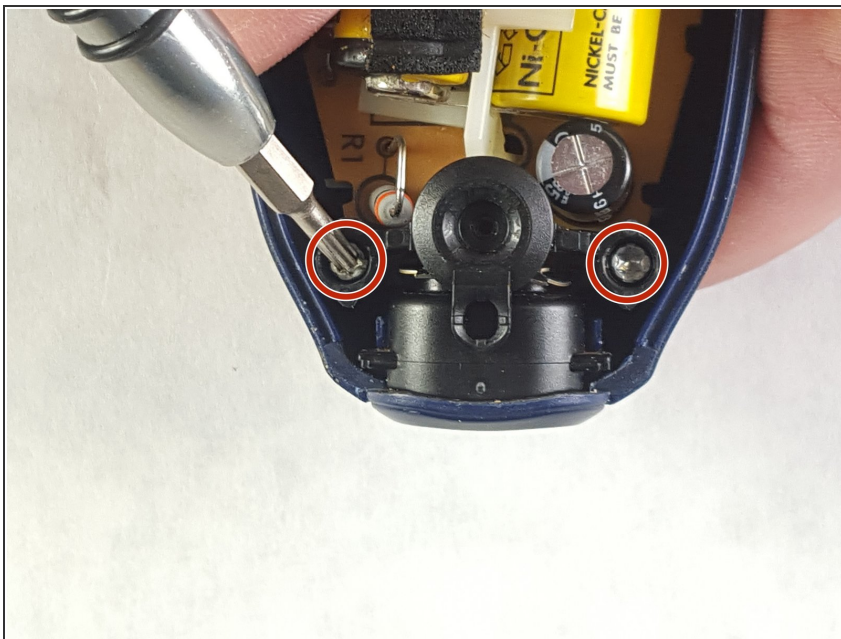
Step 4

- Remove the two T8 2 mm screws near the bottom of the device.
- Remove the bracket the screws were holding in place.

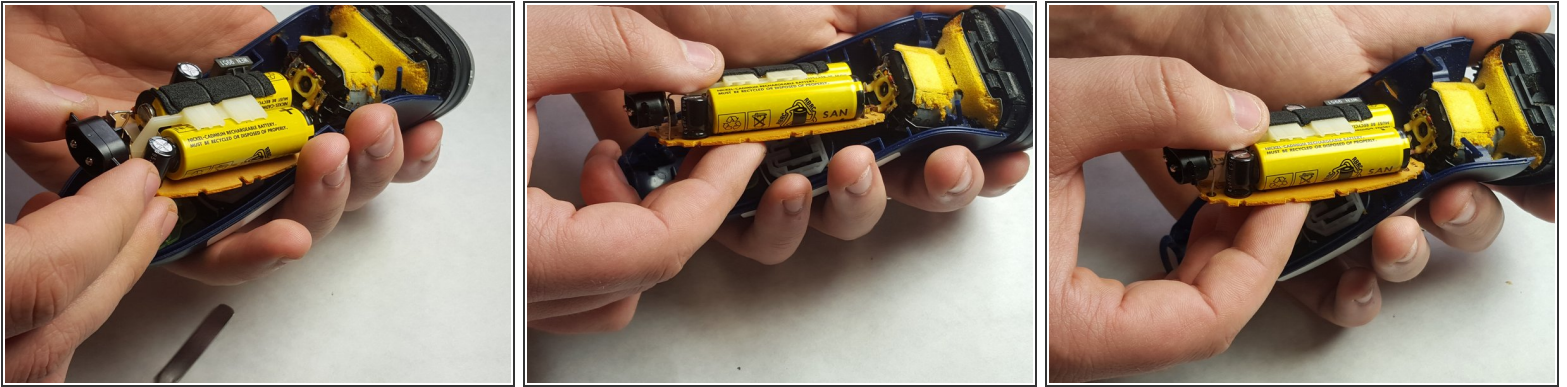
Step 7

Cautiously lift and twist the circuit board, then begin sliding the inside assembly forward.

- After sliding it forward, the whole assembly will separate from the rear housing.

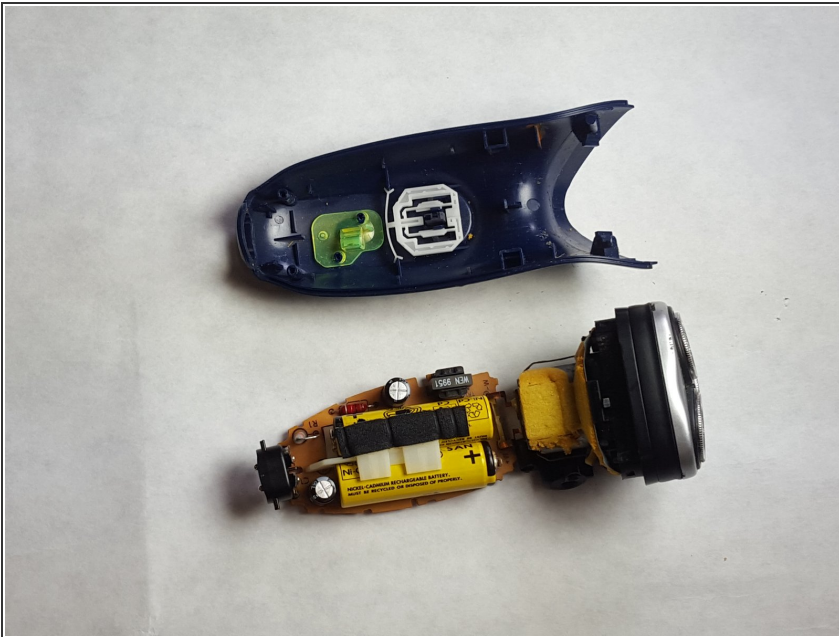
Step 8

- The housing and the inside assembly should be completely separated.

Now, you can put the new housing on. To reassemble your device, follow these instructions in reverse order.
