# Kodak ESP C315 - How to reseat printhead ribbon cable

Open the printhead assembly to reseat a disconnected ribbon cable

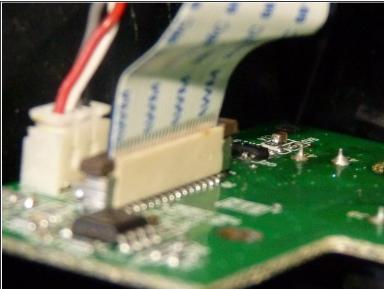
#### Step 6 — Reseating Ribbon Cable Part 2

- Lift the brown holding tab up on the connector (Image 1 orange arrows)
- The ribbon only has writing on one side, that side needs to face towards the clear plastic sensor on the other end of the board
- Feed it into the connector and while holding it in place with your finger and thumb in the centre of the ribbon cable, push each side of the brown connector tab down until the connector grips the ribbon cable
- You should notice the tops of the metallic strips/pins stuck out the top of the connector should be uniform (Image 2). If you have put it in incorrectly, then there will be more of the strips/pins showing at one end or the strips will not be visible because it is in backwards

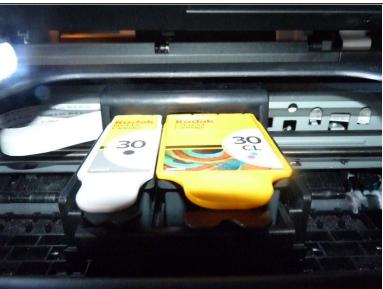
# Step 9 — Reassembly - Cartridges

- All that is left is to replace the printhead cartridge carrier tray ensuring you push against the white label (Image 1 orange arrow) until it clicks under the grey sprung catch (Image 1 red) and then replace the cartridges (Image 2) as normal ensuring they also click into place
- You can now move the assembly all the way to the right to park it
- Close the printer lid
- Restore power and test it moves at the request of the printer during start up sequence
