HP Compaq Presario CQ56-110US CD Drive Replacement

This guide will detail the process of replacing a CD Drive from the HP Compaq Presario CQ56-110US laptop.

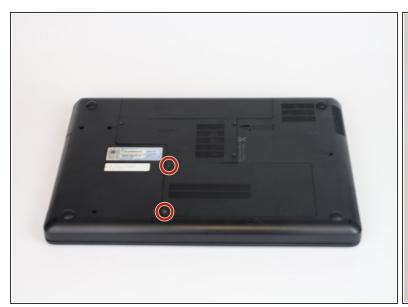
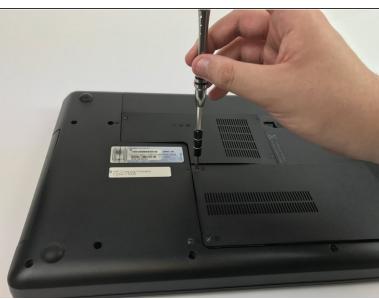
Step 1 — CD Drive

- Loosen the two indicated screws on the panel using a Phillips screwdriver with a PH1 head size.
- (i) The screws do not come free from the panel. They only need to be loosened enough so that the panel can be lifted/pried using a plastic opening tool.

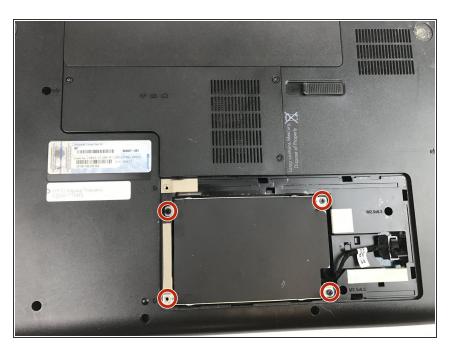
Step 2

Use the screwdriver to unscrew the four 5mm screws holding down the hard drive.

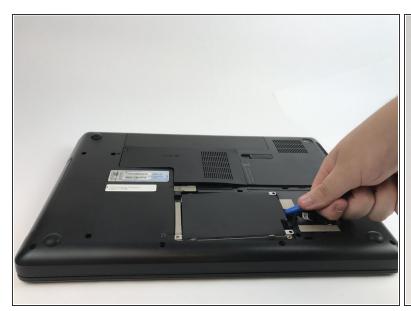
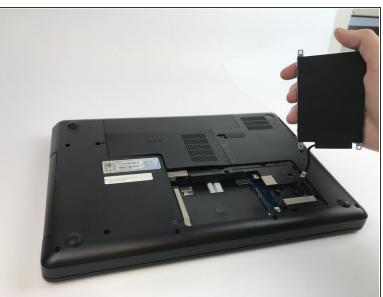
Step 3

Use plastic opening tools to lift up the hard drive. Set aside the hard drive without disconnecting the wire.

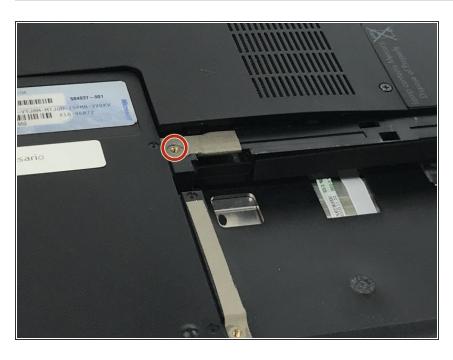
Step 4

Use a Phillips screwdriver with a PH0 head type to unscrew the indicated 5.5mm screw.

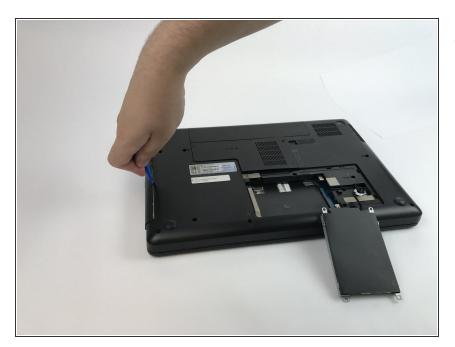
Step 5

Use plastic opening tools to pry open the CD Drive.

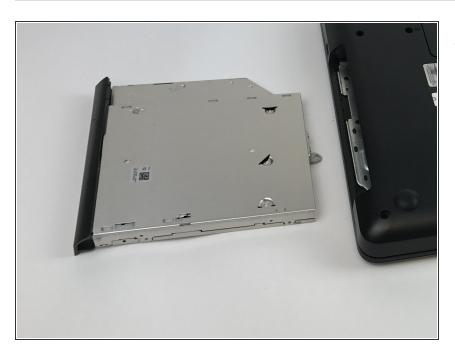
Step 6

Use your hands to pull the CD drive out and remove it from the laptop.
